**U.S. COAST GUARD
MARINE SAFETY OFFICE PORTLAND, MAINE**

SAFETY ALERT

Use of PVC piping in vessel systems

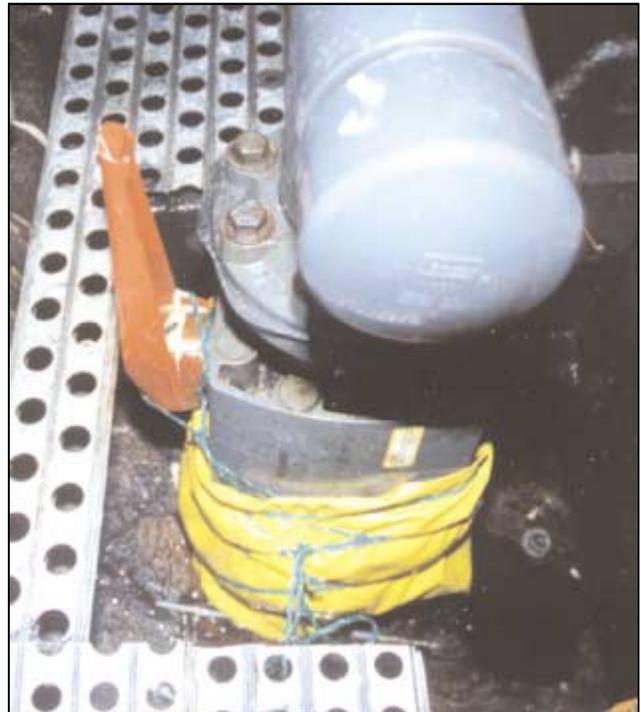
A large Portland based trawler experienced a flooding casualty at sea while steaming towards Portland on February 5, 1997. The source of the flooding was a cracked 4" seacock valve housing, which was damaged upon impact when a marine battery fell from a storage area located approximately 15 feet above the seacock.

The PVC seacock was part of the vessel's main engine raw water cooling system that was constructed entirely of PVC components from the through hull fitting to the main engine.

In this incident the crew of the vessel was quickly alerted to the flooding condition by a properly installed and functioning high water alarm in the engine compartment. Upon investigating the reason of the high water alarm activation, vessel crew members observed the damaged seacock flooding from a crack between the valve and the vessel's hull, rendering the valve completely ineffective at stopping the incoming flow of water.

This incident points out the danger of using PVC pipe and piping system components in critical piping systems, especially water intake systems and pressurized piping systems. While PVC piping, valves, and other components can be considerably less expensive than steel pipe and piping components, PVC has considerably less strength and impact resistance than steel.

In this particular incident, the simple accident of a battery slipping from a storage area resulted in a situation where the vessel was in very real danger of sinking. While the storage of the battery in this instance was inadequate, the accidental shifting of objects should be considered possible at all times in heavy weather. The mechanical arrangement of a vessel should not be such that an adrift object creates a serious flooding condition that could result in a vessel sinking.

The Coast Guard specifically advises against the use of PVC components in vital systems, especially in sea water intake systems and pressurized piping systems.

The loss of this vessel was prevented by quick action of the crew, who controlled the flooding rate by applying a damage control patch consisting of clothing, oilskins, and net twine. Fishermen should have a damage control plan and materials onboard to respond to flooding conditions at sea.

This incident highlights the advantages of a properly operating bilge high water alarm system. High water alarms are required on certain fishing vessels, but are recommended on all fishing vessels. High water alarms should be installed using good electrical wiring practices and should be positioned to activate immediately above normal bilge levels. Early warning is imperative to a proper response to a flooding condition at sea.
