U.S. COAST GUARD
MARINE SAFETY OFFICE PORTLAND, MAINE

SAFETY ALERT 99-02

Rudder port Fairing Blocks Supplemental information sheet

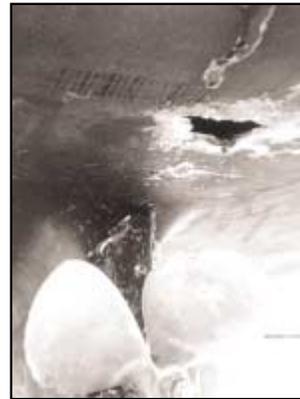
Diagram 1: The March 26th, 1999 flooding incident involved a vessel fitted with a fairing block, to which the rudder port fitting had been secured with bolts anchored to the wood that did not penetrate the fiberglass hull laminate. When the wood fairing block failed, this mounting arrangement allowed the fitting to tear away from the hull, forming a significant hole in the hull, (Photo 1) leading to a very serious flooding rate. The vessel was beached to prevent sinking.

Photo 1: Hull damage from fairing block failure

Diagram 2: Experienced marine surveyors report that an effective temporary fix for this problem is the replacement of the bolts securing the rudder port fitting to the fairing block with bolts through-bolted across the hull laminate. This increases the strength of the fitting and reduces the potential for a catastrophic hull failure as shown in photo 1. If a fitting is so installed, the bolt heads should be visible on the outside of the hull as in photo 2.

Diagram 3: Leading boat builders in Maine report that current technology to reinforce the hull in way of the rudder port fitting involves strengthening the hull structure by multiple layers of fiberglass. This increases the hull strength significantly without the use of wood laminates in the hull, which may be damaged by rot, stress, bonding failures, or swelling from water ingress.
