U.S. Coast Guard Marine Safety Office Portland, Maine

STATE OF REGULATORY COMPLIANCE WITH 406 MHZ EPIRB CARRIAGE REQUIREMENTS ON COMMERCIAL FISHING VESSELS IN NORTHERN NEW ENGLAND

Jeff Ciampa
Fishing Vessel Safety Examiner, U.S. Coast Guard

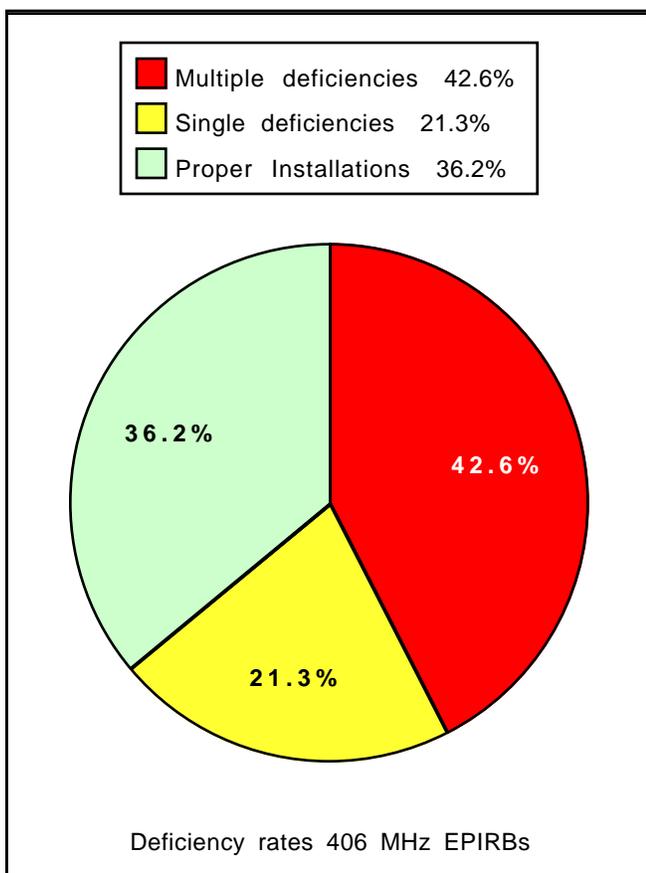
Of vessels studied, 63.9% were not equipped with satisfactory 406 MHz EPIRB installations, including 2 vessels that were not equipped with any type of EPIRB.
