INVESTIGATION REPORT
ON
M/S CELEBRATION
GENERATOR ROOM FIRE
11JAN00

**SUBJECT: M/S CELEBRATION (LI),
L8314134, GENERATOR ROOM FIRE
ENROUTE MONTEGO BAY FROM
NEW ORLEANS, LA, ON 11JAN00.**

PRELIMINARY STATEMENT

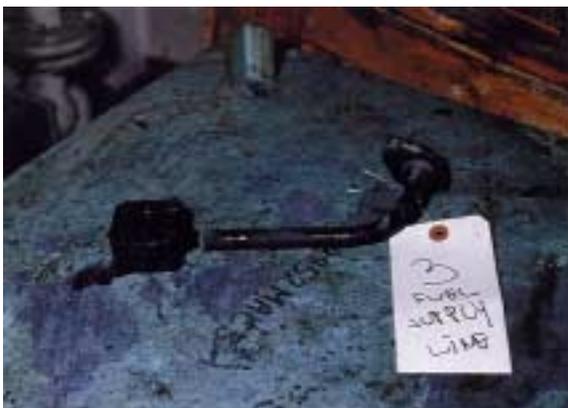
3. At 23:39:00 the 2/E received a high temperature alarm on cylinder A1, indicating 817 F (436 C), with 747 F (397 C) being the normal temperature. The 3/E confirmed the readings on the gauges at the cylinders, removed the F/O injector pump cover for cylinder A2 to investigate, and discovered what he described as a drip from the weld in the supply line feeding the pump.

Figure 2: F/O supply line for affected pump. Notice break at welded connection on the flange.

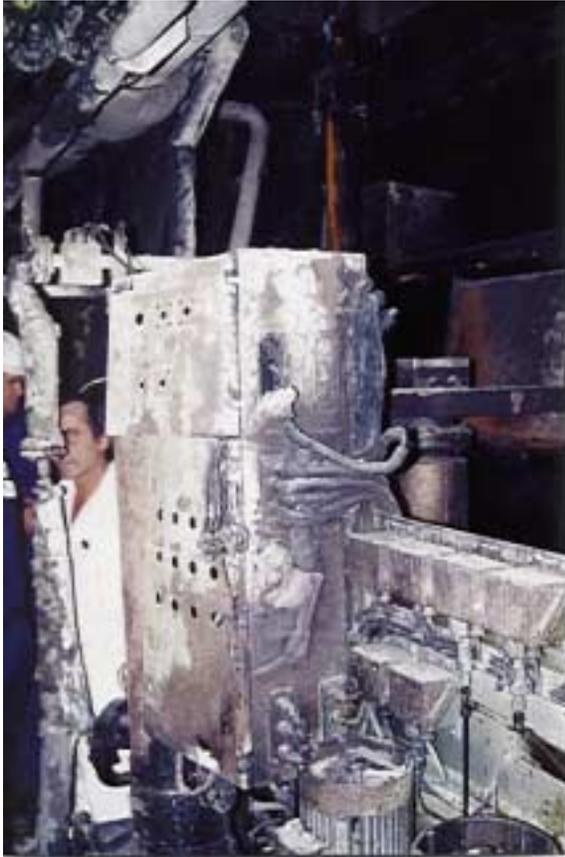
Figure 3: Damaged electrical panel directly adjacent to #3 generator.

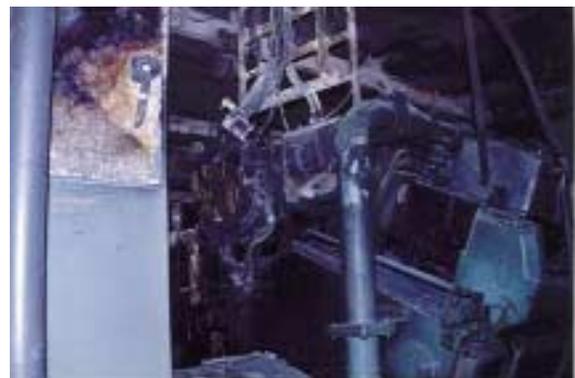
Figure 4: Fire damage to temperature monitoring equipment on #3 generator.

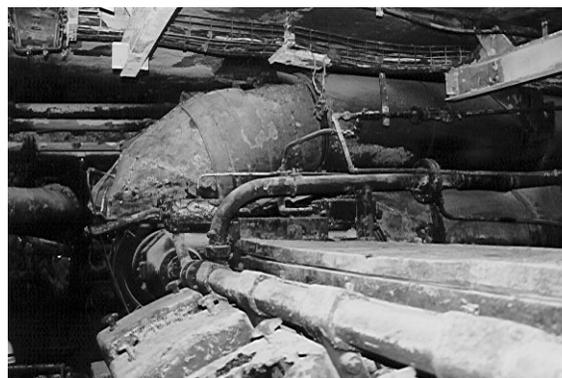
Figure 5: Fire damage to the air intake and overhead above #3 generator.

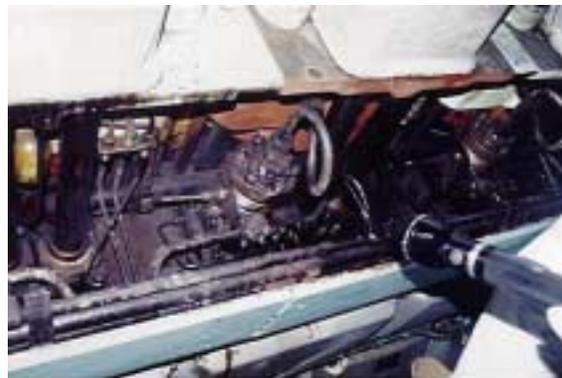
Figure 6: Fuel oil injection pump on #1 generator. Notice supply line coming from bottom left side and coiled injection line to cylinder on top. Cylinder head is immediately adjacent and above the pump with the exhaust manifold above the cylinder head. These pumps are normally protected by heavy metal covers, which are removed in this photo. There is free communication of air around the cylinder head and between the pump and exhaust manifold.

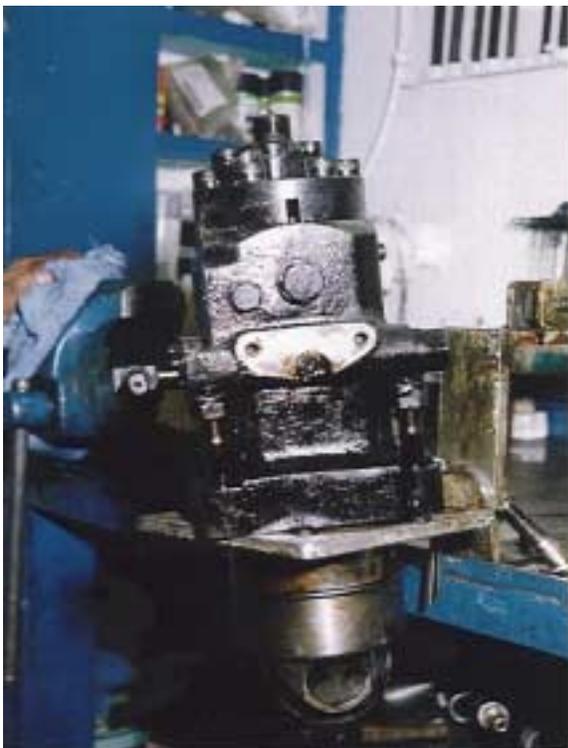
Figure 7: Affected F/O pump mounted on workbench for inspection. Notice roller on bottom of piston for cam operation.

7. The testing of the F/O injector pump mounting bolts and nuts conducted by Lucius Pitkin, Inc., in New York, NY, concluded the following:

c. The bolts failure occurred by way of progressive fracture in the nature of low-stress, high cycle fatigue.

f. It is apparent that the fatigue fracture of the bolts occurred due to inadequate pre-load. The service load exceeded the pre-load and subjected the bolts to a cyclic load, which, over time, resulted in the fracture.

j. In summary: inadequate tightening of the nuts securing the F/O pumps resulted in vibration of the entire pump assembly. Fatigue cracks started at the bolt thread roots and promulgated across the bolt until it could no longer withstand the applied load from the cyclic cam action, causing the pump to become dislodged from the engine and breaking the fuel oil supply lines.

8. WartSila should review the service manual and consider the torque listing for the nuts that secure the F/O injection pumps. Lucius Pitkin proposes 171 ft-lb for this type bolt in this application. In addition, the use of self locking nuts with plastic inserts must be considered in computing the proper torque.

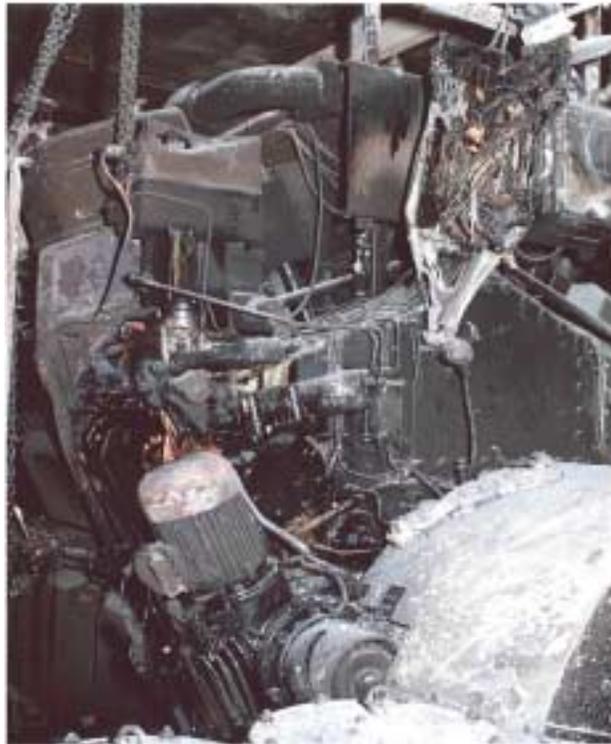
**Forward starboard corner of Generator #3.
Fire started in this area.**

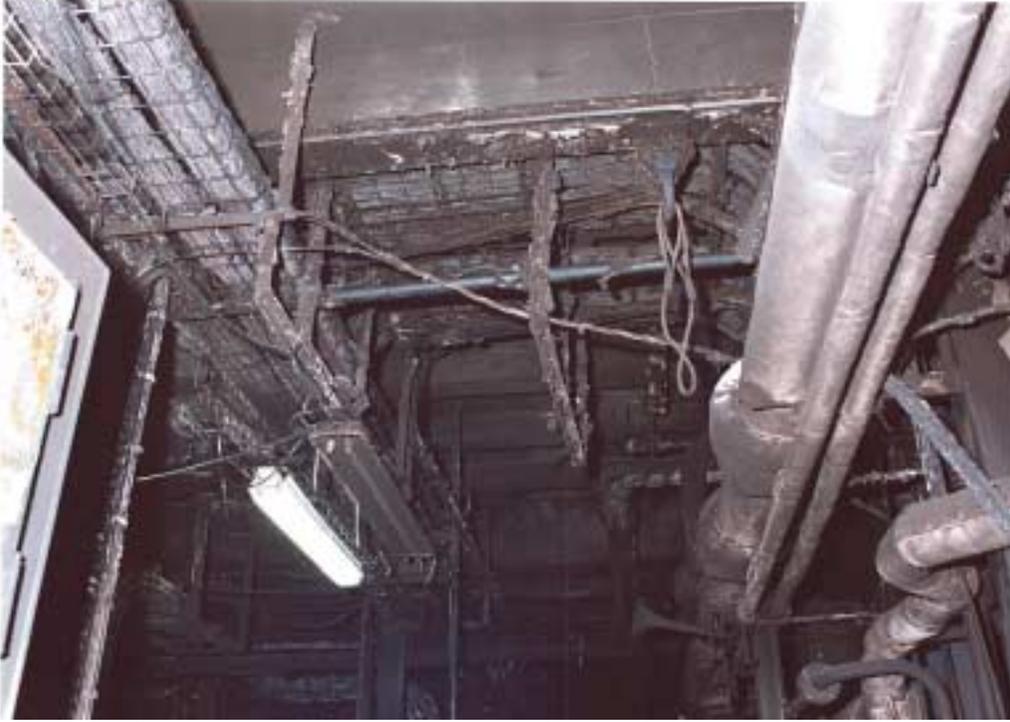
Overhead above Generator #3.

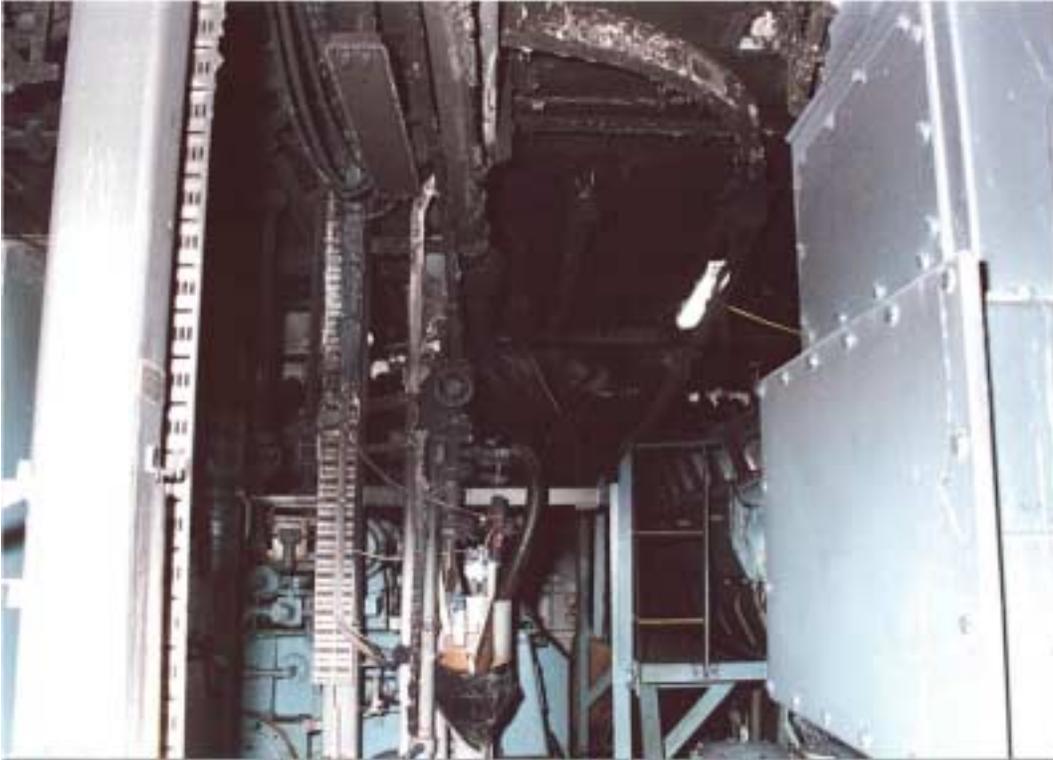
Machinery between Generators #3 and #2 with damage overhead looking forward.
