U.S. Department  
of Transportation

United States  
Coast Guard

16700/MC98016578  
October 2, 2000

Subj: SUPPLEMENTAL REPORT ON THE DISAPPEARANCE OF THE COMMERCIAL  
FISHING VESSEL LINDA E (O.N. 236906), WITH THREE CREWMEMBERS  
NEAR PORT WASHINGTON, WI ON LAKE MICHIGAN ON DECEMBER 11, 1998

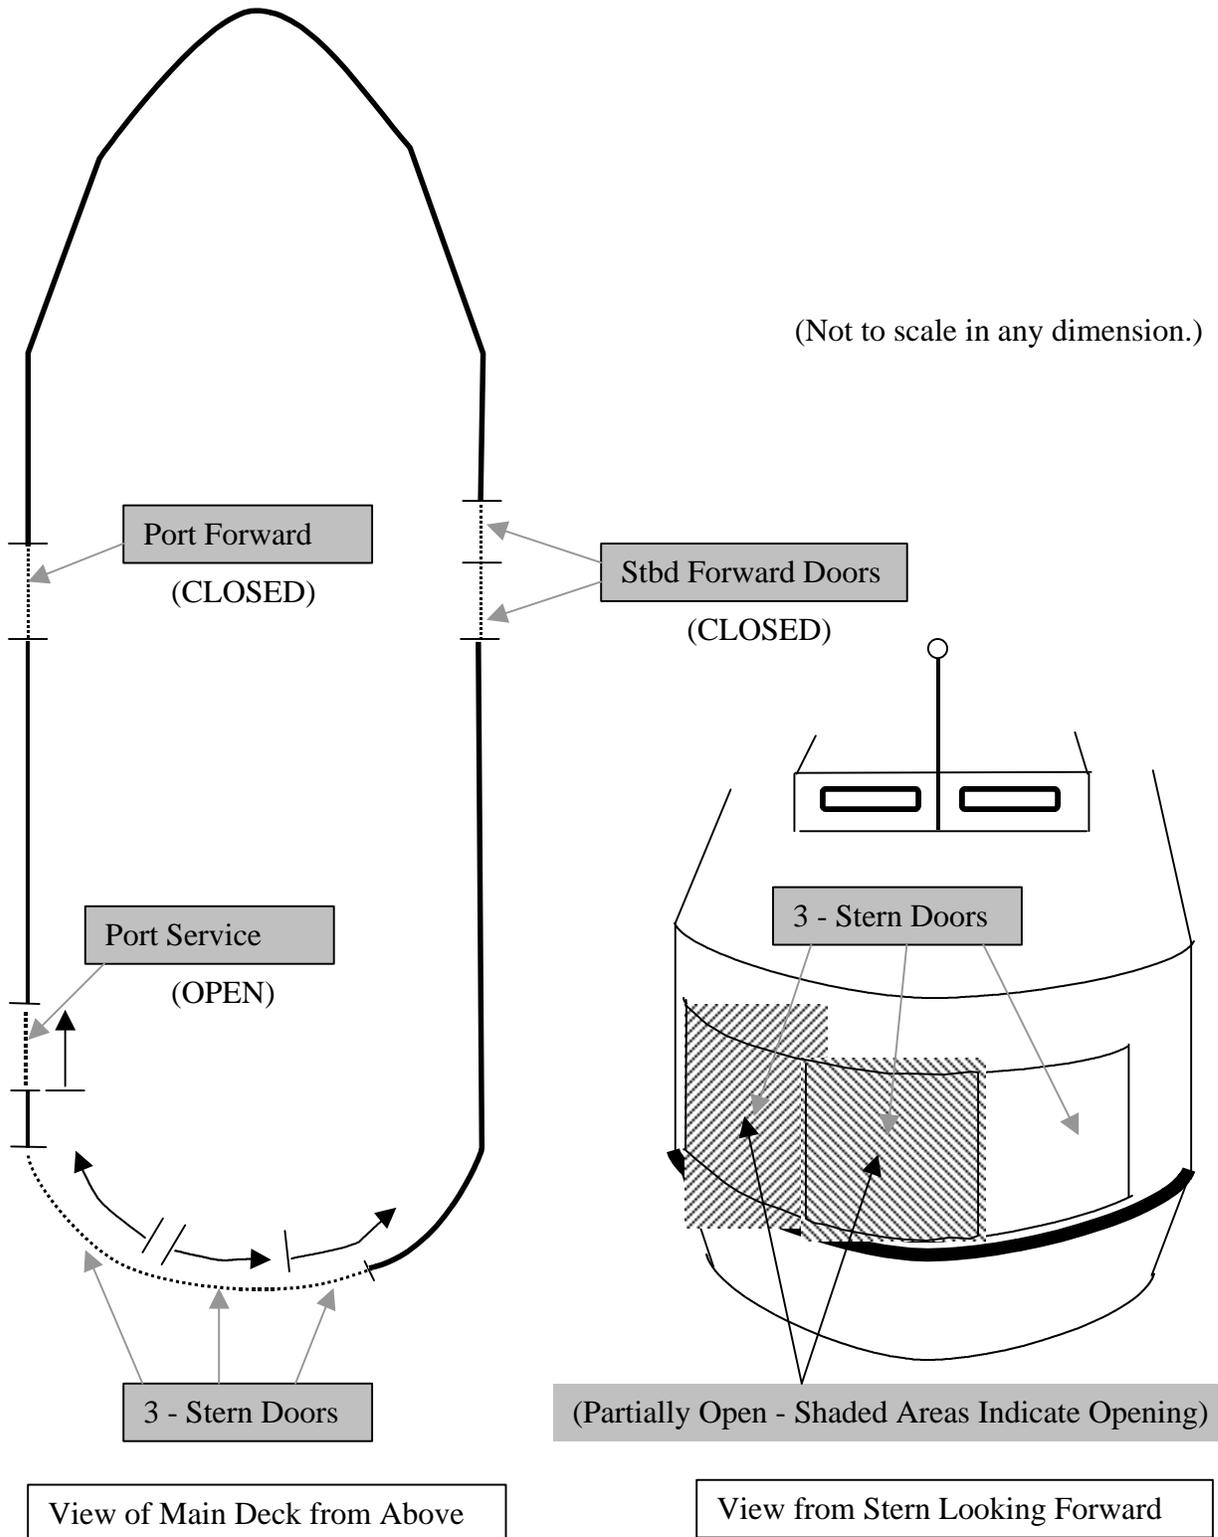
Figure (1): Door Locations on the LINDA E

3. The service door, located on the aft port side of the LINDA E, was found in the open position. A small tangle of fishing nets can be seen extending just outside this door. See Enclosures (2- A and F)

4. Two of the three stern doors on the LINDA E were found in the open position. The door that slides open to the port side of the vessel was fully open. One of the two doors that slide open to the starboard side of the boat was fully open; the other was partially open. See Figure (1). The spreader bar over which nets are normally set can be seen. A small amount of nets are visible through the stern door. No nets extend through the stern door. See Enclosures (2-B,C)

5. All other doors, including the two doors on the starboard forward side and the one door on the port forward side, were found in the closed position. See Enclosures (2-D,E)
