## Photographs of LINDA E from June 21, 2000 ROV Dive

These photographs of the LINDA E wreck site were taken on June 21, 2000 using the University of Michigan's Remotely Operated Vehicle (ROV). The photographs with the date/time stamp were taken using a high-resolution, low light video camera. Selected portions of the video were then converted to digital still images and annotated below. The other photographs below were taken using the ROV's 35-mm still camera, scanned into digital format and annotated. LCDR Bryan Emond witnessed the recording, conversion and annotation of each image.

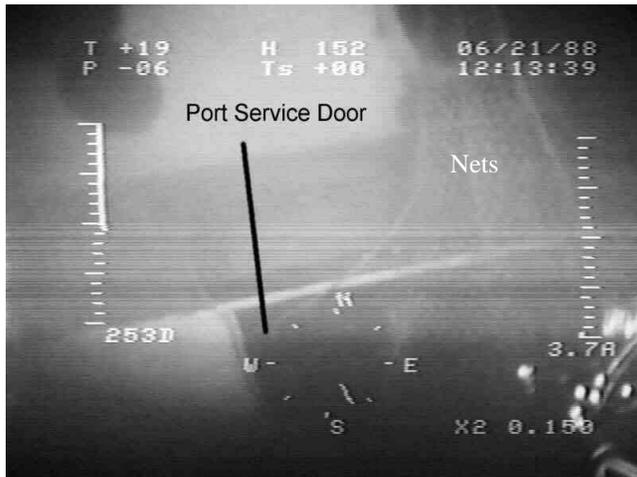
**(A)** Service door on the port side of LINDA E. Note fishing nets extending out this door.

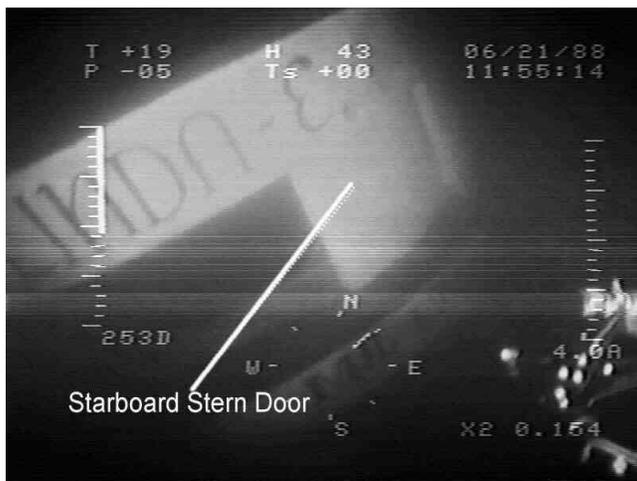
**(B)** Stern doors. Note that the door on the port side is open. One of the two sliding doors on the starboard side is visible.

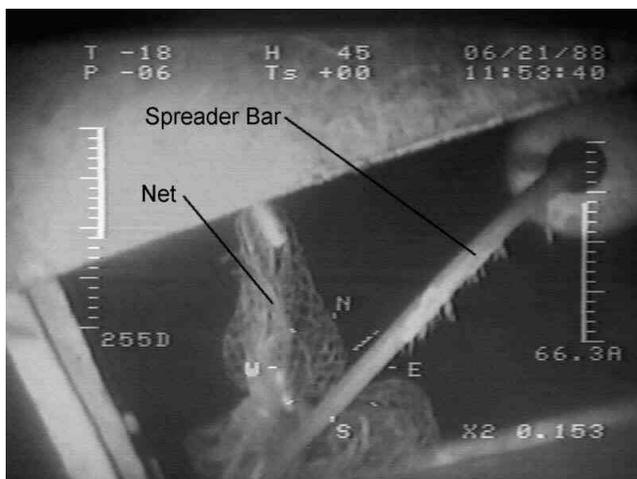
**(C)** Close view of open stern door. While fishing nets can be seen inside, no nets are visible extending out this door.

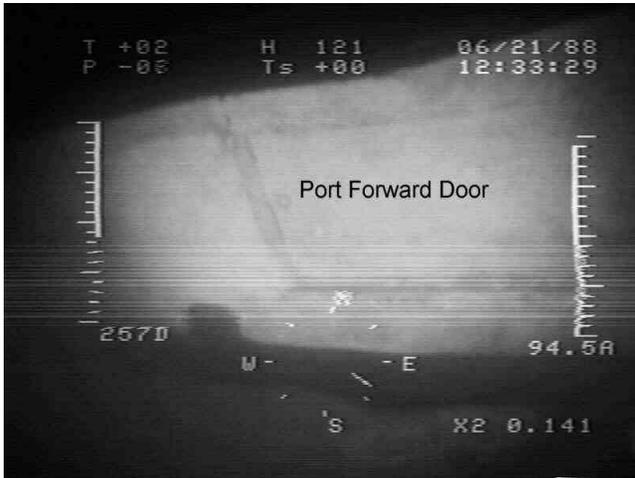
**(D)** Port Forward door closed.

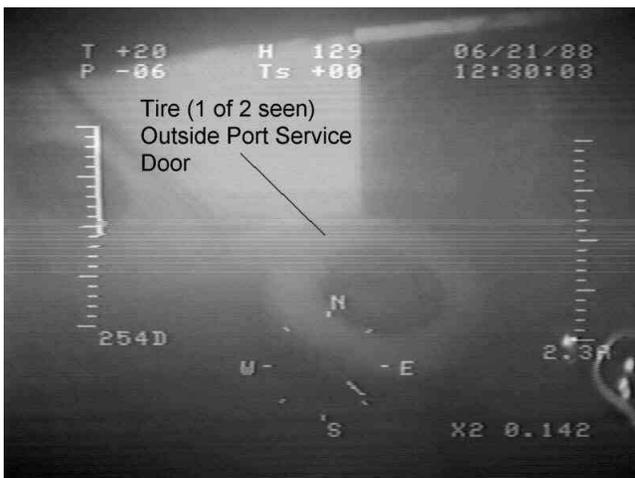
**(F)** Tire outside service door, port side, one of two tires observed. These tires are located near two broken lines tied to the upper deck rail with a slipknot.

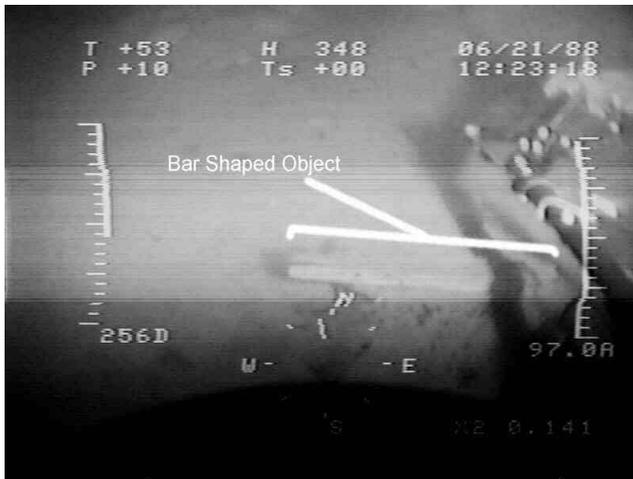
**(G)** Unidentified Bar shaped object outside stern door. One of few items found outside the LINDA E.

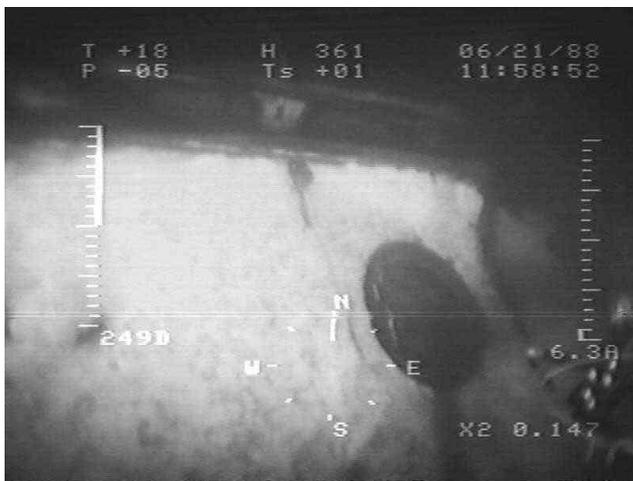
**(H)** Creases at Starboard Quarter.

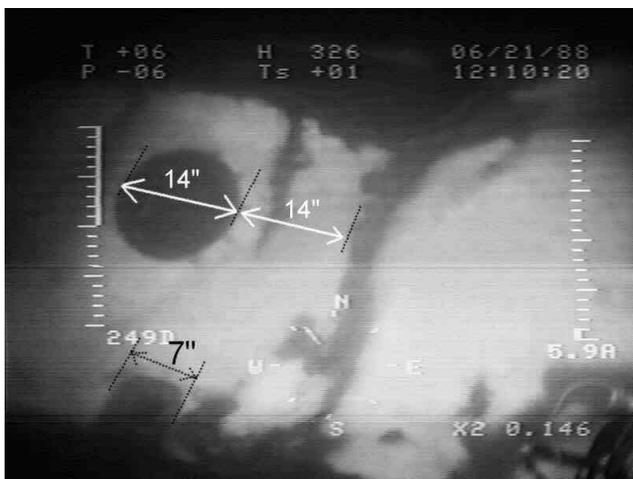
**(I)** Wide view of main inset on starboard quarter. This photograph includes the portlight and chock hole that were used for scale.

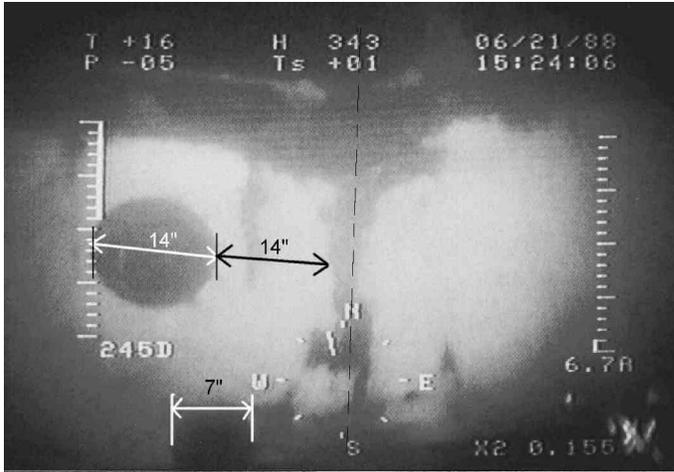
**(J)** Wide view of main inset. The thin black line indicates the alignment of the inset from the top of the lower deckhouse down to the rub rail.

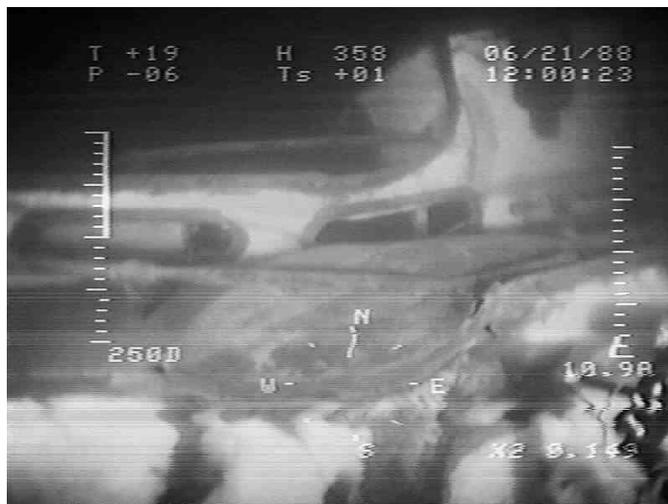
**(K)** Upper portion of main inset, showing crush damage to lower deckhouse and upper deck.

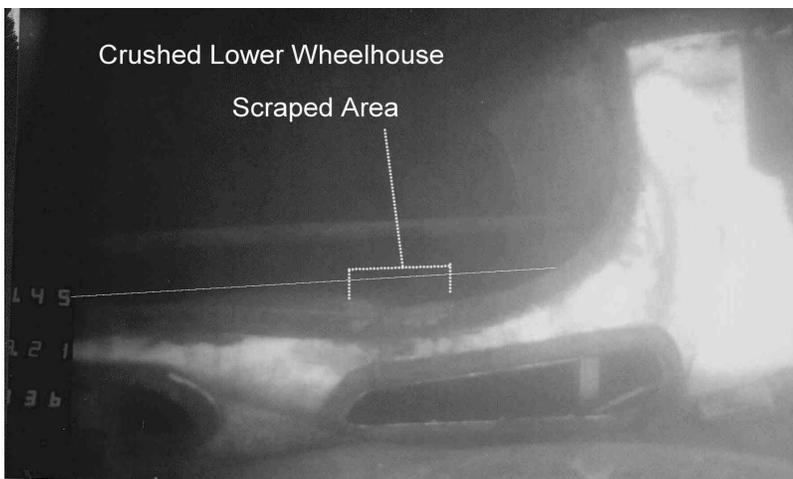
**(L)** Close up of crush damage to lower deckhouse. Note width of scraped area. This mark lines up with the gouge that runs vertical in the inset.

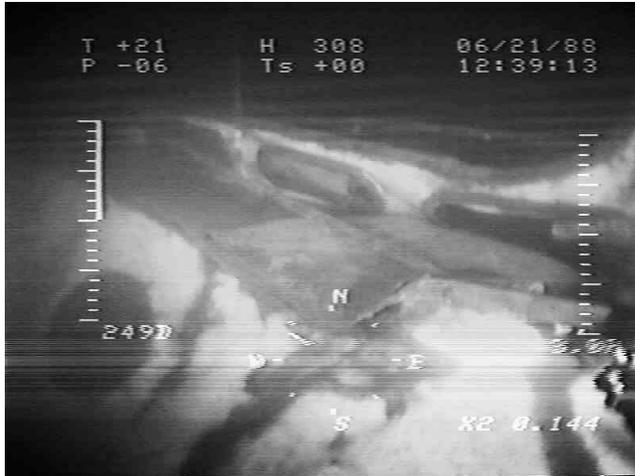
**(M)** Crushed lower deckhouse and upper deck in way of main inset.

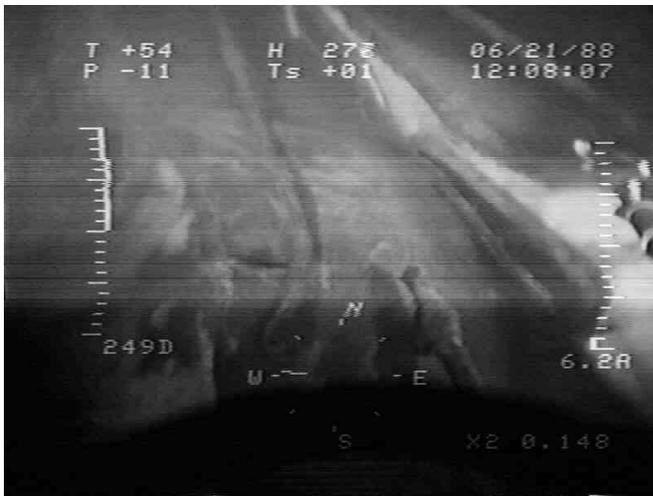
**(N)** Main inset at upper deck. Note broken rail and crushed window frame on lower deckhouse.

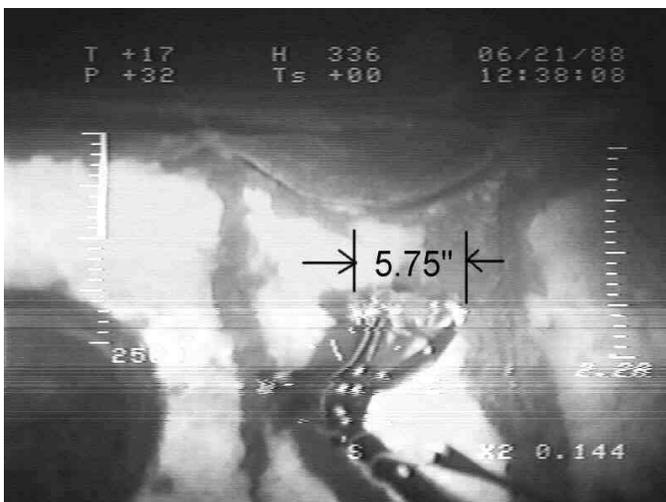
**(O)** Main inset at upper deck line. Note width of gouge mark. Scale based on tool used to gather paint samples.

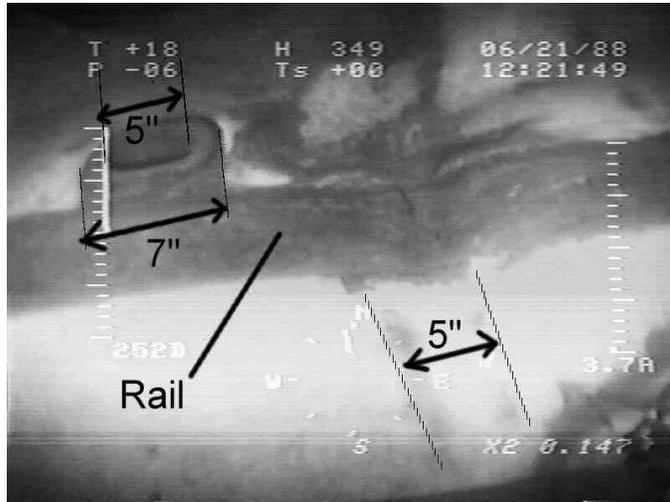
**(P)** Main inset damage at rub rail. Note the spacing between marks below the rub rail. There were very few other marks below the rub rail.

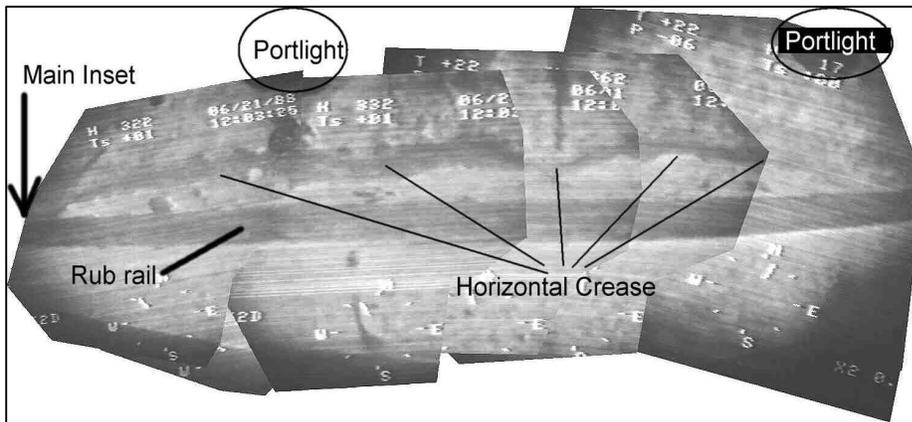
**(Q)** Horizontal Crease forward of main inset, just above the rubrail

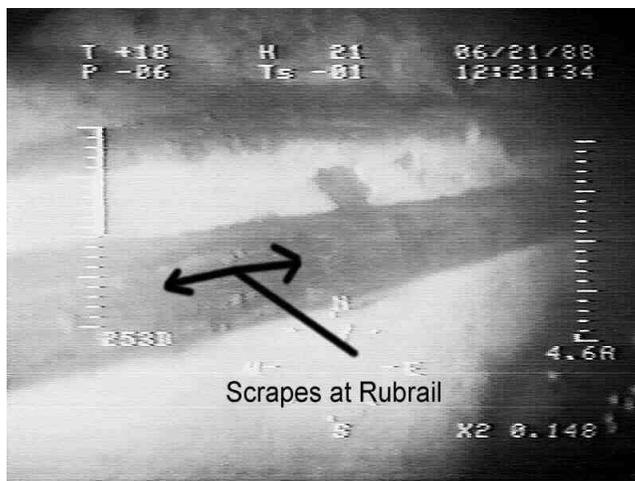
**(R)** Scrapes at rubrail forward of main inset

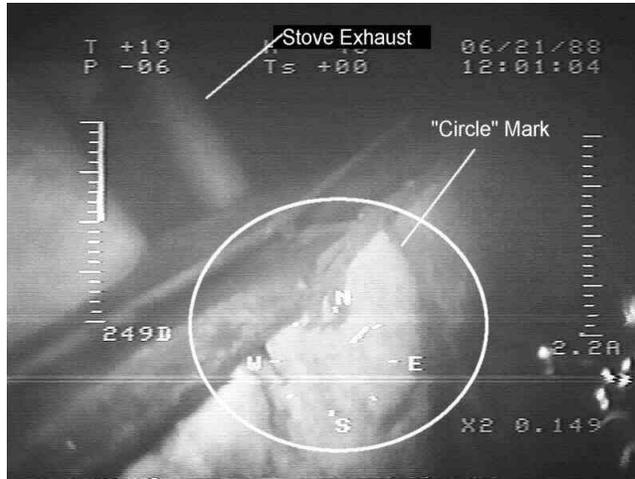
**(S)** Semi-circular mark on starboard side. Note that base of the stove exhaust stack is visible and intact.

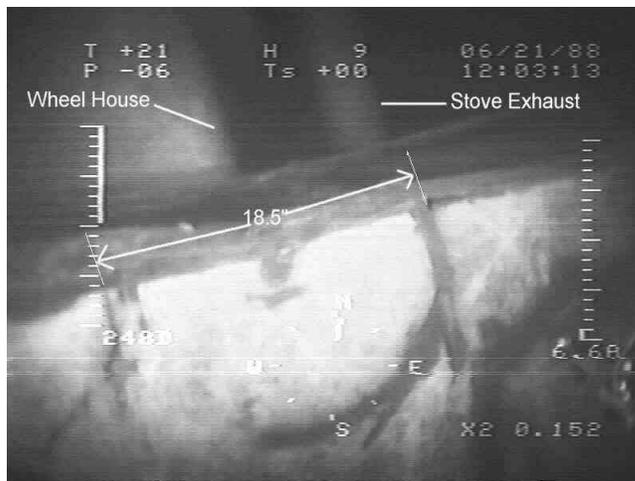
**(T)** Semi-circular mark on starboard side. Dimensions of this mark were estimated from comparison with a nearby portlight (off camera).

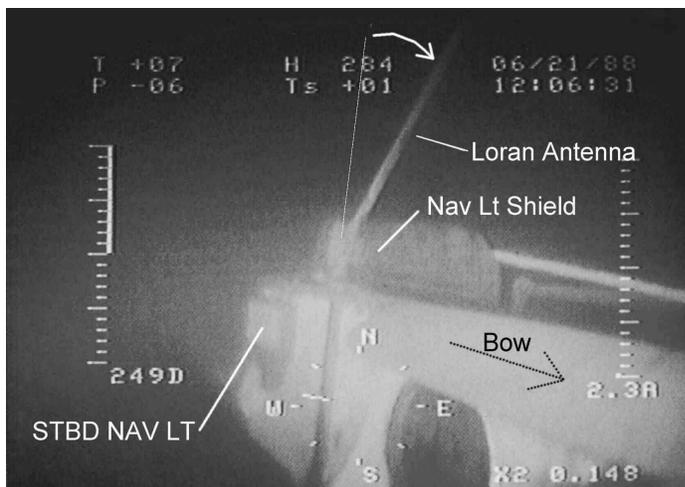
**(U)** Loran Antenna. This antenna is bent forward and to port. Although the starboard navigation light is hanging loosely, the navigation light shield does not appear to be disturbed.

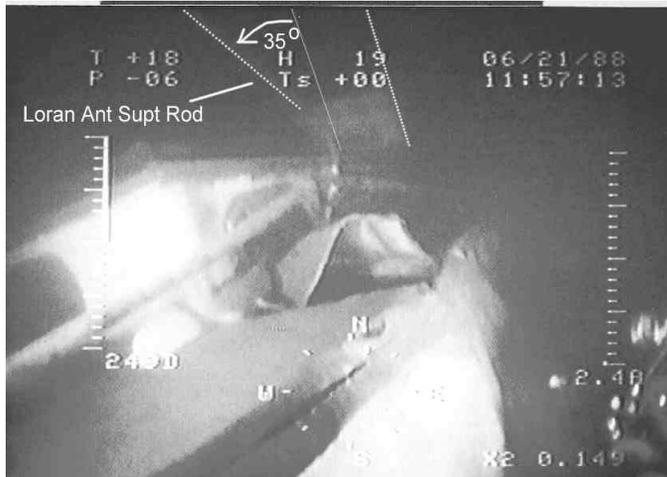
**(V)** Loran antenna support rod & tear at upper deck aft.

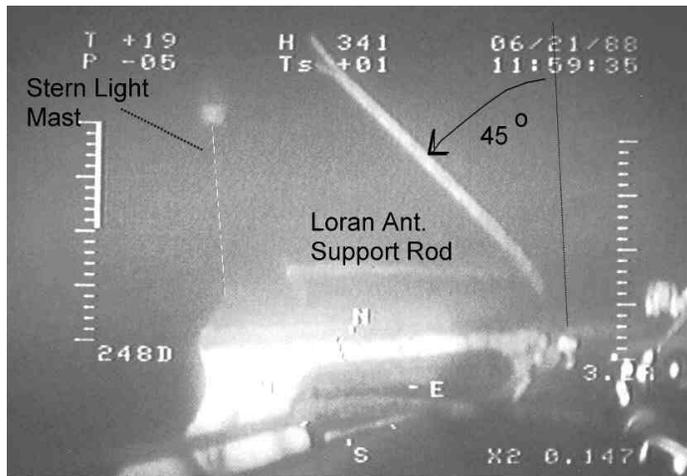
**(W)** Loran support rod and stern light mast. While the support rod is bent aft, the stern light shows no deformation.

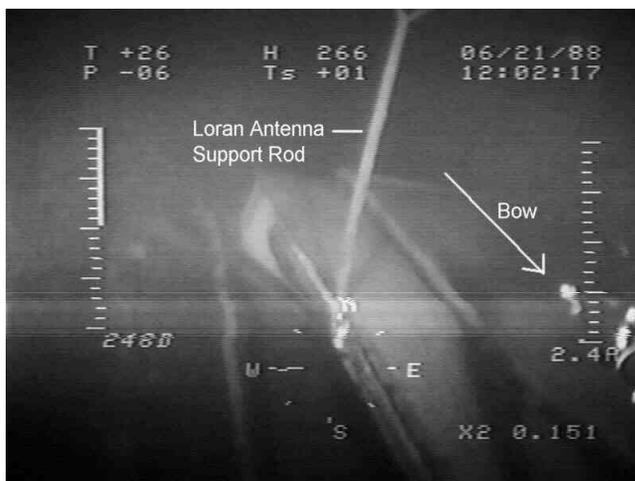
**(X)** Loran Antenna Support Rod. This support is bent aft and to port.

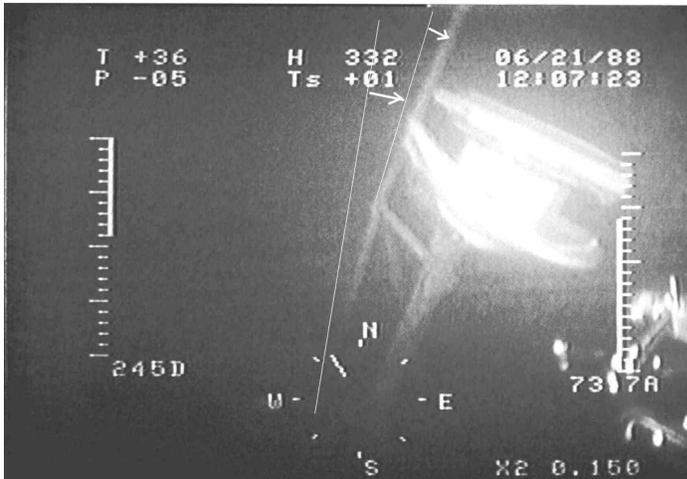
**(Y)** Radar and navigation light masts. Radar dome damaged. Note second deflection of navigation light mast above supports.

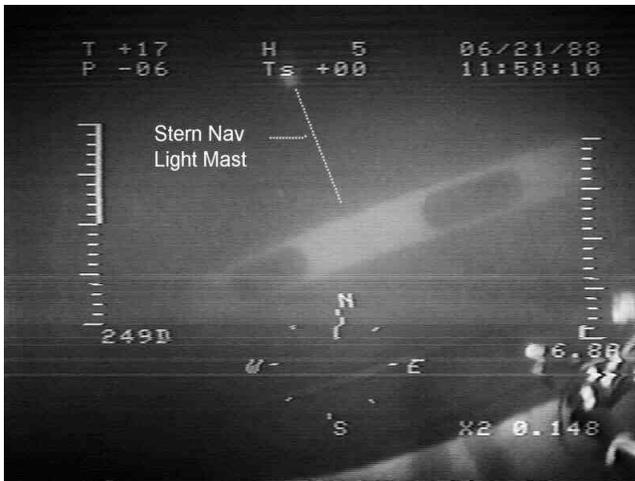
**(Z)** Stern light mast  
Note lack of deformation to mast.

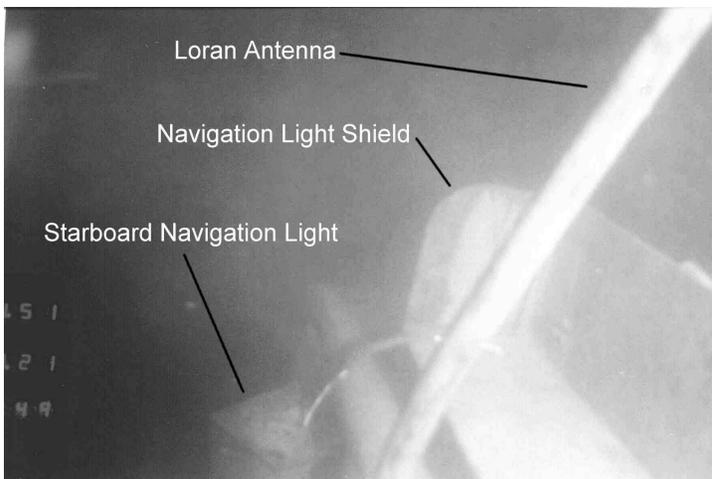
**(AA)** Starboard navigation light /shield. Note lack of observable damage to the navigation light shield.

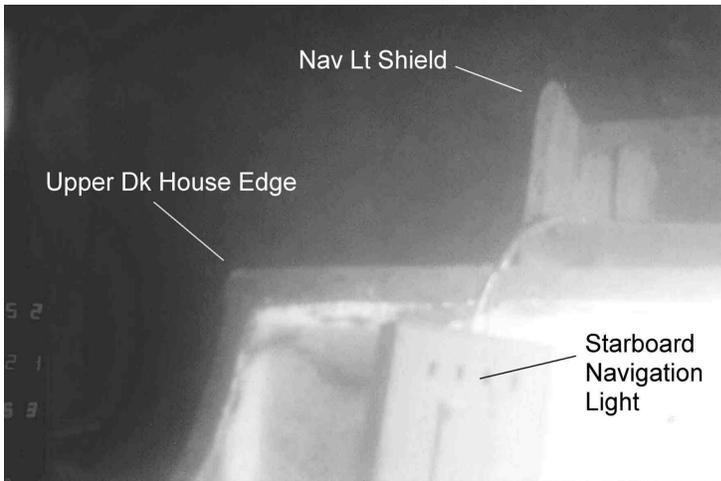
**(AB)** Aft edge of the upper deckhouse and navigation light shield. Note lack of observable damage to either.

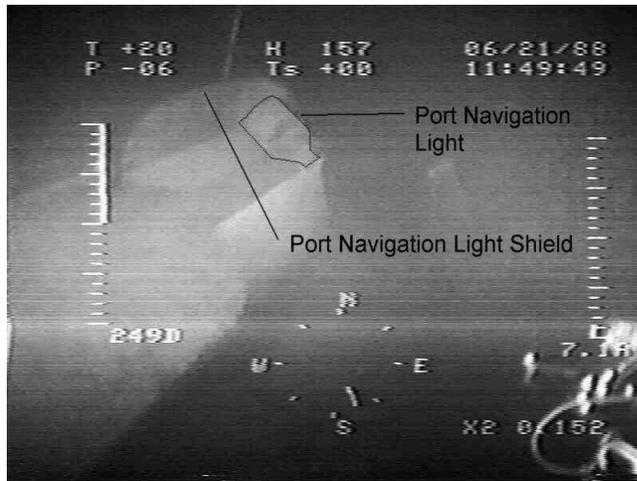
**(AC)** Port Navigation Light and Shield: Port Navigation Light is loose from its mount but shield appears to be intact

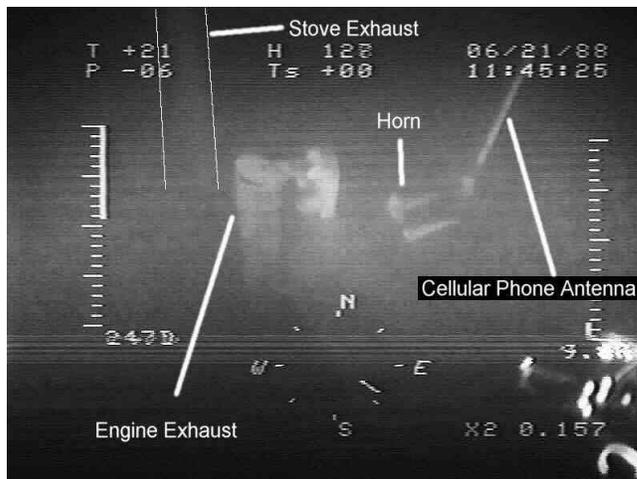
**(AD)** Engine and stove exhausts, horns, cellular telephone antenna. All appear to be intact.

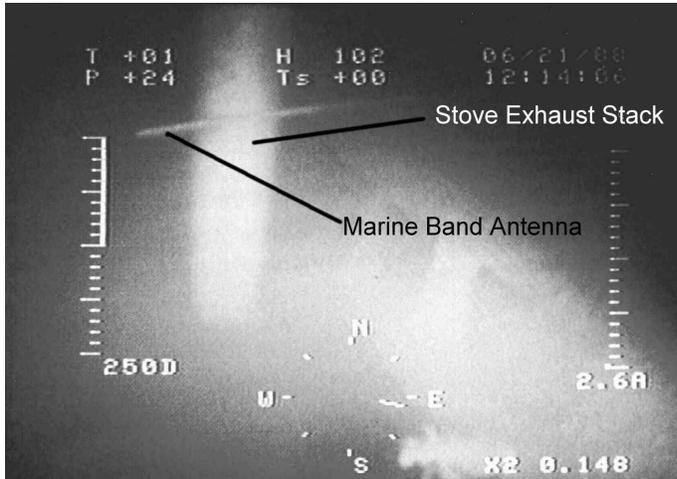
**(AE)** Stove Exhaust Stack. This stack shows no sign of being disturbed. The marine band antenna is in its usual position.

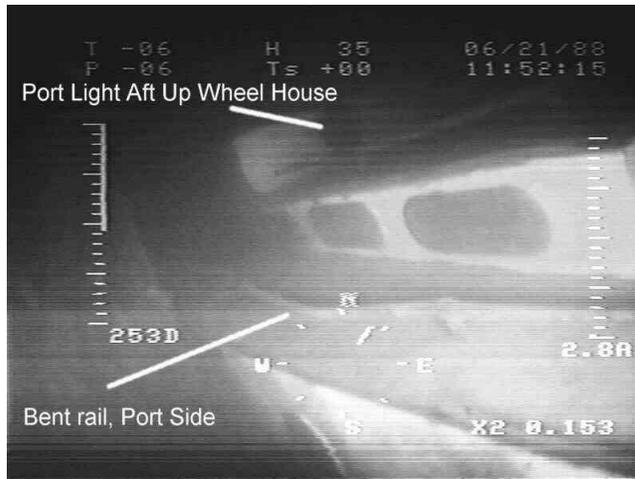
**(AF)** Bend in port rail. This is reportedly an existing condition.

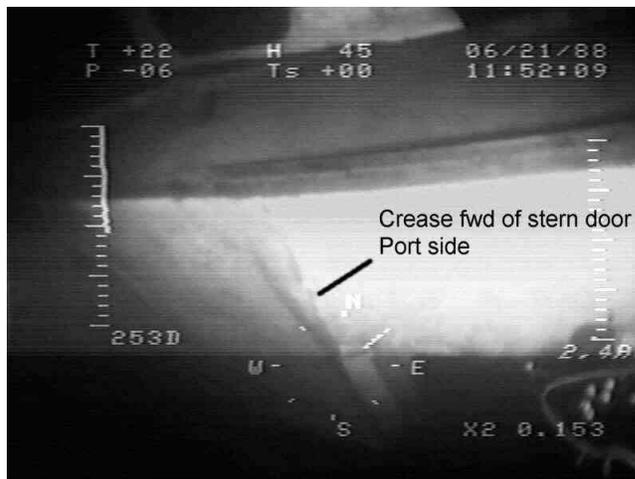
**(AG)** Small Crease on port side, just forward of stern door.
