MAR 06 2014

MEMORANDUM

From: D. M. Fears, CAPT
Board President

Subj: MAJOR INCIDENT INVESTIGATION (MII) BOARD REPORT REGARDING THE
CIRCUMSTANCES OF THE CASUALTY TO CGC WAESCHE'S SRP 24104 &
INJURIES TO A SMALLBOAT CREWMEMBER ON 11 NOV 13

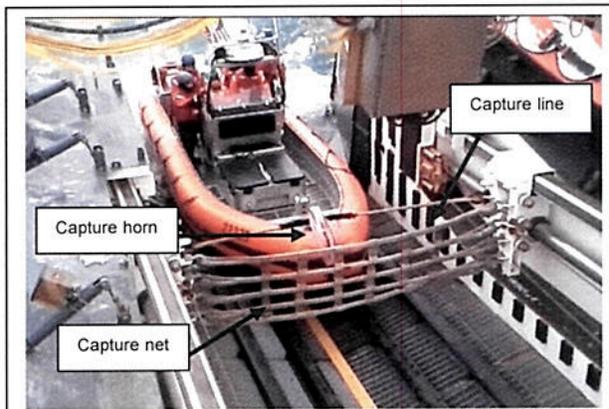
Figure 1: OTH Mark IV (CG-23225), 23 November 13 - Small boat recovery operation in stern notch of WAESCHE with stern doors open. Capture net is located forward of the bow, and the capture line is properly hooked on the capture horn. During the evolution pictured above, a crewmember needed to come forward to hook the capture line on the capture horn of the OTH. (Exhibit 37.)

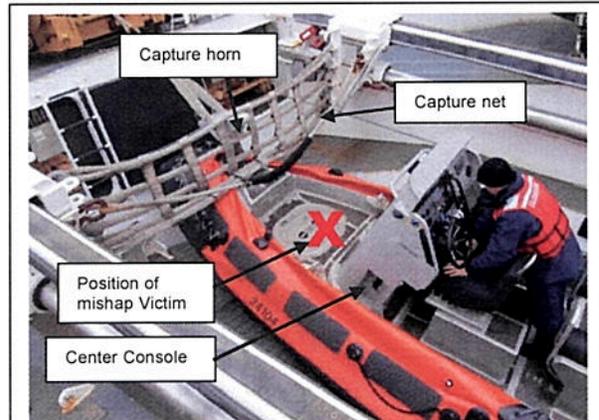
Figure 2: Mishap SRP (CG-24104) improperly secured in the notch. Specifically, the capture net is supposed to remain forward of the bow horn to arrest the forward movement of the small boat and to prevent the capture line from hitting the console or crew. Note the slack in the capture line. (Exhibit 37.) At the time of the incident, the mishap Victim was on the bow (marked with a red X above) kneeling down, facing forward with his back to the center console of the SRP

(2) Second, a swell caused the bow of the mishap SRP to slide under the capture net allowing the capture net to forcefully pin the mishap Victim against the center console.

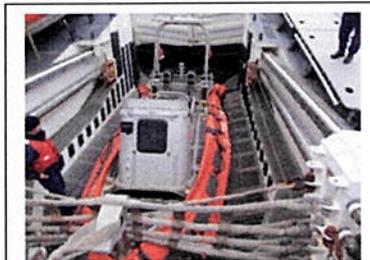
A detailed description of the configuration and operation of the SRP is contained in the Owner's Manual provided as USCG WMSL TP-6201. (Exhibit 29.) Post-mishap damage to the mishap SRP is illustrated in Figures (3-A) through (3-C). The sponsons were deflated (see Figure 3-A) under pressure from the capture net as the net slid over the bow and the center console was sheared off its foundation when the capture line and net contacted the console.

Figure 3-A: Mishap SRP seated in stern notch. Deflated sponsons, damage to the deck, and center console are visible. (Exhibit 37.)

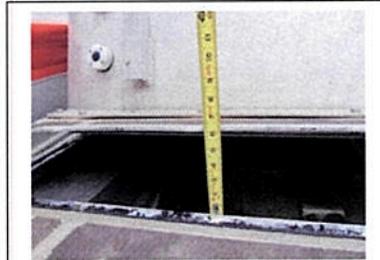
Figure 3-B: Base of center console of Mishap SRP torn approximately 6 inches from the deck. (Exhibit 37.)

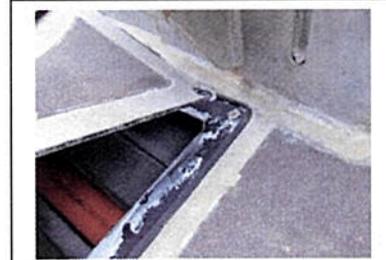
Figure 3-C: Mishap SRP. Additional imagery of deck damage. (Exhibit 37.)

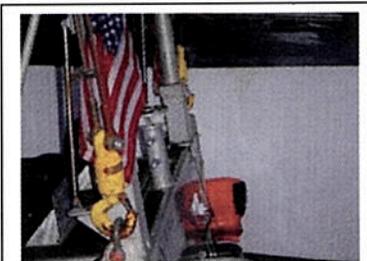
(c) Figures 5-A through 5-C below are a demonstrative sequence intended to simulate the approximate angle of approach of the mishap SRP relative to the capture system at the time of the incident. WAESCHE's stern gantry crane was used to lift the stern of the SRP for the simulation. Figure 5-C in particular demonstrates how the capture horn slips under the capture line and net when the SRP's stern angle increases relative to the ramp. Figure 6 shows a measurement of the 43 inch gap between the capture net and the stern ramp.

Figure 5-A: Use of WAESCHE gantry crane to lift the stern of the SRP simulating the mishap angle of entry. (Exhibit 37.)

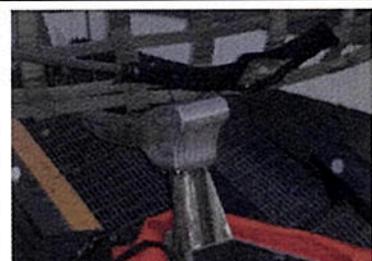
Figure 5-C: Mishap SRP capture horn sliding under capture net and line. (Exhibit 37.)
