## The Loss of the Coast Guard-manned USS *PC-590*

USS PC-590 AFTER TYPHOON OF 9 October, 1945, OKINAWA

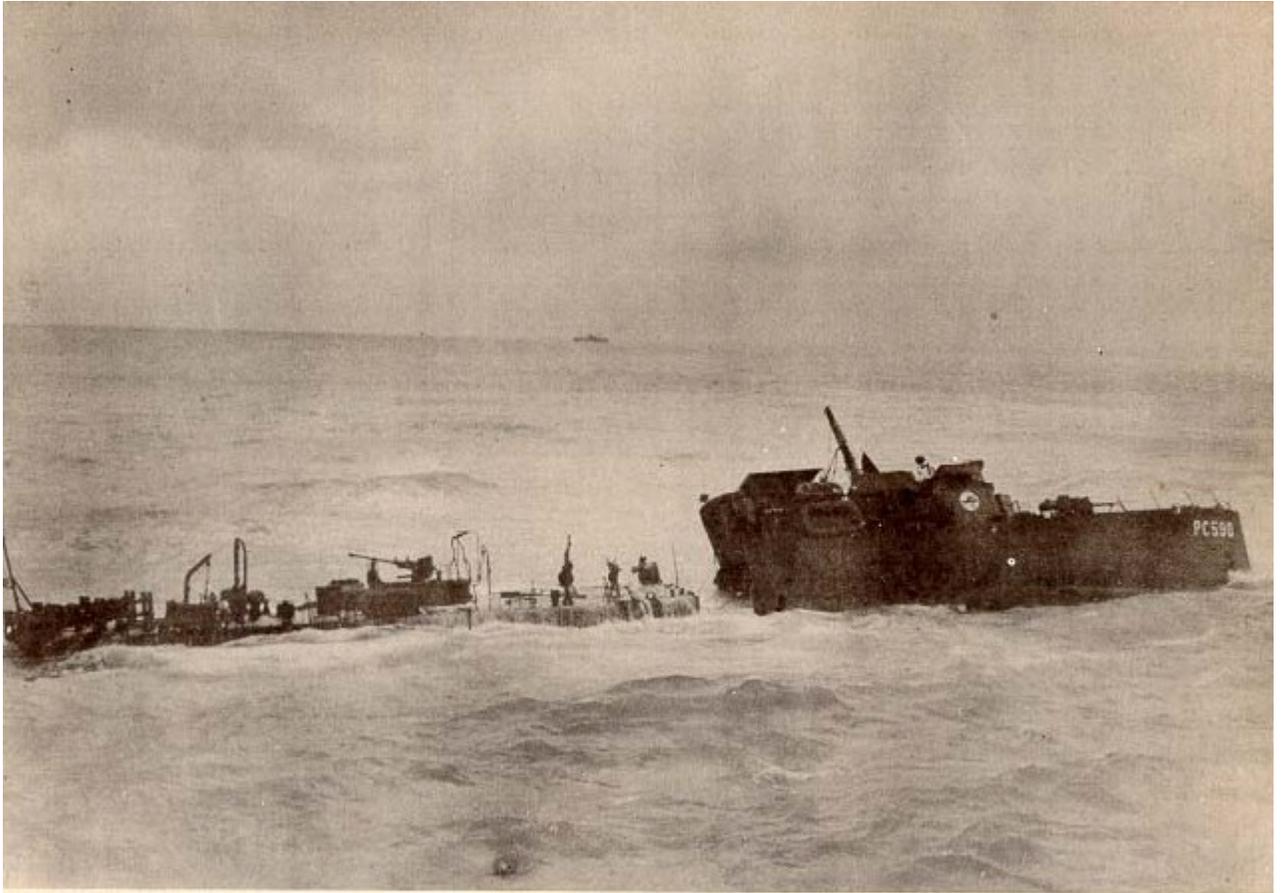
"The absence of any loss of life is due only to God's will" the commanding officer, Lt. Charles C. Pool, USCGR, later reported. By 1925 forty men were saved. Twenty minutes later the gunnery officer started up the line. Midway in transit the hauling line fouled around the engineering officer's right foot and he was jerked out of the 40 MM gun tub. At the same time his left foot twisted in the drifting gun cover and jammed on the upper gun tub edge. He was badly split apart by the tension and was upside down for a moment, his head under water. He was immediately extricated by the two officers still remaining on board, the commanding officer and executive officer. Meanwhile, the sudden stopping of the breeches buoy caused the gunnery officer to bounce in the catenary and parted the 3-inch line dropping him into the seas. He started to sink at once, but heard a cry to "Hold On!" and was brought like a shot up to the deck on the MONA ISLAND. Within a few minutes the hauling line was pulled back aboard the 590, along with the breeches buoy and the remainder of the 3-inch line was attached. This was made fast around the 40 MM gun foundation and the engineering officer and executive officer went up without mishap. The commanding officer had gone up the line ten feet when the hauling line, now unattended, jammed again. Return to ship was necessary to clear the badly twisted line. After three attempts to clear it, a knife was finally sent down the sloping line, the 590's hauling end was cut, and the trip up made safely. Shortly after this, at about 2015, the PC-590 broke completely in half.
