MARINE SAFETY ALERT

Safety Alert 01-96

MACHINERY HAZARDS

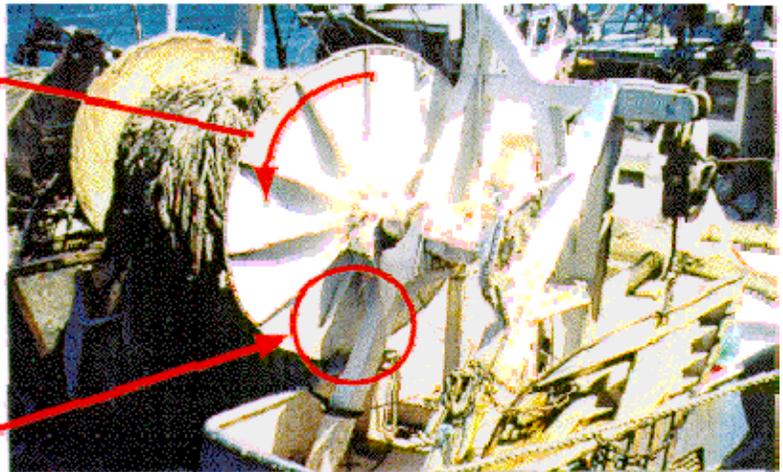
On August 23rd, 1995 a crewman on a fishing vessel operating from Portland, Maine was seriously injured when his right arm was partially severed during haul back of the trawl net. The accident occurred when the crewman's arm was caught between the gallows frame and a stiffening flange on the net reel while the net reel was being backed off. The resulting injury shattered the bone just above the elbow and left the arm partially severed.

The net reel on this vessel had twelve stiffening flanges arranged like spokes on a wheel that were approximately three inches deep and cleared the gallows framing by less than one half an inch. As the net reel was within reach of the main deck, this hazard should have been guarded to prevent injury.

Direction of
net reel
rotation

Crew man
injured at
this point.

View of net reel arrangement on vessel (injury occurred on port side).

Operators of commercial fishing vessels are requested to examine their vessels to insure that this particular hazard does not exist onboard their vessels as well. Also noted during this accident was the inadequacy of the first aid kit onboard the vessel.

Unlike shore based factories and businesses fishing vessels may encounter situations where persons are injured and medical assistance is hours away. Even vessel operators with professionally prepared first aid kits should insure that their vessels are equipped with extra first aid equipment, especially bandages and gauze pads to control serious bleeding.
