United States
Coast Guard

**FORMAL INVESTIGATION INTO THE CIRCUMSTANCES SURROUNDING THE
ALLISION BETWEEN THE BARGE TOW OF THE M/V BROWN WATER V AND
THE QUEEN ISABELLA CAUSEWAY BRIDGE ON SEPTEMBER 15, 2001, IN PORT
ISABEL, TEXAS, RESULTING IN MULTIPLE LOSS OF LIFE**

INVESTIGATION REPORT INTO THE CIRCUMSTANCES SURROUNDING THE ALLISION
BETWEEN THE BARGE TOW OF THE M/V *BROWN WATER V* AND THE QUEEN ISABELLA
CAUSEWAY BRIDGE, TEXAS, ON 15 SEPTEMBER 2001, RESULTING IN MULTIPLE LOSS
OF LIFE

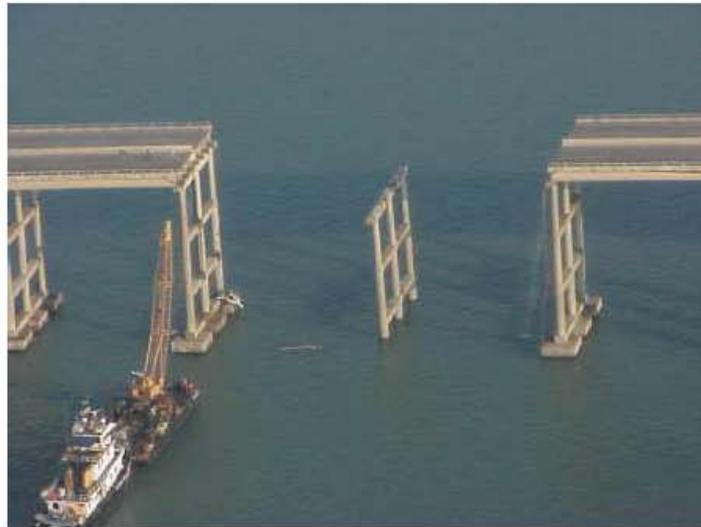
At or near 2110 on Friday, September 14, 2001, the M/V *Brown Water V* departed Brownsville, Texas, under the control of Captain Rocky Lee Wilson. The *Brown Water V* was pushing four loaded hopper barges ahead of it, lined up in a straight line, single-file. At 2400 Captain David D. Fowler took the helm. The vessel successfully cleared the Long Island Swing Bridge at 0145 on September 15, and at 0200 allided almost head-on with the Queen Isabella Causeway Bridge approximately 375 feet west of the channel. The Queen Isabella Causeway Bridge connects Port Isabel with South Padre Island. The allision caused two 80-foot sections of the bridge to collapse. Following the collapse, nine vehicles entered the water through the missing bridge sections, resulting in eight deaths and three injuries.

The bridge with two sections collapsed

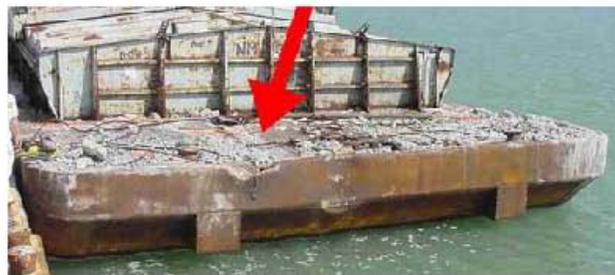
There was some damage to the alliding barge but no flooding.

Damage to barge

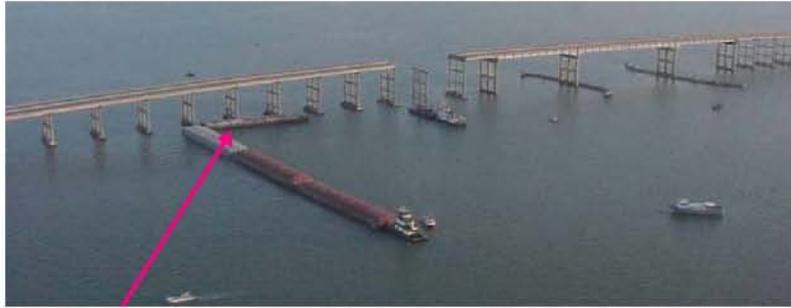
The coupling connecting the lead barge to the second barge was either snapped by the allision or snapped following the allision due to the current pushing the vessel and tow to the west of the allision point.

*Vessel and barge configuration following the allision,
lead barge decoupled*

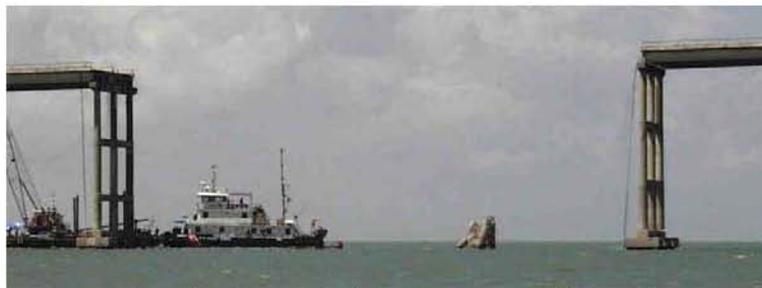
Later that day, during the search and rescue operation, a third 80-foot section of the bridge collapsed but caused no injuries or deaths.

The bridge with three sections collapsed

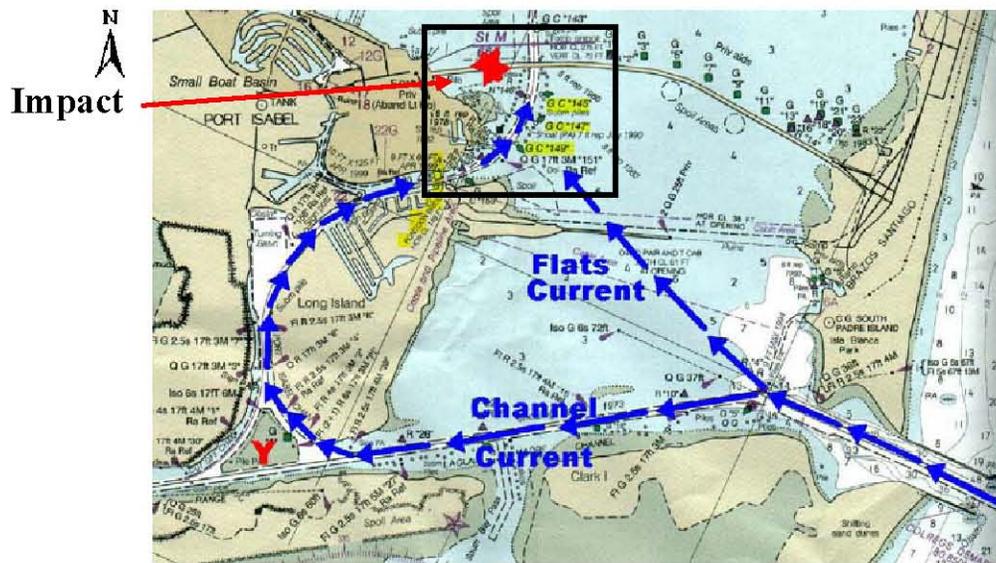
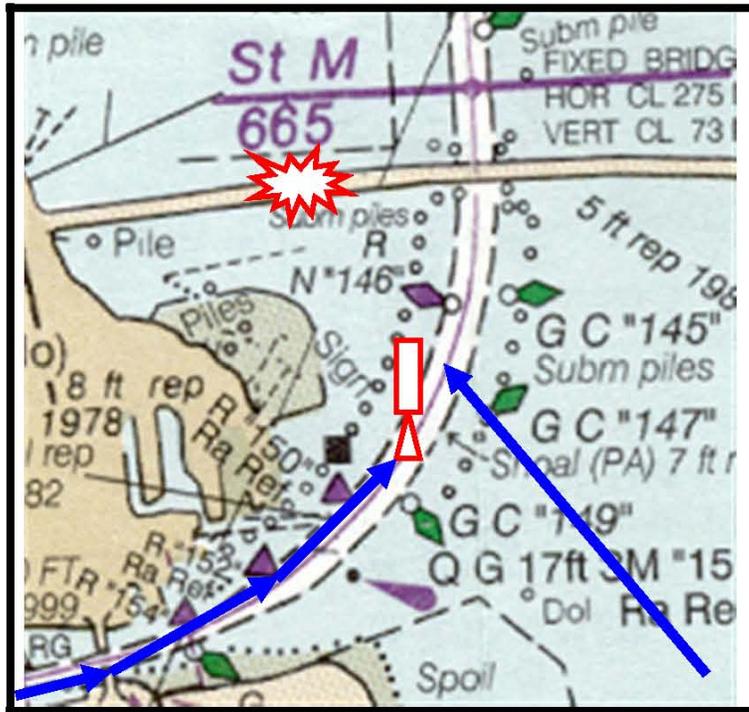
The M/V *Brown Water V* and its tow continued northbound through the Long Island Swing Bridge into the curve between the Long Island Swing Bridge and the Queen Isabella Causeway Bridge. The vessel and its tow were being pushed from behind in an east to northeast direction by the "hard running" channel current.

As the head of the tow passed Long Island and neared aid 149, the flats current began working on it. The vessel and tow were now being affected by two separate currents -- a channel current pushing the stern of the tow from behind in a northeast direction, and a flats crosscurrent pushing the head barge northwest. As the 851-foot long vessel and tow configuration continued past Long Island and further into the flats crosscurrent, more of the configuration was affected, and the head of the tow began swinging to port. The head of the tow continued swinging northwest in response to the increasing effect of the flats crosscurrent, while the stern of the towboat continued to be pushed northeast by the channel current. This swinging action pivoted the stern of the *Brown Water V* into the shallows on the east side of the channel near aid 149. Whether or not the towboat bumped bottom, this pivoting action had taken control of the configuration and the flats crosscurrent swept the configuration west, out of the channel and into the bridge.

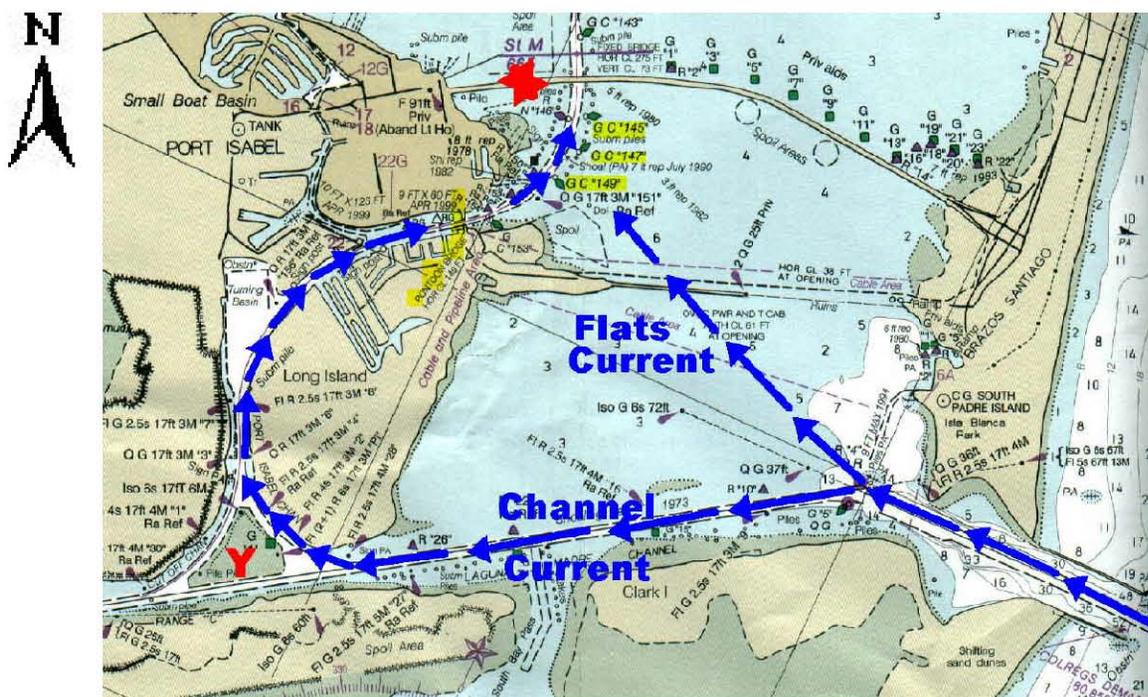
As the head of the tow passed Long Island and the spoil area east of the island and neared aid 149, the flats current began working on it. The vessel and tow were now being affected by two separate currents -- a hard running channel current pushing the entire configuration northeast and a flats current pushing the head barge northwest. As the 851-foot long vessel and tow configuration sailed past the current-sheltering island and spoil area, the intruding flats crosscurrent increased its effect, and the head of the tow began swinging to the port. Because Captain Fowler was not aware of the crosscurrent and had not "set up for it," the converging currents overwhelmed the configuration.

The head of the tow continued swinging northwest in response to the increasing effect of the flats crosscurrent, while the stern of the towboat continued to be pushed northeast by the channel current. This swinging action may have pivoted the stern of the *Brown Water V* into the shallows on the east side of the channel near aid 149, and the stern of the vessel may have bumped bottom. Whether or not the towboat bumped bottom, the configuration was past the point-of-no-return when Captain Fowler failed to set up for the flats current as he exited the Long Island Swing Bridge. The vessel and its tow were swept west of the channel and into the bridge.
