BUCKLING OF TRANSVERSE WEB FRAMES IN THE UPPER WING TANKS OF BULK CARRIERS

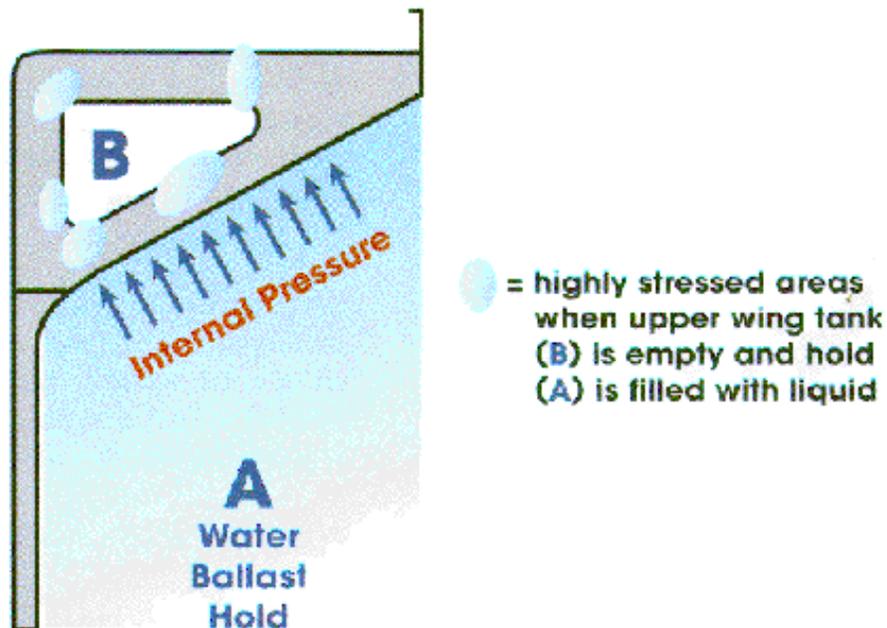
Through the years there have been incidents of damage to the upper wing tank transverse web frames of several midsize bulk carriers. Buckling has occurred on the deck, sloping bulkhead, and side transverses, along with fractures along the radii (see illustration and photos). Speculation as to the cause of these damages includes improper air-pipe venting during ballasting operations, inappropriate design or workmanship of structural details, and improper loading.

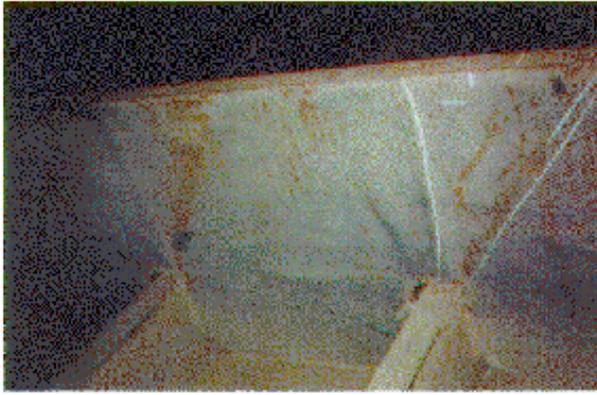
Although many factors may contribute to transverse web frame failures, ABS has identified an important factor in the failure of the upper wing tank transverses. During the development of the SafeHulls criteria for bulk carriers, extensive research was conducted on the behavior of web frames under various loading conditions. It was found that when a cargo tank is used as a ballast hold and the topside tank is left empty, high bending stresses can occur on the transverses (see illustration) These stresses may be very close to the yield stress and may exceed the ultimate strength of the plate panel.

Typical buckling

If a cargo hold of a bulk carrier is to be used for water ballast, it is important to assess the strength of the upper wing tank structure for the pressures induced by this loading. During the design phase of new bulk carriers, the depth of the transverses and the web plating thickness are often increased in the upper wing tank transverses.

In the past, the dynamic and static components of ballast loads may not have been considered during the design. Therefore, for existing ships it is particularly important to monitor corrosion rates and thoroughly inspect the condition of the structure in way of the ballast hold. A revised ballast condition, in which the topside tank and ballast hold are fully loaded, will reduce the stresses on the transverses. Additionally, a SafeHull or DLA analysis is a good way to assure the adequacy of this structure.

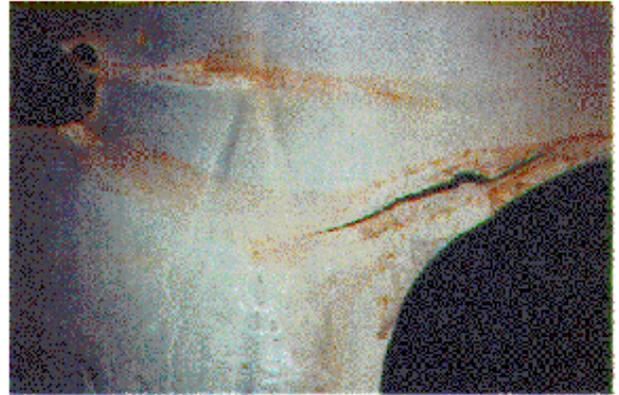
Fractured radii
