Final Report
for
**UNITED STATES DEPARTMENT
OF THE INTERIOR**

**FORENSIC EXAMINATION OF DEEPWATER
HORIZON BLOWOUT PREVENTER**

VOLUME II APPENDICES

Report No. EP030842
20 March 2011

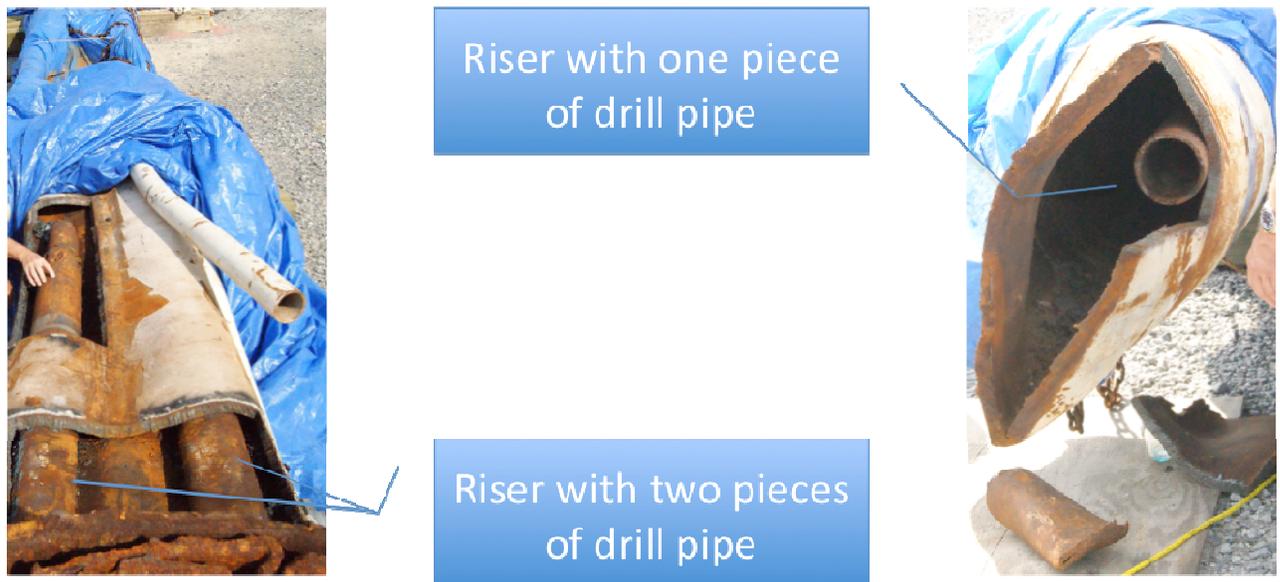
Figure 1 - Photograph of Riser showing two pieces of drill pipe at downstream end of riser and only one piece of drill pipe at upstream end of riser.

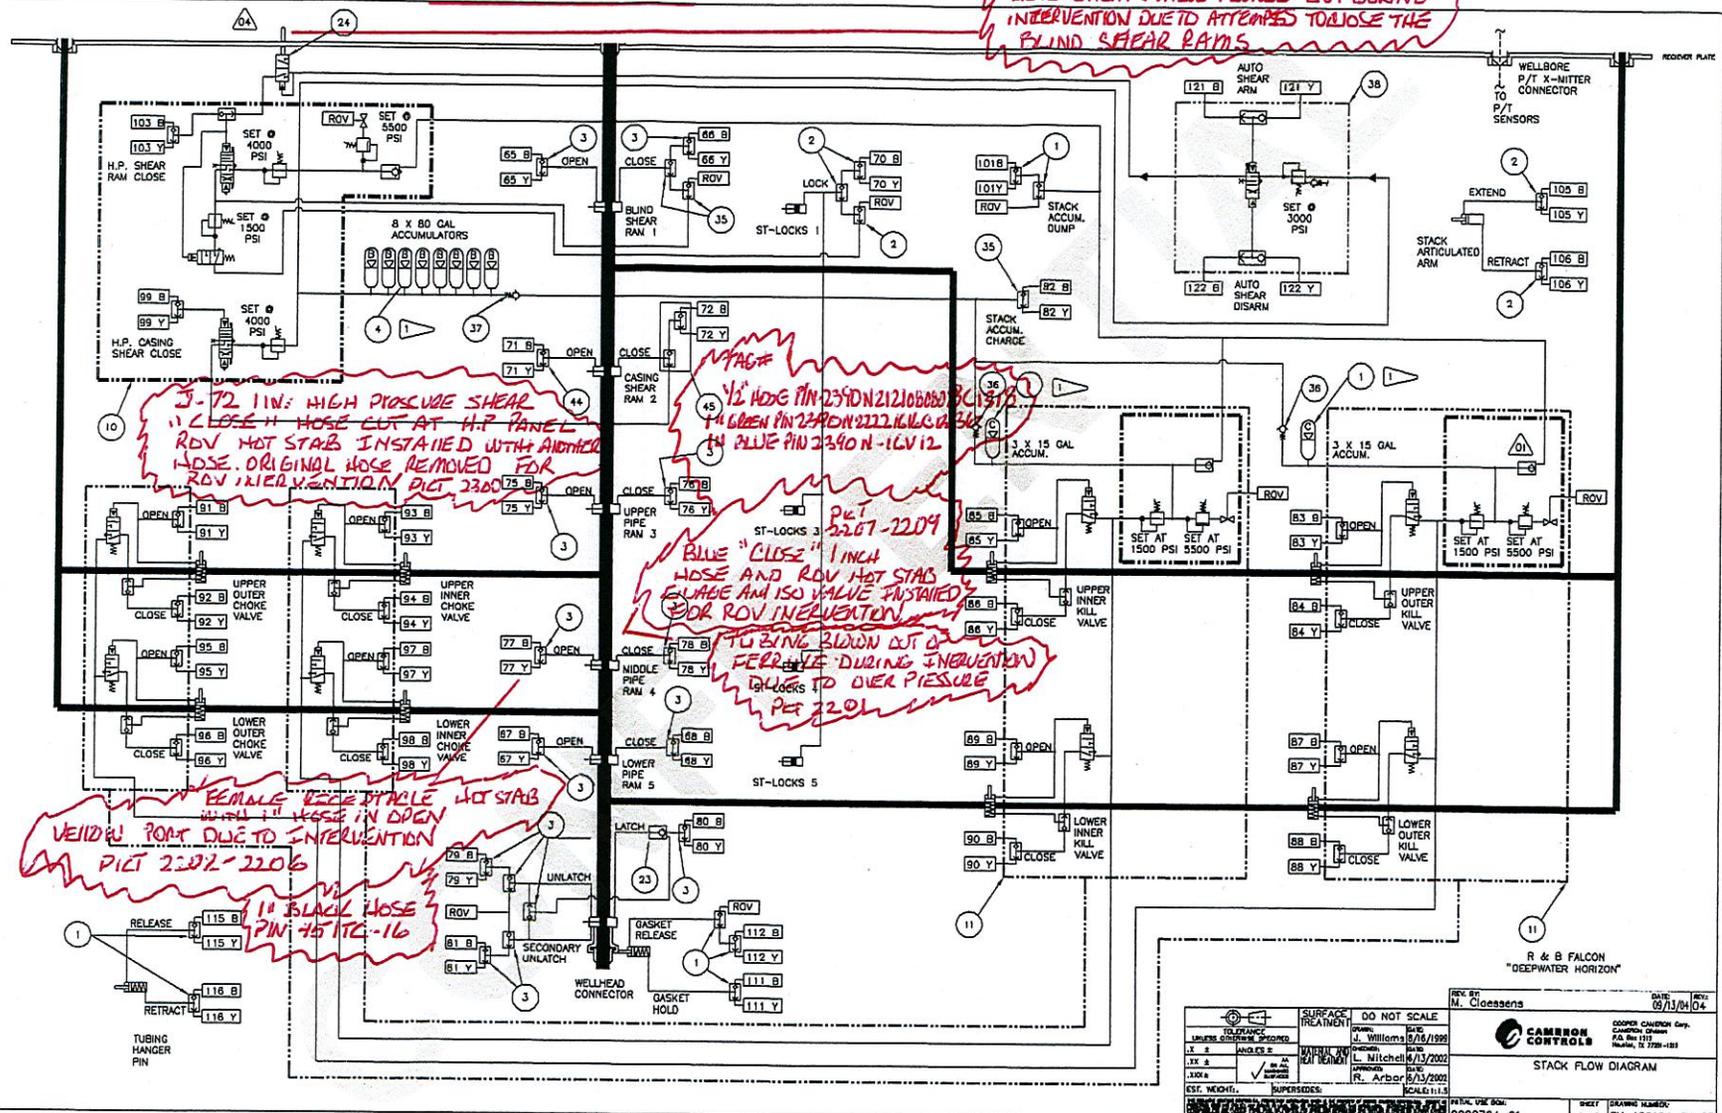
AUTO SHEAR VALVE PLUNGER CUT DURING INTERVENTION DUE TO ATTEMPTED TO LOOSE THE BLIND SHEAR RAMS

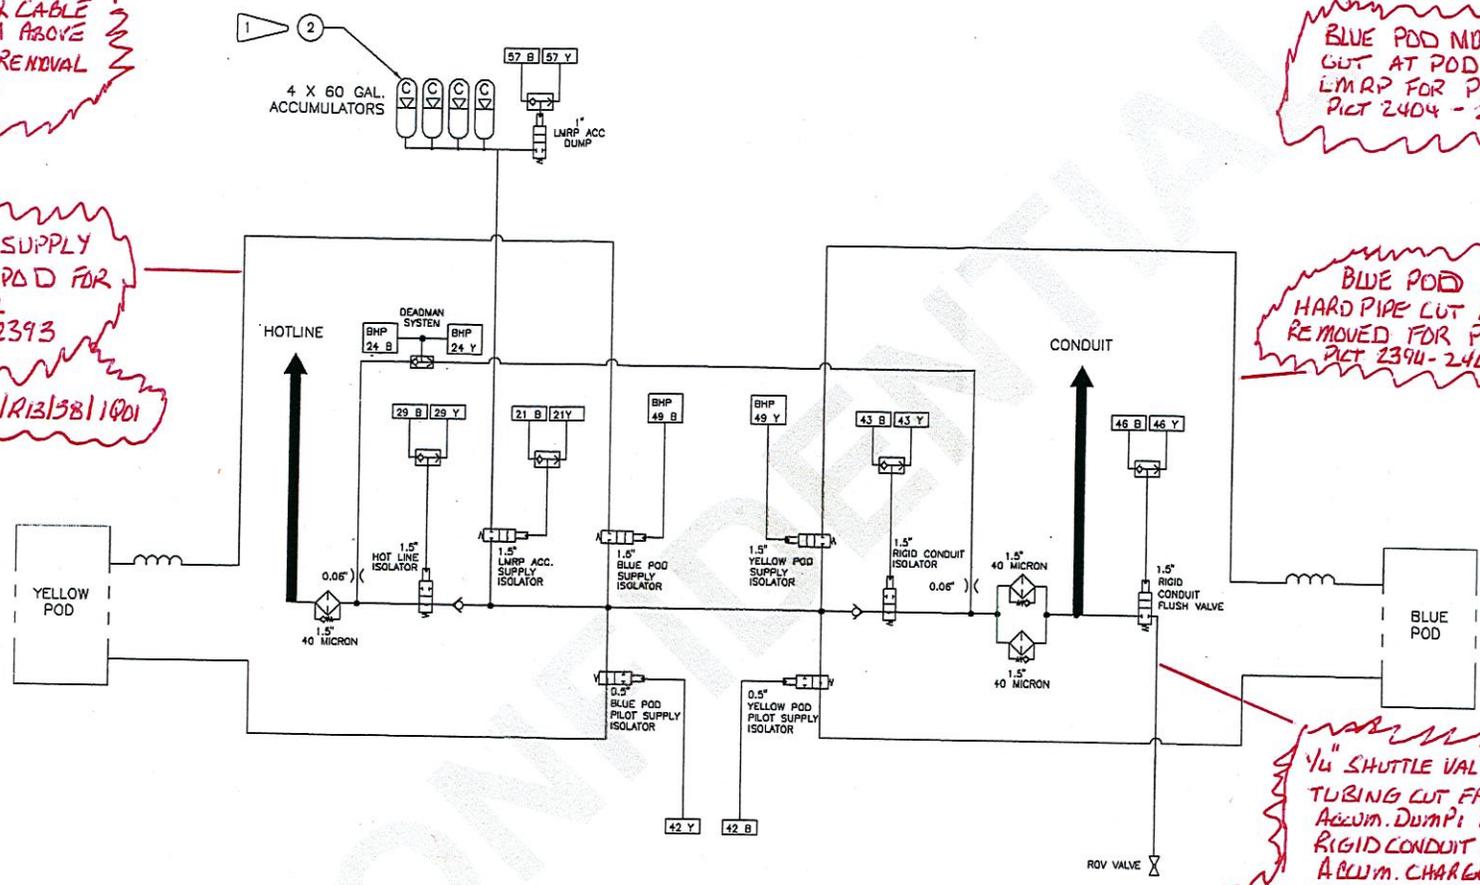
BLUE POD SUPPLY HARD PIPE CUT AND HOSE REMOVED FOR POD REMOVAL PICT 2394-2400

1/4" SHUTTLE VALVE ARRANGEMENT TUBING CUT FROM DEADMAN, ACCUM. DUMP; RIGID CONDUIT FLUSH; RIGID CONDUIT ISOLATOR, LMRP ACCUM. CHARGE FOR ROV INVENTION R & B FALCON "DEEPWATER HORIZON" PICT 2508-2516

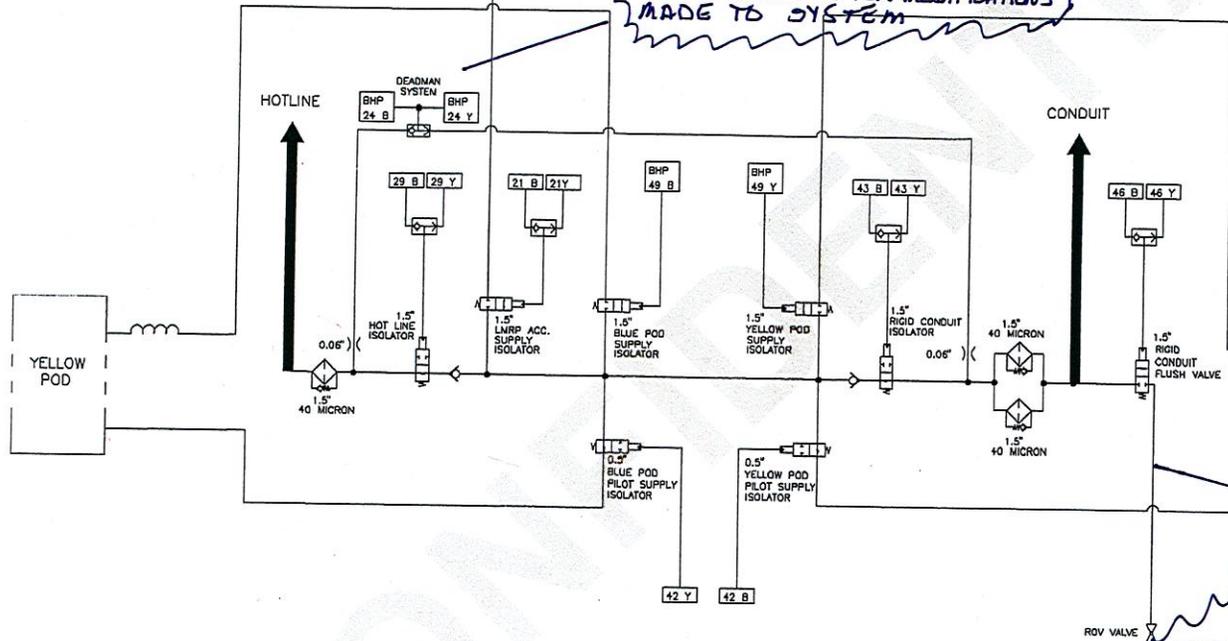
BLUE POD MUX CABLE CUT AT POD AND ABOVE LMRP FOR POD REMOVAL ATA ARMOR TERMINATION ASSY. ADDED. PICT 2404-2417

ORIGINAL DEADMAN PANEL REMOVED FOR MODIFICATIONS MADE TO SYSTEM

YU SHUTTLE VALVE ARRANGEMENT TUBING CUT FROM DEADMAN. ACCUM. DUMP. RIGID CONDUIT FLUSH. RIGID CONDUIT ISOLATOR. LMRP ACCUM. CHARGE. PICT 2508-2516 MODIFICATION R & B FALCON "DEEPWATER HORIZON"

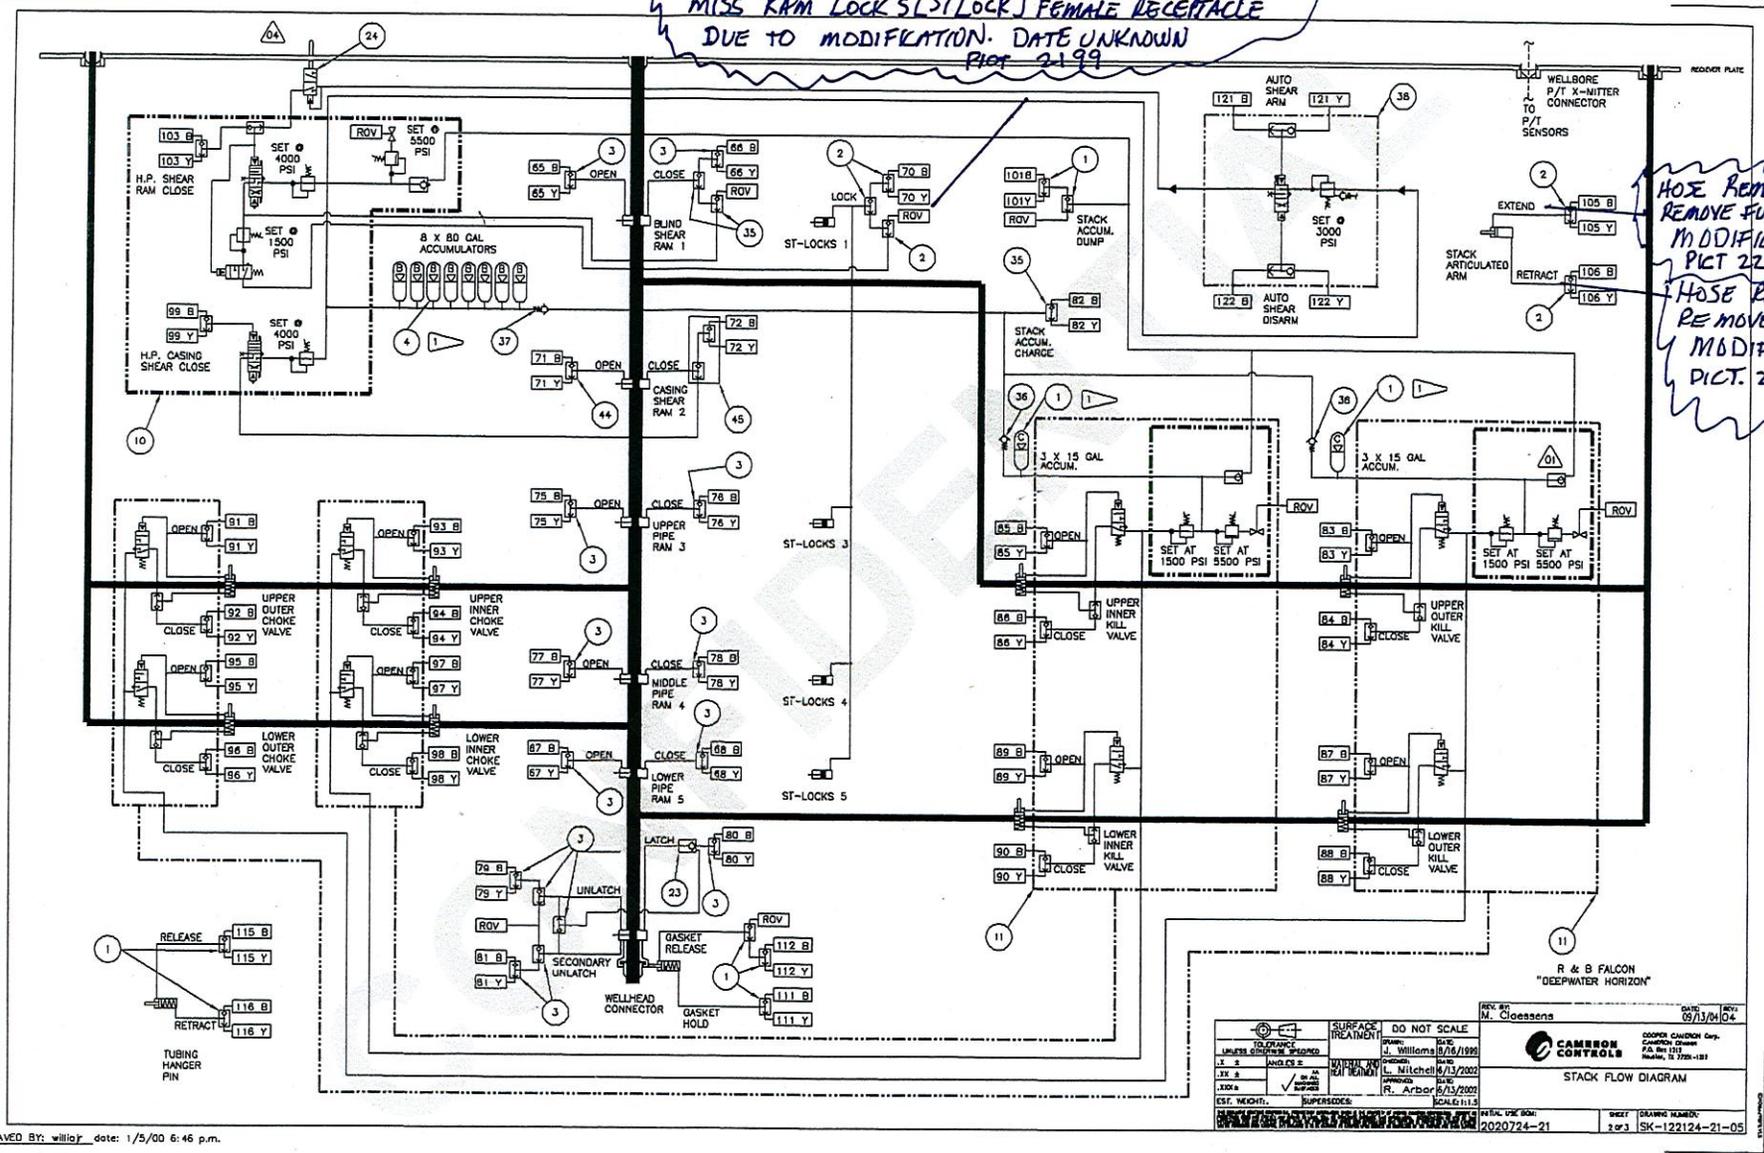
MISS RAM LOCKS (ST LOCK) FEMALE RECEPTACLE
 DUE TO MODIFICATION. DATE UNKNOWN
 PICT 2199

HOSE REMOVED TO REMOVE FUNCTION
 MODIFICATION 2
 PICT 2237-2283
 HOSE REMOVED TO REMOVE FUNCTION
 MODIFICATION 3
 PICT. 2237-228
