UNITED STATES COAST GUARD

Report of Investigation into the Circumstances Surrounding the
Explosion, Fire, Sinking and Loss of Eleven Crew Members
Aboard the
MOBILE OFFSHORE DRILLING UNIT

DEEPWATER HORIZON

In the GULF OF MEXICO
April 20 – 22, 2010

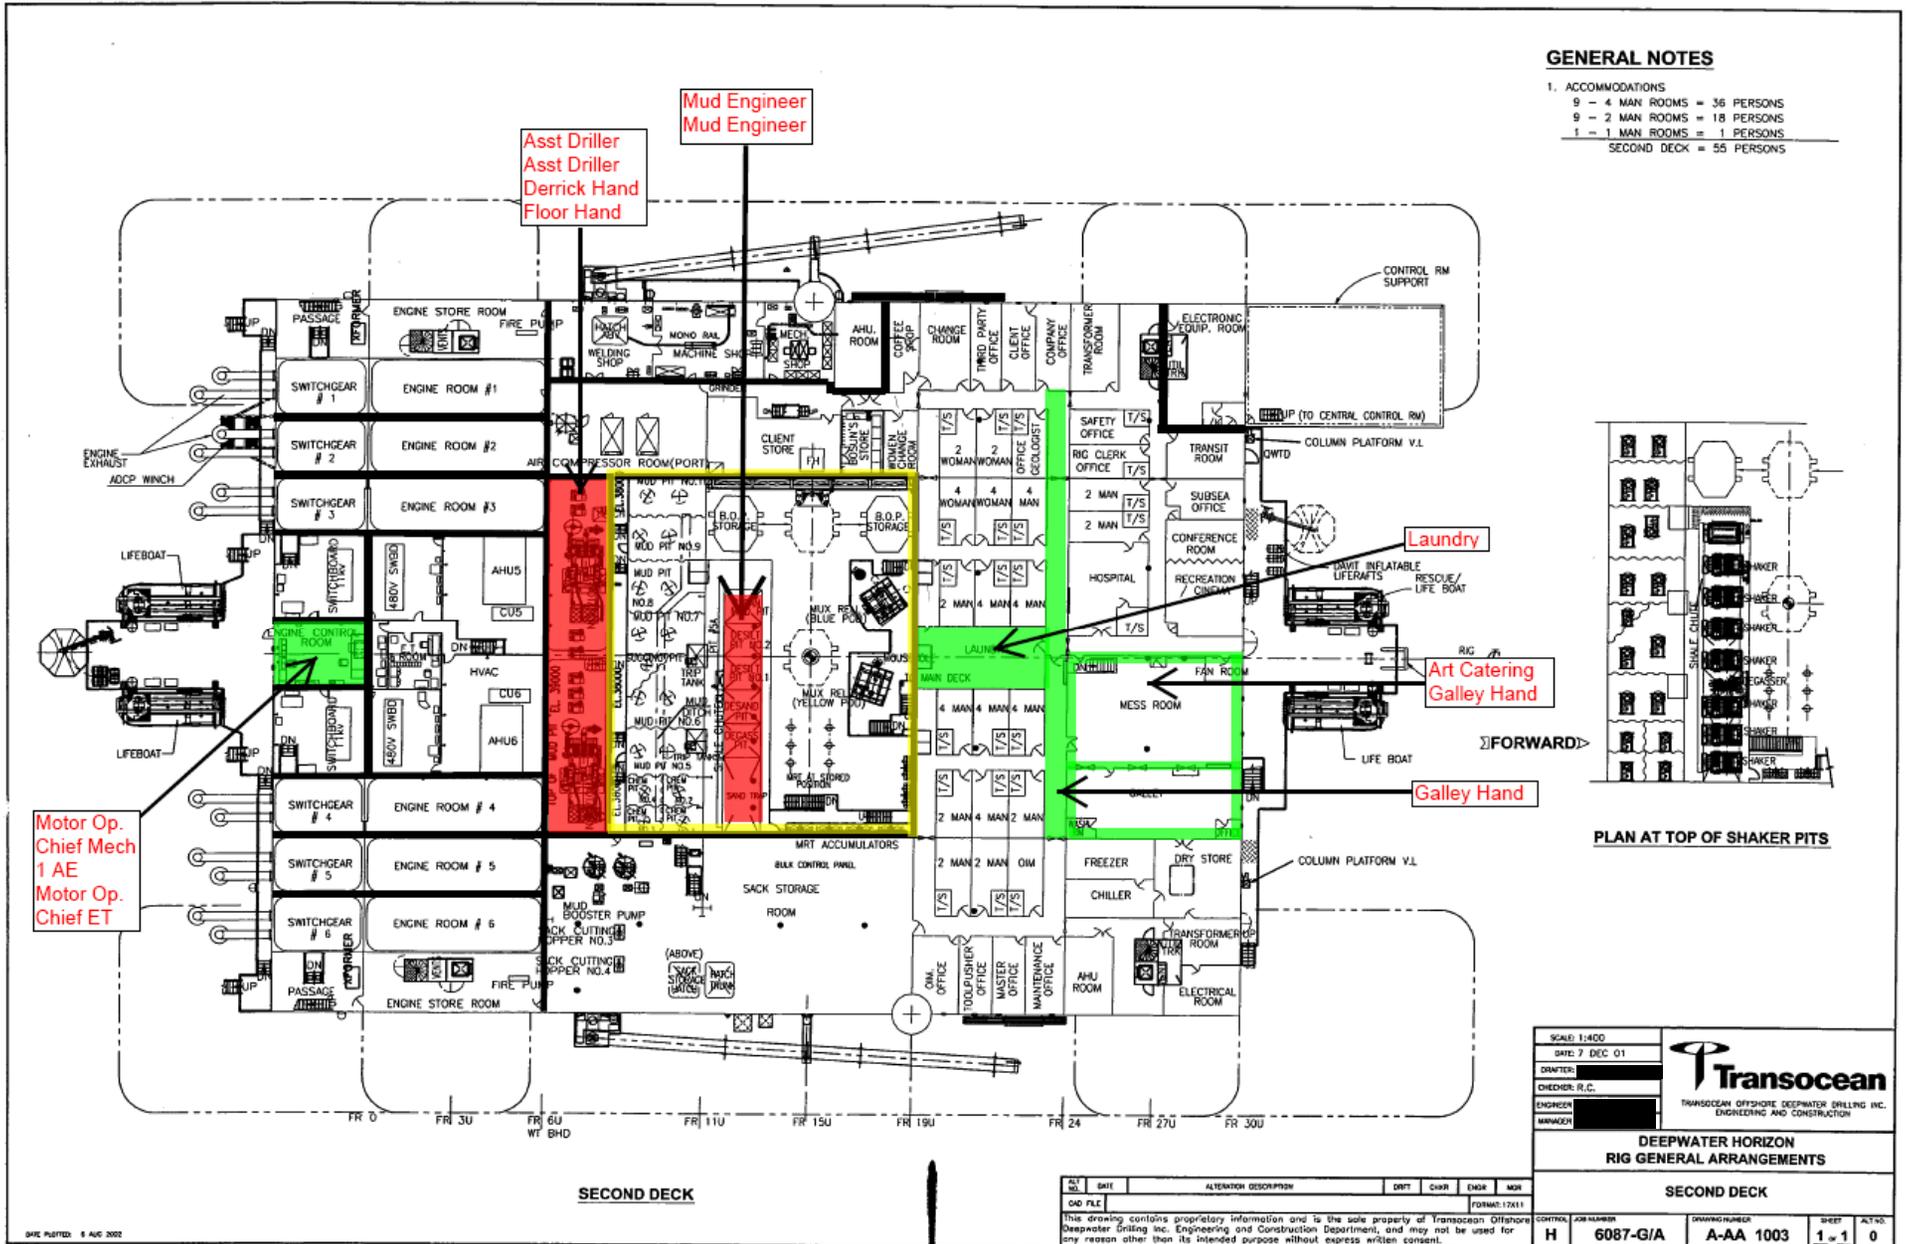
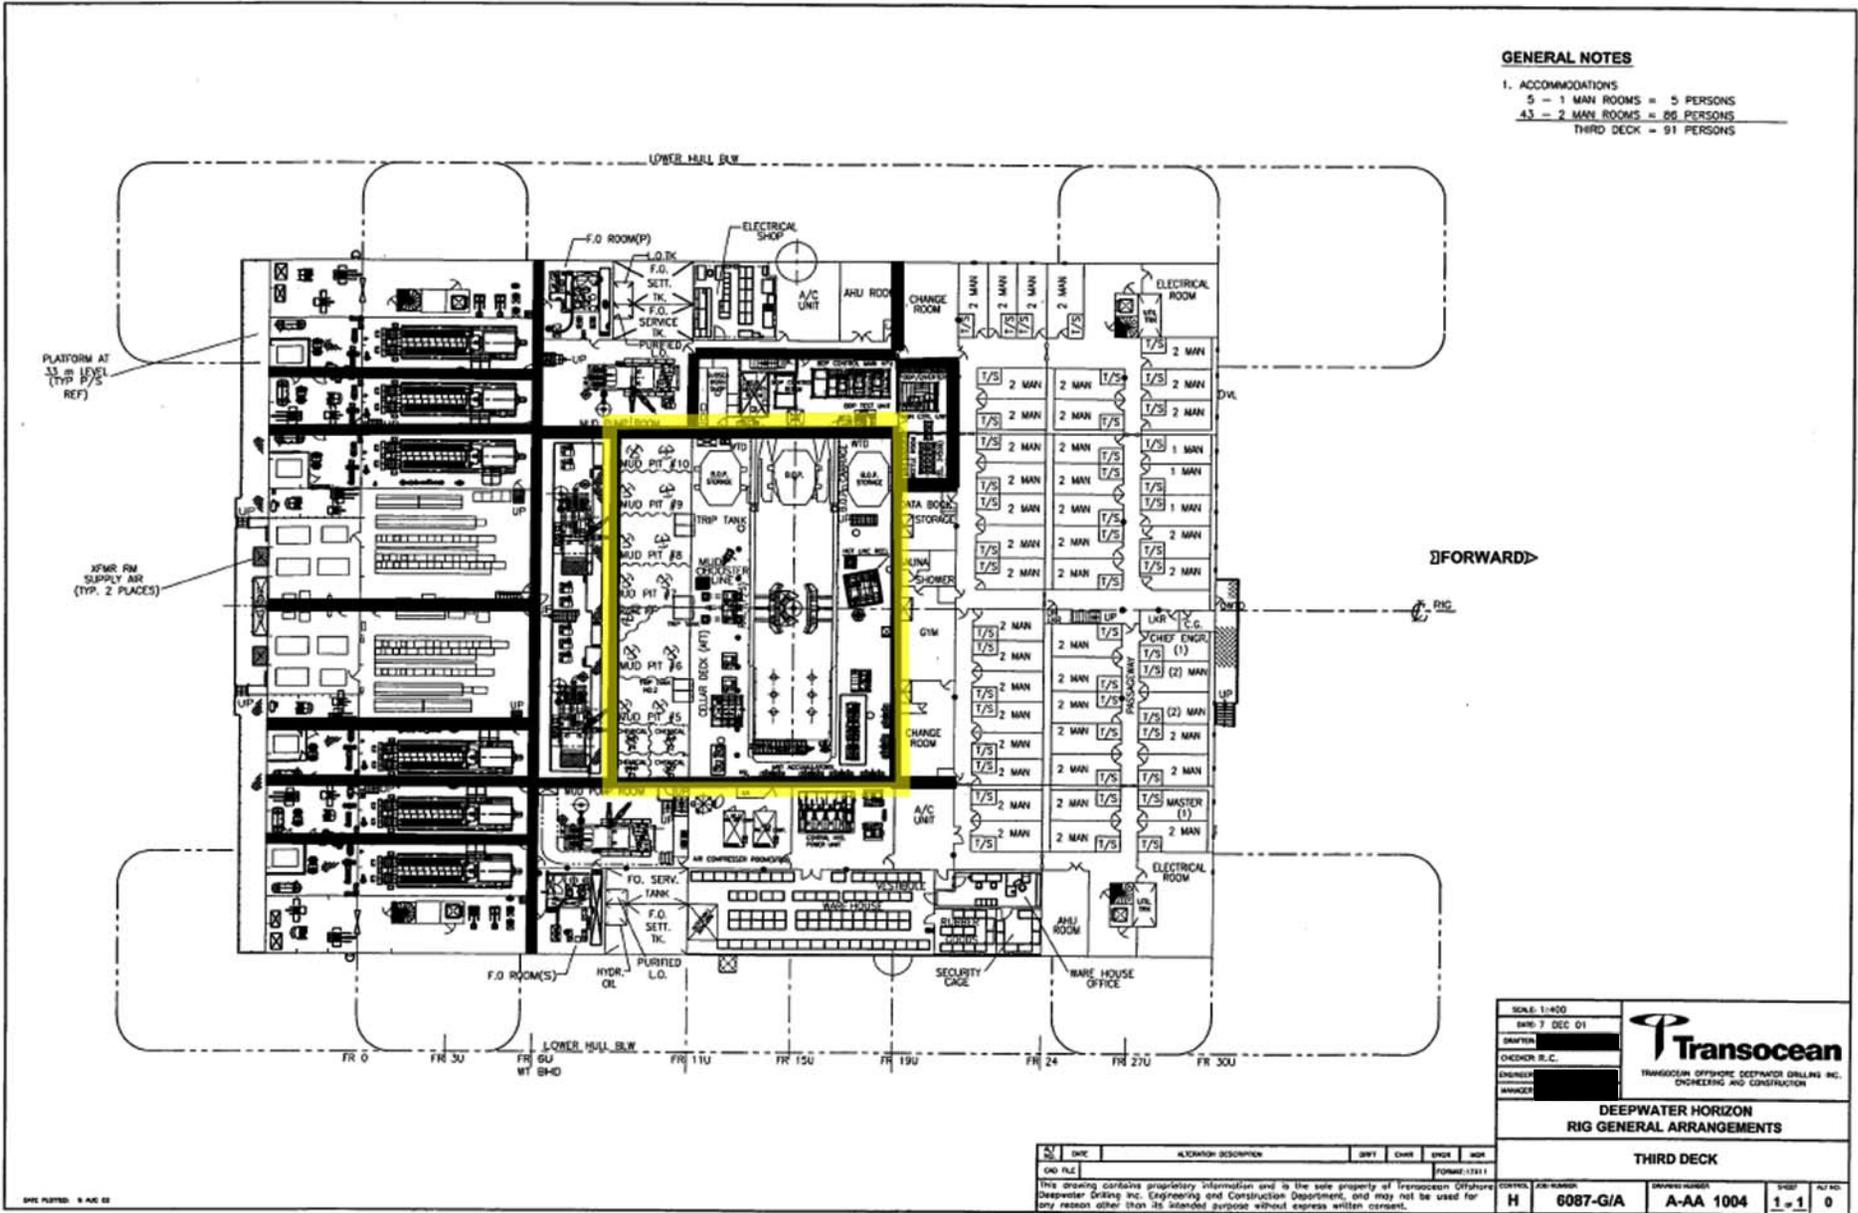
Another possible ignition source for the explosion was one of the main engines. Certain crew members testified that the explosion originated with Engine #3. At the time of the casualty, Engines # 3 and # 6 and their associated generators were supplying electrical power to the MODU. The other four generators were kept in a reserve mode. In the case of a fault or loss of power, one of the reserve generators would automatically start up and function as the emergency power source.

To the extent that the explosion initiated with an engine, the ventilation inlets for the engine rooms may have allowed the flammable gas cloud to travel to the main engines located aft of the Drill Floor. Because each of the six Wärtsilä diesel engines did not have (and were not required to have) independently ducted combustion air vents, the engines drew combustion air from the air supplied to the individual engine rooms by the ventilation inlets.

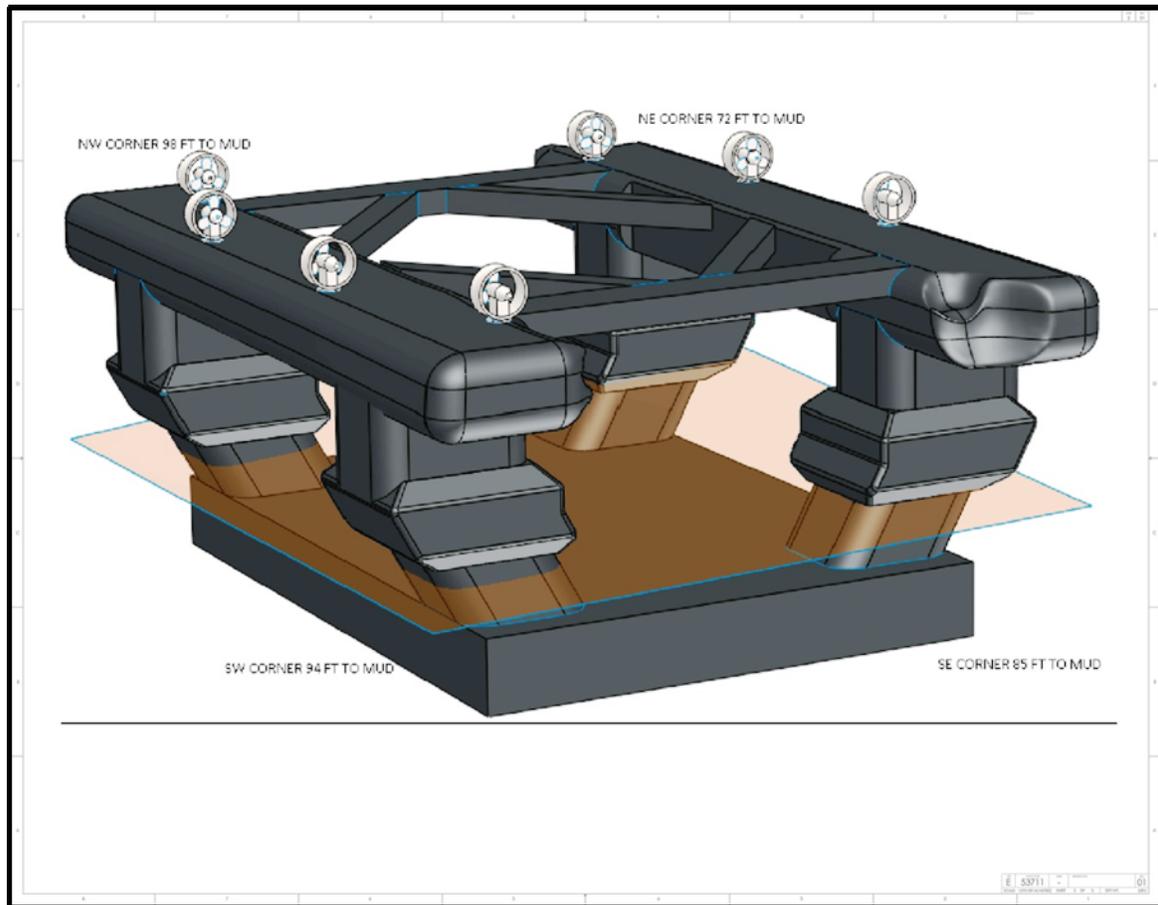
Figure 13 – *DEEPWATER HORIZON* on the Ocean Floor

Figure 13 shows *DEEPWATER HORIZON* as it came to rest on the ocean floor, depicting some of the damage and showing that the upper hull was buried and is not visible.²⁸⁰

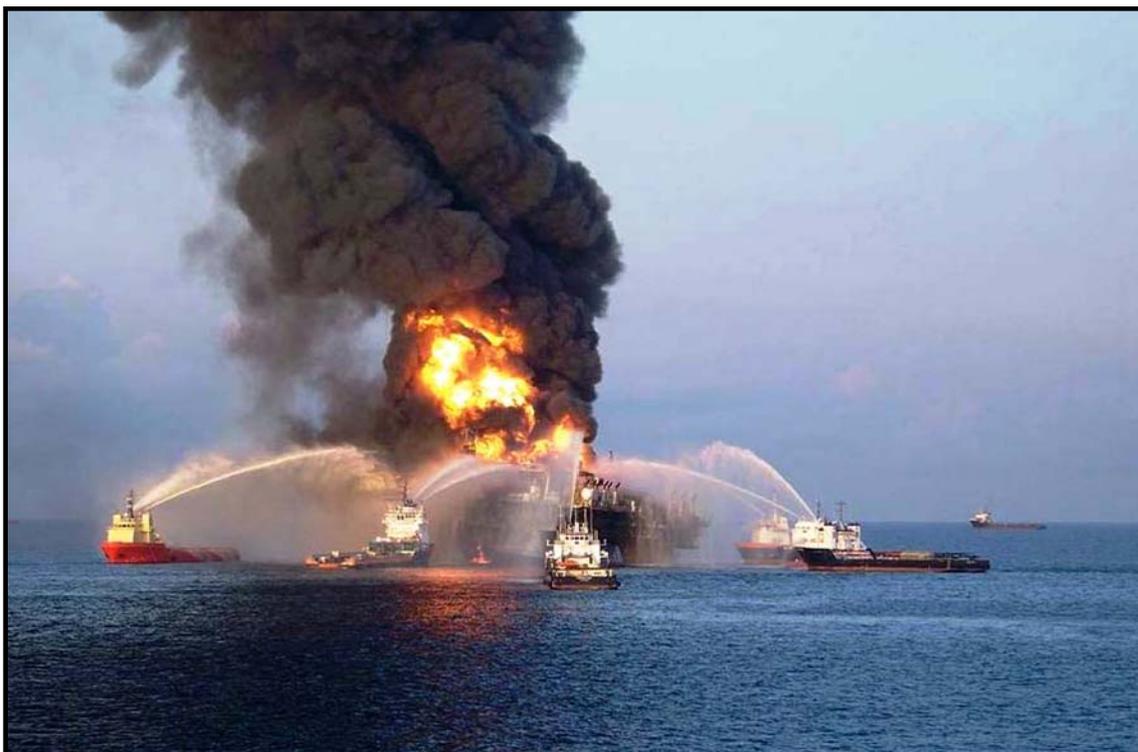
Figure 14 – Vessels directing water towards the fire

In the case of a vessel fire or casualty, the vessel owner typically develops a salvage plan to ensure that the situation does not worsen and that the risks to personnel, the vessel, and the environment have been addressed and minimized. However, despite having SMIT Salvage Americas in the Transocean emergency response center within about 6 hours of the initial incident, Transocean and SMIT Salvage Americas did not produce a salvage plan in the following day and a half before *DEEPWATER HORIZON* sank.

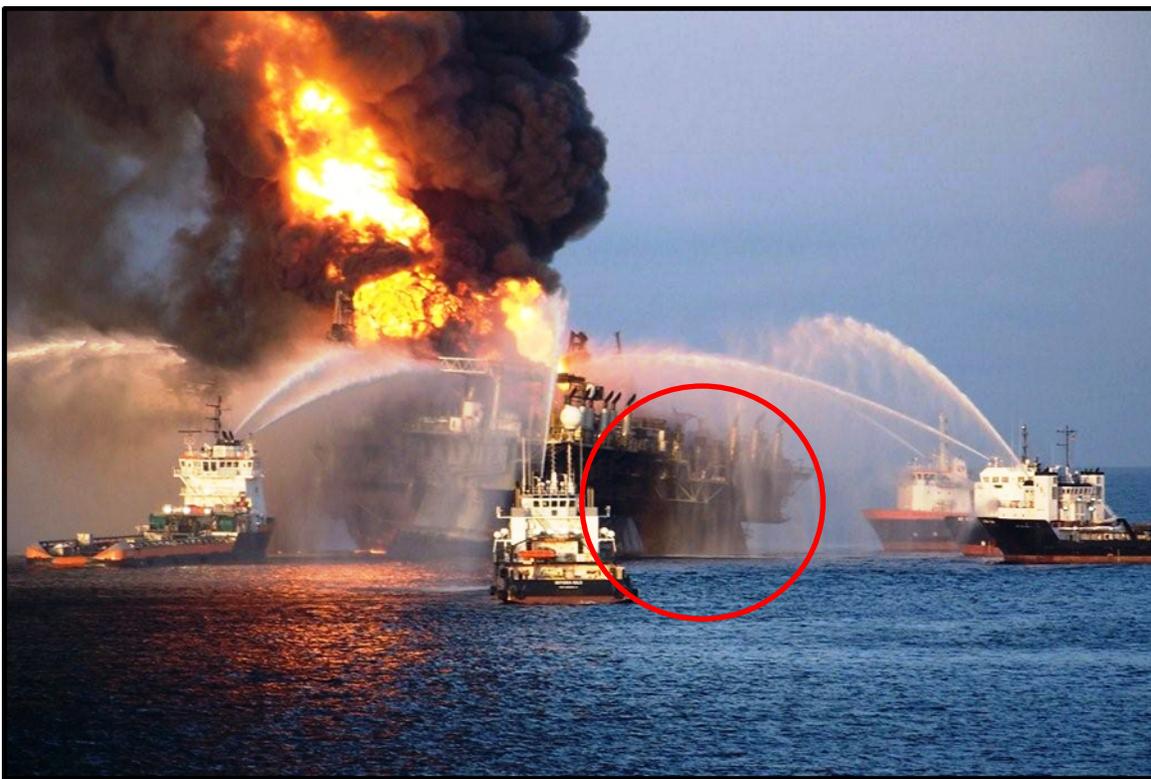
Figure 15 – Water from Responding Vessels Spilling Off the Deck of *DEEPWATER HORIZON*

This would appear to indicate that some of the fire-fighting water had accumulated within the MODU's structure, and may have contributed to its sinking. At the same time, it is possible that the influx of seawater through openings in the hull below the waterline, caused by the explosions and fire, was responsible for this added weight or loss in buoyancy. It is also not clear what the overall impact of a more timely coordinated fire-fighting effort would have been. The fact that this fire was being fueled from an uncontrolled source made it virtually impossible to extinguish without securing the well or removing the fuel source. Thus, although a more coordinated fire-fighting effort would have likely resulted in less water being put onboard, it is possible the MODU's structure would have been exposed to more extreme heat, hastening catastrophic structural failure. It is therefore not possible to conclude that the uncoordinated application of fire-fighting water from the responding vessels resulted in a more adverse flooding condition than anticipated from a coordinated fire-fighting effort.

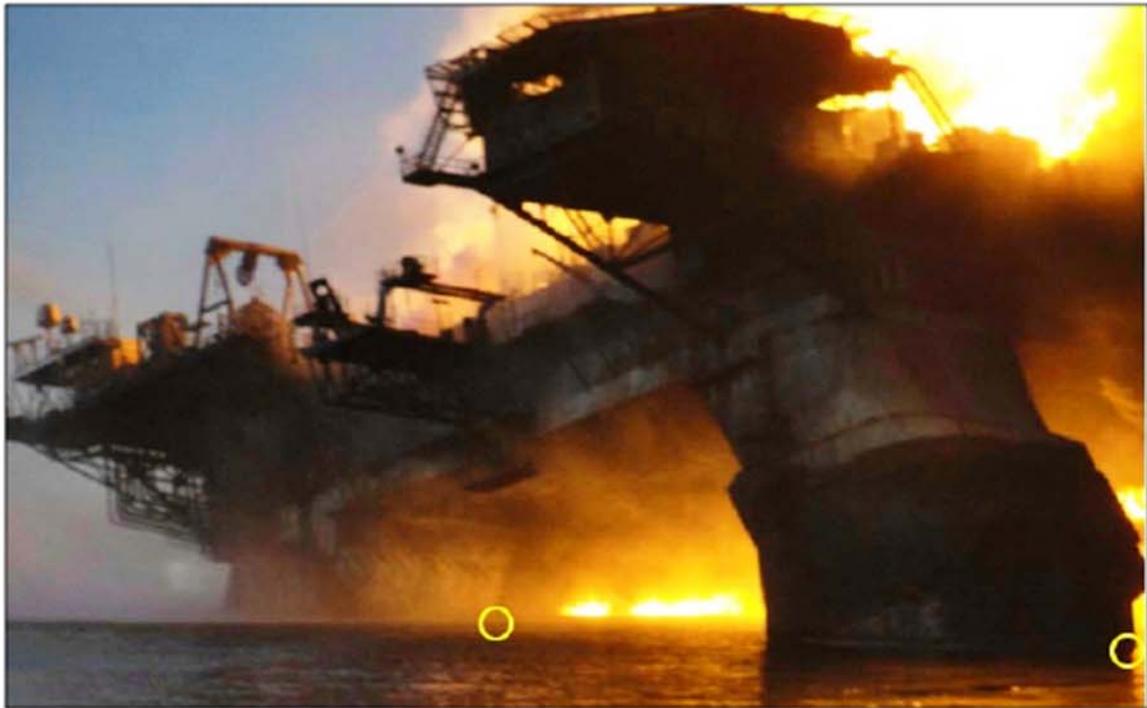
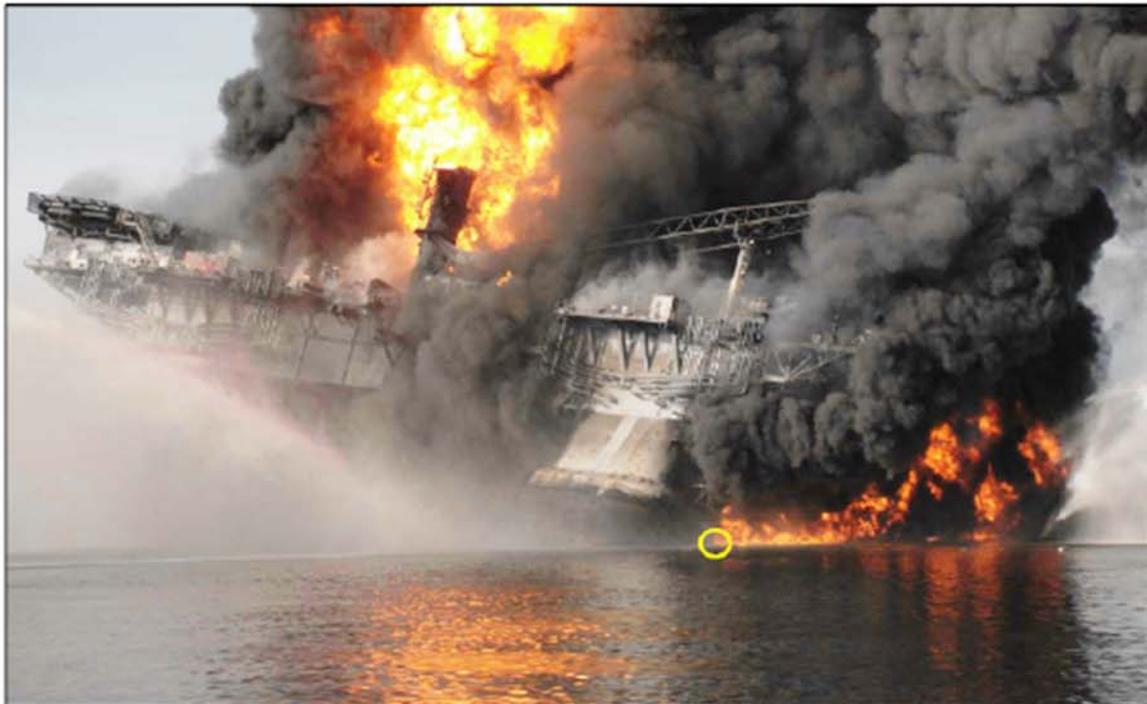
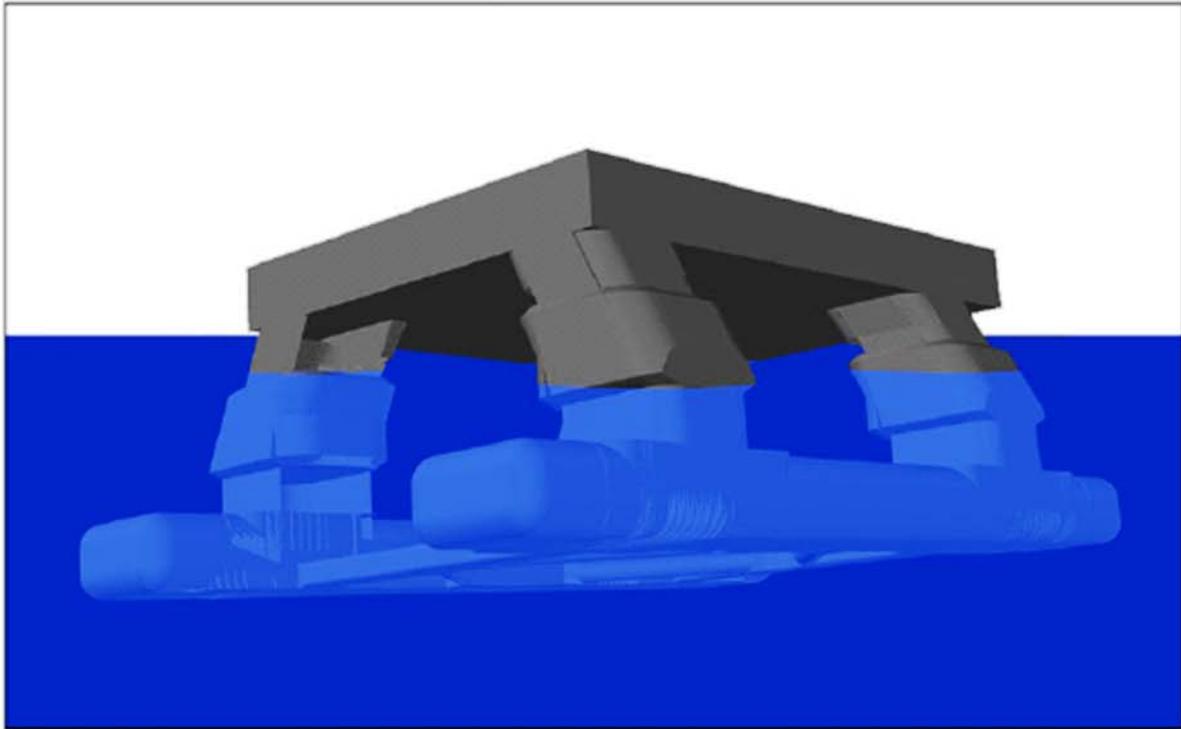
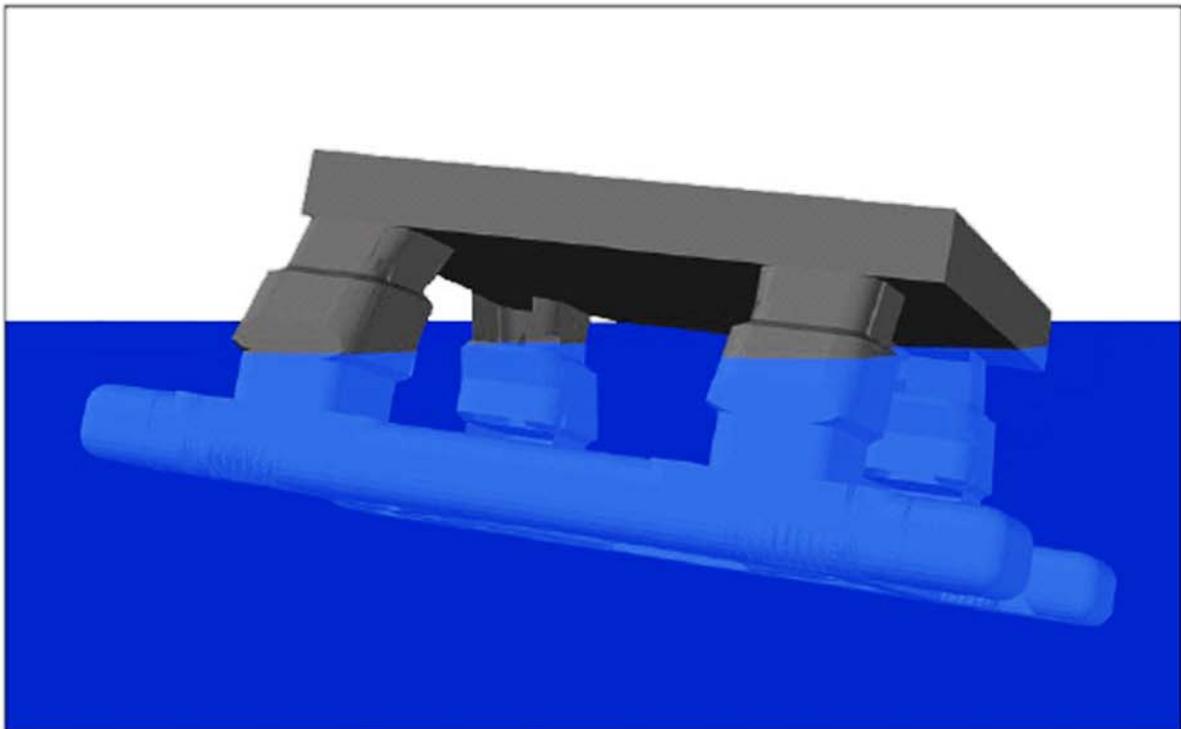
Without information on the rig’s loading prior to the casualty, it is impossible to analyze specific damage scenarios. We also lack precise information regarding the rig’s draft, heel, and trim as the casualty progressed. However, using photographs of the DEEPWATER HORIZON during the casualty, we estimated her waterplane in the damaged, floating condition. To estimate the waterplane, we used photographs taken at known times and identified three recognizable hull locations that intersected the waterline. The hull locations at the waterline that we used are marked on the photographs (see below) with yellow circles. Figure 3 and Figure 4 were reportedly taken at 0612 on April 22, 2010. Figure 5 and Figure 6 illustrate how the waterplane estimated from these photographs looks when applied to our computer model. Figure 7 and Figure 8 were taken at approximately 1030 on April 22, 2010, just prior to the rig sinking. Figure 9 and Figure 10 illustrate how the waterplane that was estimated from these photographs looks when applied to our computer model. Although the extent of damage shown in Figure 7 and Figure 8 indicate that some hull deflection may exist, our waterplane estimates cannot account for deflection and necessarily assume that the hull was not deflecting in the pictures.
