PROCEEDINGS

OF THE MERCHANT MARINE COUNCIL

UNITED STATES COAST GUARD
Vol. 22, No. 11 • November 1965

Marine Casualties Reviewed

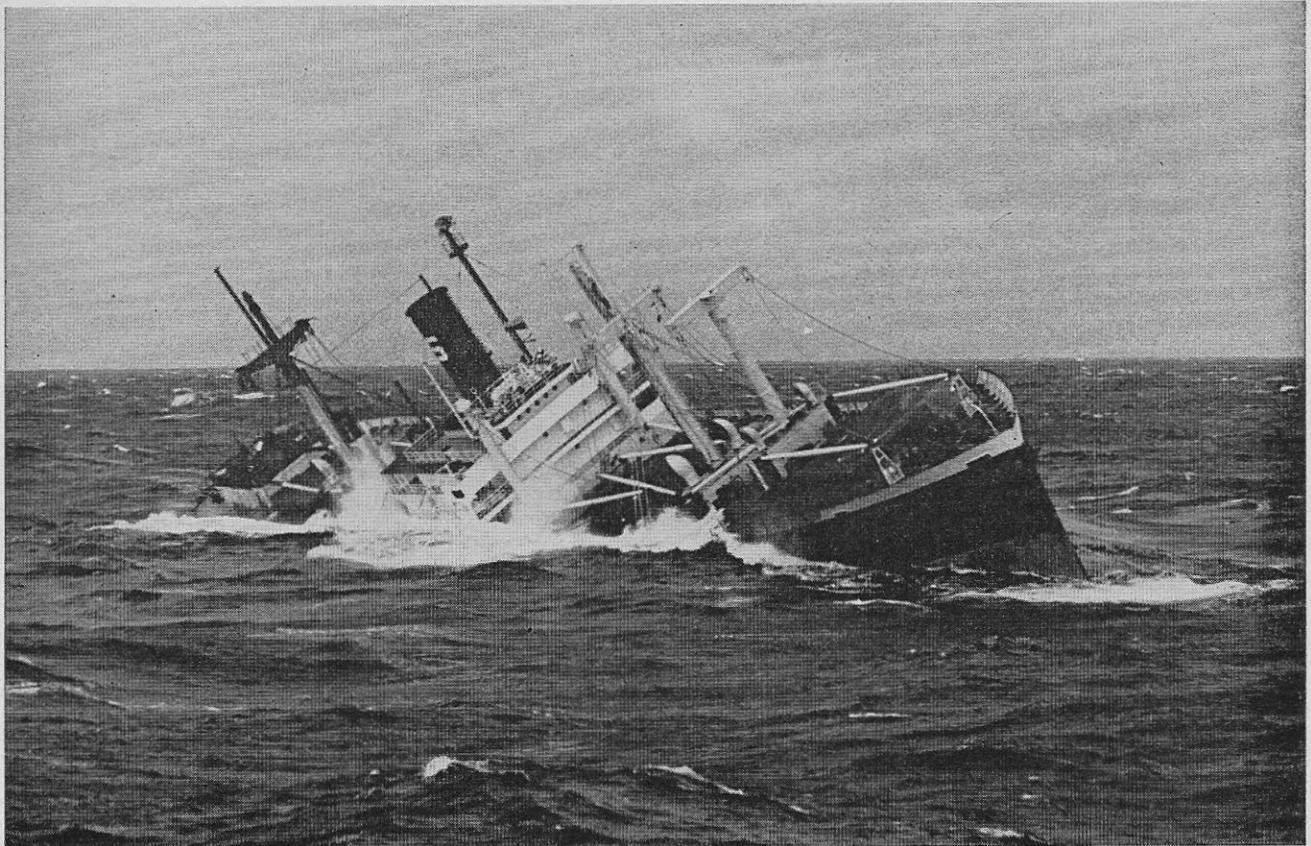
The Smith Voyager lists heavily after grain cargo shift.

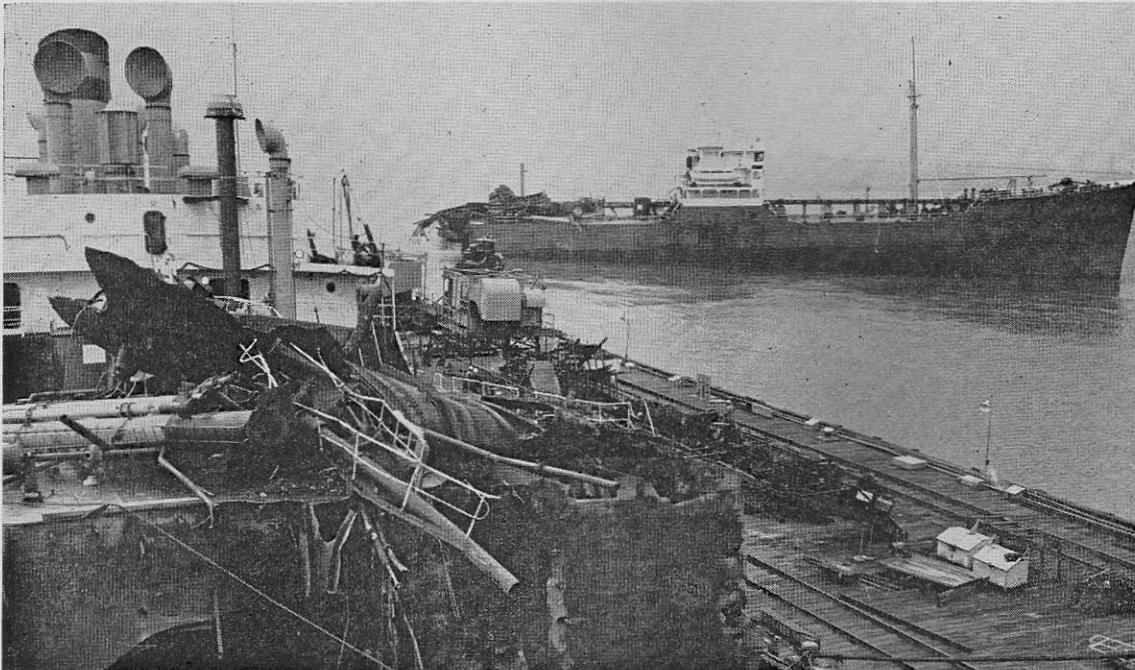
SS San Jacinto. During the night of 25 March 1964 a violent explosion occurred in the No. 8 tanks of the modified T-2 type tank ship *San Jacinto*. As the result of the explosion, the vessel was blown in two and one crewmember died of a heart attack. At the time of the explosion, the vessel was en route to a shipyard for dry-docking and repairs. Throughout the day, prior to the explosion, the crew

Salvaged stern and bow sections of tanker *San Jacinto*.

was engaged in gas freeing the cargo tanks. At the time of the explosion, No. 8 center tank had been water washed but not gas freed. The Board in its report concluded that the explosion was most probably caused by a magnesium anode falling in the tank creating an incendiary spark. As the result of this casualty, the Commandant promulgated regulations to prohibit the installation or use of sacrificial anodes of a type capable of producing a spark as the result of falling in tanks used for the carriage of inflammable or combustible liquids.

crewmembers who were in the midship house, are missing and presumed to have been lost. Prior to the explosion, the crew had been involved in cargo tank washing operations in preparation for the loading of a petroleum cargo and to assure that there would be no cargo contamination. The No. 9 tanks across had been water washed, stripped and dried by use of the vessel's gas exhauster. The gas exhauster is a device operating on the venturi principle utilizing auxiliary steam under pressure to draw liquid and vapor from a tank via its cargo suction and discharge lines. The Board in its report concluded that the use of the gas exhauster probably lowered the petroleum vapor-air concentration to the critical range for explosion. It further concluded that the source of ignition was probably a magnesium anode or a piece of the no longer used chemical wash pipe system falling in the center tank.
