PROCEEDINGS OF THE MERCHANT MARINE COUNCIL

Continental Oil Rig 43A Gulf of Mexico . . .

Shipboard Fire and Safety Test Facility Dedicated	184
Issue Numbers on Merchant Marine Officers' Licenses	186
Continental Oil Rig 43A Gulf of Mexico, 24 October 1967 Explosion and Fire With No Loss of Life	188

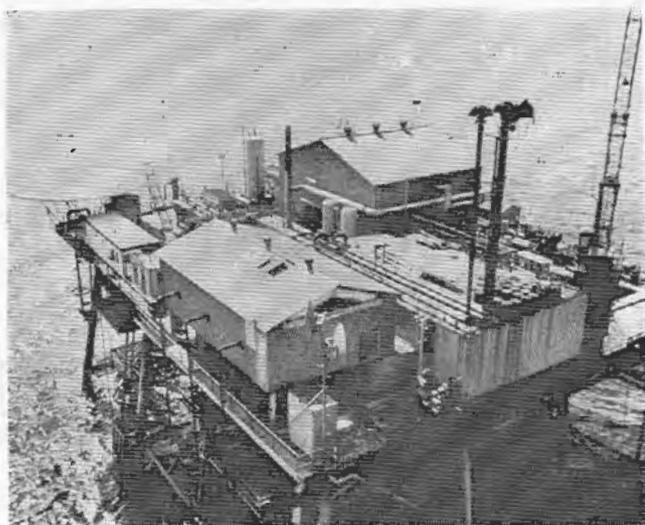
BEFORE: Continental Oil Rig 43-A stands in the Gulf of Mexico, everything normal on another working day. The platform served as a collection and processing point for crude oil produced by adjacent fields.

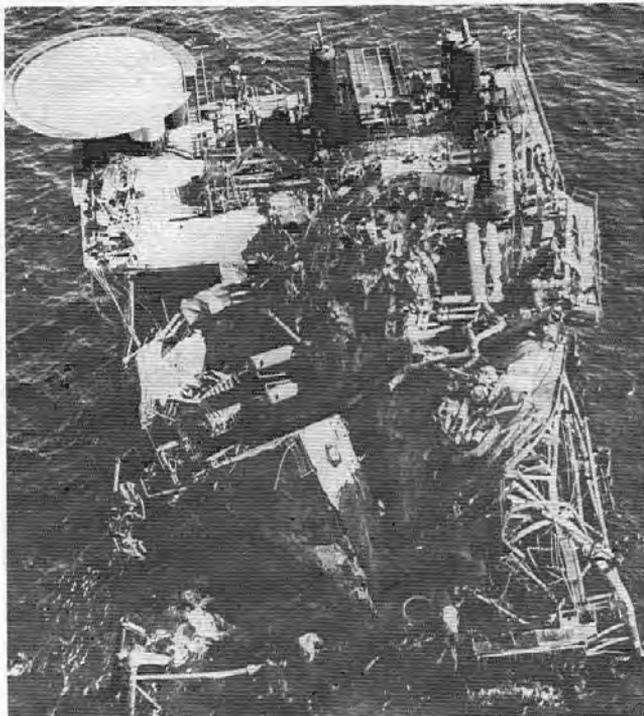
AFTER: The rig is transformed into a mass of blackened wreckage. An explosion followed the rupture of a storage tank, touching off a blaze that enveloped the platform for 48 hours. No lives were lost, but damages ran to \$3½ million.

1. It is concluded that the cause of the casualty was the rupture of the 3,835 barrel storage tank by an excessive pressure, exerted internally. The exact source of this pressure cannot be definitely determined; however, it may be reasonably concluded that the gas pressure arrived at the platform with the pig from 69-K. After passing through the primary separator, and causing the secondary separator relief valve to lift, the gas reached the storage tank at a pressure in excess of 230 p.s.i. due to probable failure of the level-actuated dump valves, possibly due to fouling by sand.

5. It is concluded that a most probable source of ignition for the gas and oil emitted from the tank after rupture was the rental generator installation which included: an uninsulated exhaust pipe; sparks issuing from the open exhaust pipe, and nonexplosion-proof terminal connections.

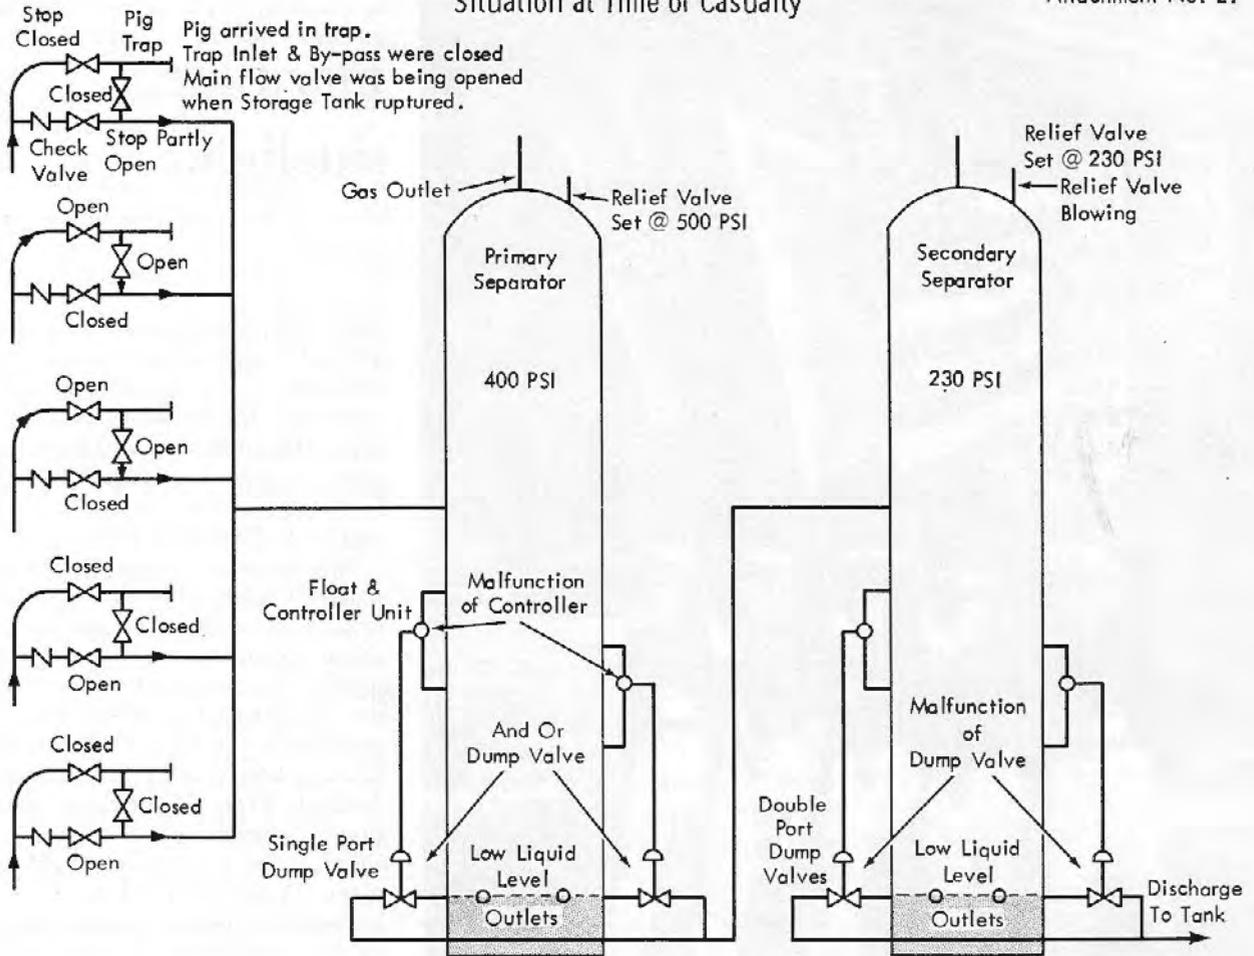
Attachment No. 2.

The first evidence of unusual conditions on the main deck was the operation of the relief valve on the secondary separator. This was followed in rapid sequence by a rumbling sound in the storage tank, the spraying of the oil from the tank vents, rupture of the tank, a loud explosion-like noise, and fire. *Attachment No. 2* indicates the hypothesis of the plant situation at the time of the casualty.

With the primary dump valve hung open, the oil level would be lowered to the point that the discharge pipe would lose its liquid seal, permitting high pressure gas to pass to the secondary separator. The crude oil in the secondary separator would be discharged to the storage tank at a higher than normal rate because of the much higher (230 p.s.i.) gas pressure behind it. With the sec-

The Safety Board concludes that the investigative record in this case does not contain sufficient information to provide a determination of the cause of this casualty. However, based on the most likely hypothesis, the Board concludes that the most probable cause was faulty operation of two of the four dump valves of the separators in a chain of events combined with a malfunction of the primary dump valve controller during the pipe cleaning

Situation at Time of Casualty
