## *PROCEEDINGS*

OF THE MERCHANT MARINE COUNCIL

The Inflatable Liferaft as a  
Rescue Vehicle . . .

Drilling Rig *Dixilyn 8*, *Julie Ann*  
Capsizing and sinking . . .

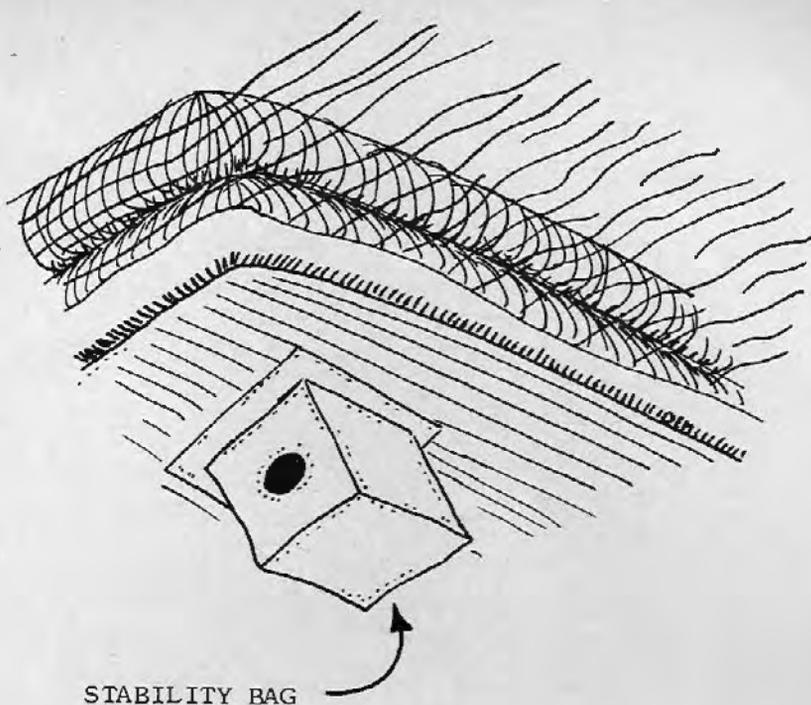
VIEW OF STABILITY BAG FROM IN WATER BENEATH RAFT
