**OF THE MARINE SAFETY COUNCIL**

**UNITED STATES COAST GUARD**

September 1974

# SIX DROWN AS TUG SINKS

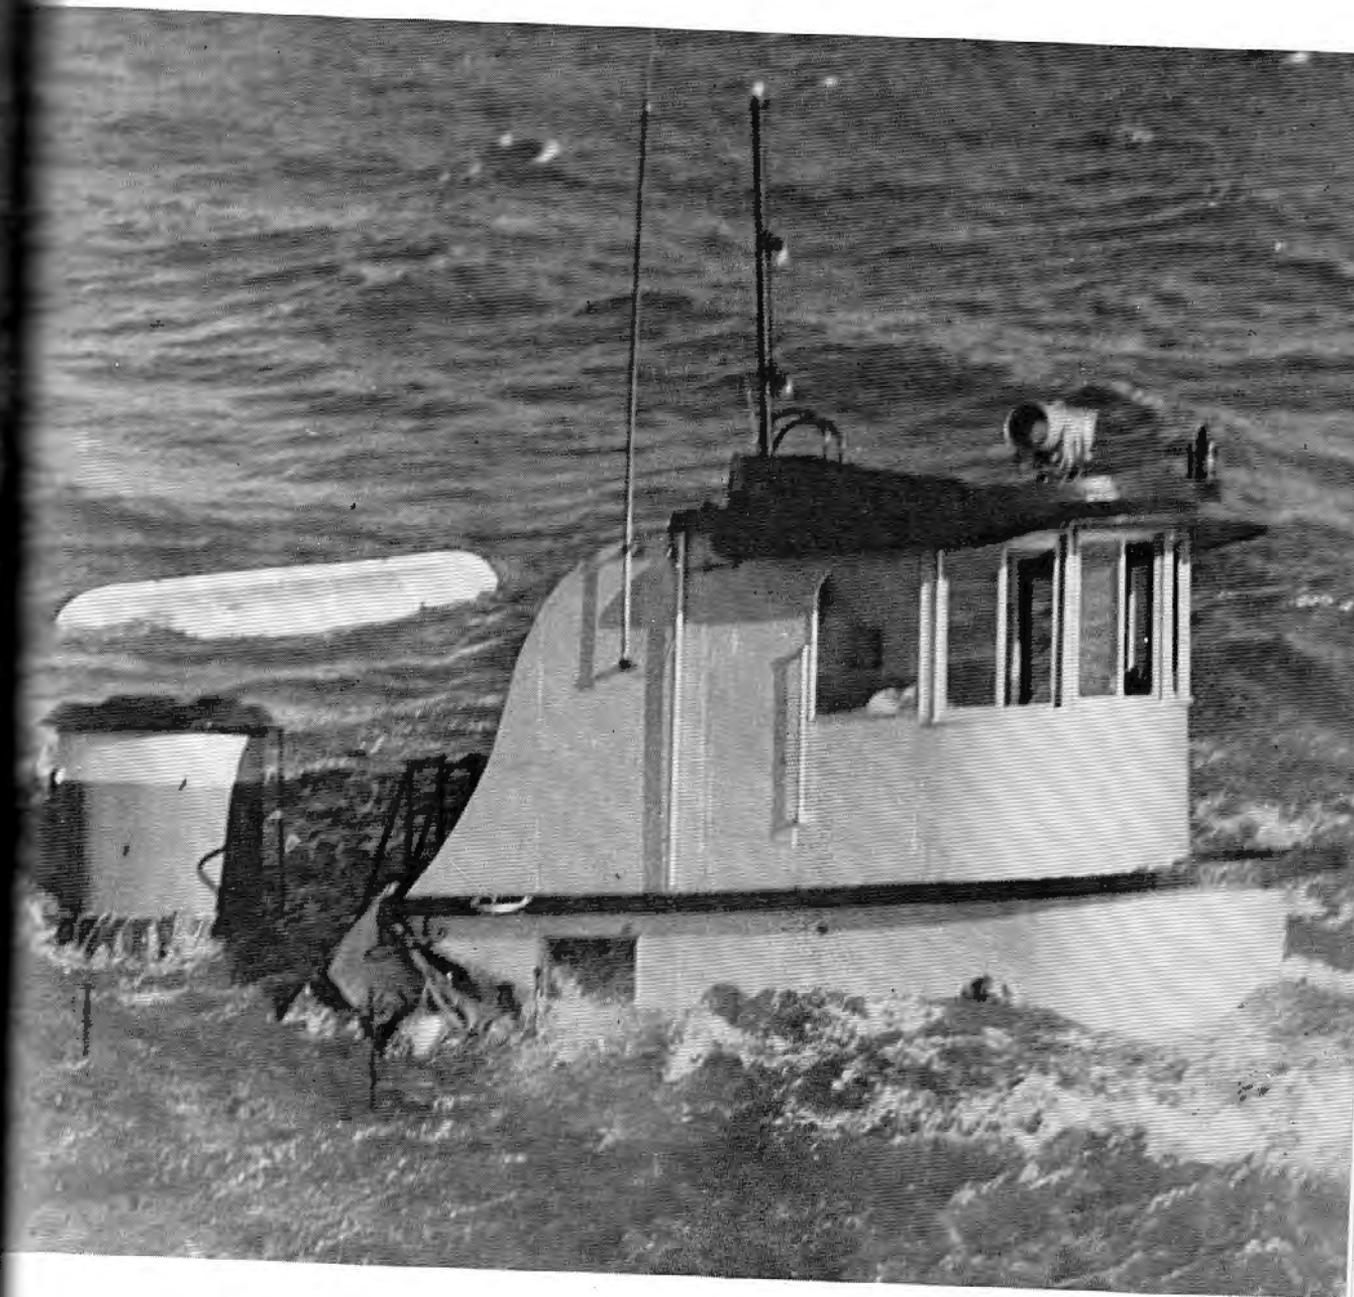
The overturned life boat and half-submerged wheelhouse of the tug M/V *Maryland* tell a tale of tragedy in the front cover photo. A narrative account of the casualty which claimed six lives begins on page 171.

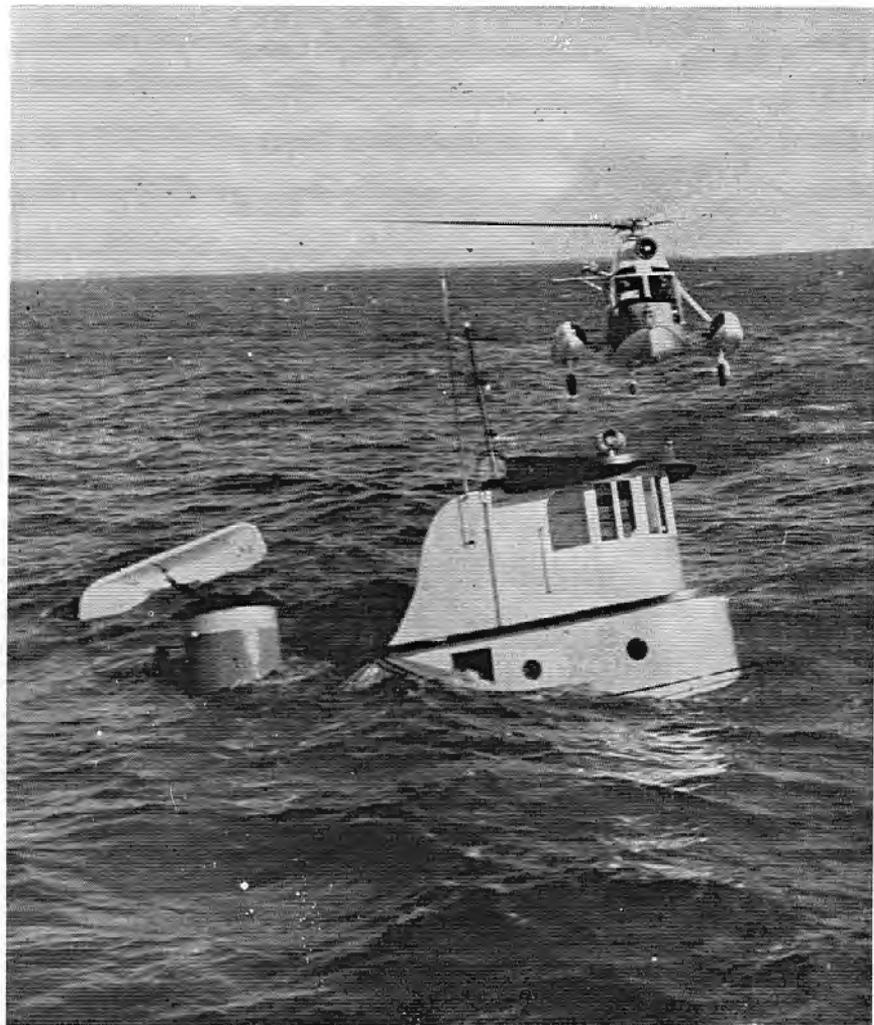
The yacht *Georgetta* was the first vessel to spot the foundered *Maryland*. Crewmembers of the yacht rescued the lone survivor of the casualty, who was then airlifted by Coast Guard helicopter to Albemarle Hospital in Elizabeth City.

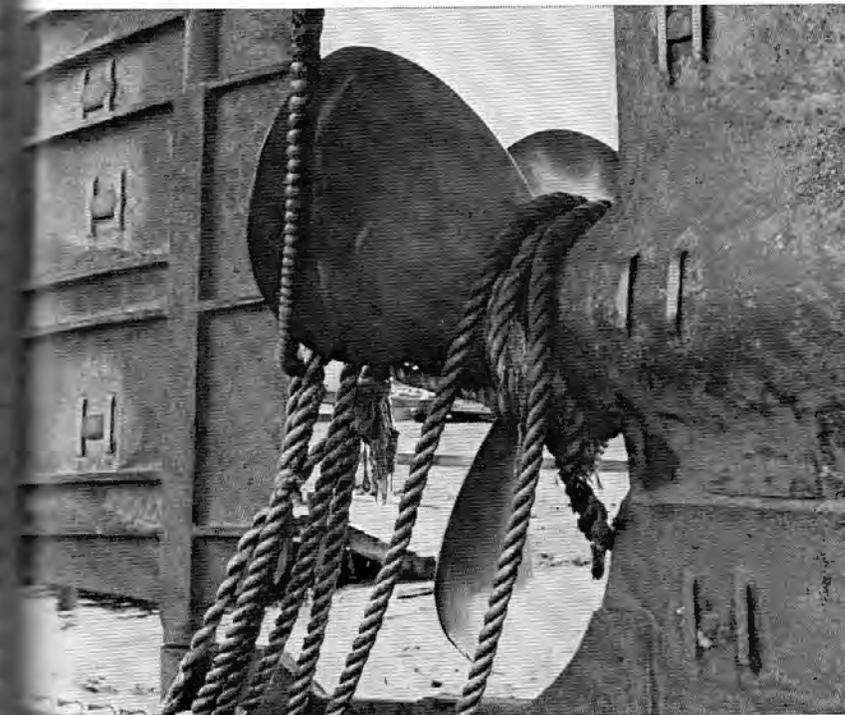
The unused section of the towing hawser washed overboard as the *Maryland* attempted to cross Albemarle Sound. When the tug stopped to lengthen the towline, a loose bight fouled the propeller as shown above.

The failure of the engine to restart, after initial efforts to pay out the towing hawser were abandoned, was caused by fouling of the propeller by the towing hawser. A bight of the free end of the hawser, initially stowed on the well deck hawser grating, was washed overboard through the aftermost starboard freeing port at some time after leaving the mouth of the Alligator River and encountering heavy weather, but prior to stopping the vessel to lengthen the hawser. When stopped, the drift of the tug caused the bight of trailing towline to tend under the tug in way of the propeller where it became fouled in the propeller when the direct driven diesel engine was cranked over for starting. Succeeding turns collected around the propeller shaft, between the propeller and stern frame, until sufficient restraining force developed to prevent further cranking of the engine.

d. The loose stowage of the unpermitted length of hawser in the well deck permitted the hawser to be washed overboard when heavy weather was encountered. Had the hawser been lashed or otherwise secured to prevent it being washed overboard, the propeller would not have become fouled and the master may have been able to get the tug and tow under control.

f. The open, unprotected, freeing ports permitted the bight of loose towing hawser to wash overboard. Had the freeing ports been provided with guards, screens or prevention bars which would have reduced the clear opening dimensions, without significantly reducing the effective area available for flow of water, the hawser may not have been washed overboard. Even if it had been washed overboard over the bulwarks, its position would not have been as susceptible to fouling the propeller under drifting conditions.
