Adrift in Fog

Poor visibility, errors in judgment, and diminished situational awareness lead to tragedy on the Ohio River.

Lessons Learned

from **Casualty Investigations**

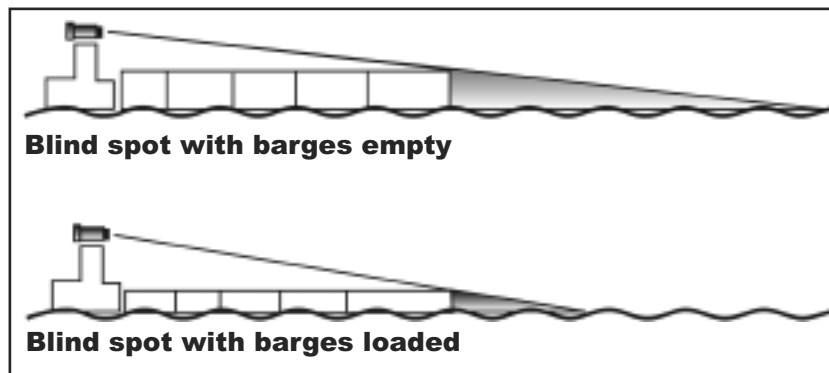
The pilot of the *Elaine G* testified he began seeing fog when the vessel was about 3.5 miles from Ohio River mile 566.7, where he was relieved. He said that, when looking forward, he could see the “swing light” and the glow of the navigation lights mounted on the head of the tow, and possibly a little farther. The towboat’s empty barges were riding high in the water, making it harder for him to see objects in front of them.

Blind spots: Visual and radar blind spots from the vantage point of the towboat’s pilothouse prevented the pilot and captain from detecting the recreational vessel. Visual contact was made even more difficult by the fact that the small boat was unlit and riding low in the water.

The pilot and the captain of the towboat were relying heavily on radar that morning, and did not understand the full extent of these blind spots. The fact that the barges were unloaded exacerbated the problem. If they had taken these factors into account, they might have halted the voyage until conditions improved.

The towboat’s empty barges were riding high in the water, making it hard to see objects in front of it.

Employ a designated lookout. As this story illustrates, radar alone cannot take the place of human eyes and ears when a vessel is pushing ahead nearly 1,000 feet of barges at night in heavy fog. Both the captain and the pilot of the towboat were well aware that visibility was a problem: They later told investigators that they could not see either riverbank 1,000 feet away. As seasoned professional mariners, they should have been aware that both the large visual and the radar blind spots further diminished their ability to see. Other vessels in the area had either pulled over to the riverbank or considered doing so.
