No Survivors

A fishing vessel meets a mysterious end in the Bering Sea.

from **Casualty Investigations**

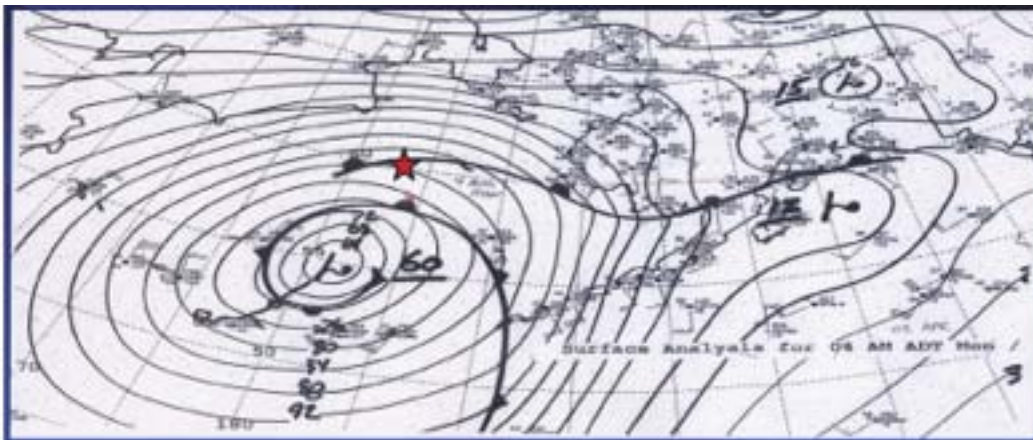
weather event called a “triple point” occurred at the vessel’s last known position. This is an area of a frontal system where a cold, warm, and occluded front join together, and is usually associated with severe weather. It is likely, based on the triple point, that the vessel experienced these three distinct weather patterns in a short period of time.

National Weather Service surface analysis for 4 a.m. on April 2, 2001. The red star indicates the approximate position of the Arctic Rose. Graphic courtesy of the National Weather Service.

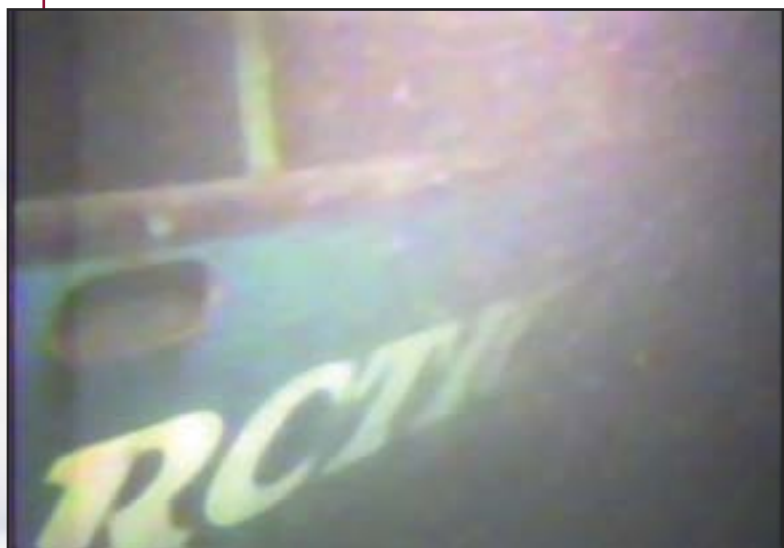
Photograph of the Arctic Rose taken during the remote operated vehicle expedition. U.S. Coast Guard graphic.

- The hull of the vessel was intact.
- The pilothouse was undamaged and all visible windows were intact.
- The rudder was hard to port.
- The trawl doors were missing and the trawl net was on the reel with the cod end in the dump box.
- The starboard overboard chute was partially open.
- Wires were spooled on the trawl winches and trawl gear, wires, and mud lines had shifted to starboard.
- Plow marks aft, where the vessel's Kort nozzle made its initial impact, indicate that the vessel landed on the sea floor, stern first.
- There was no evidence of explosion or fire.
- The vessel was not fishing at the time the casualty occurred.
