U.S. Coast Guard Safety Alert

Alert 2-05

Loosening of Critical Fasteners

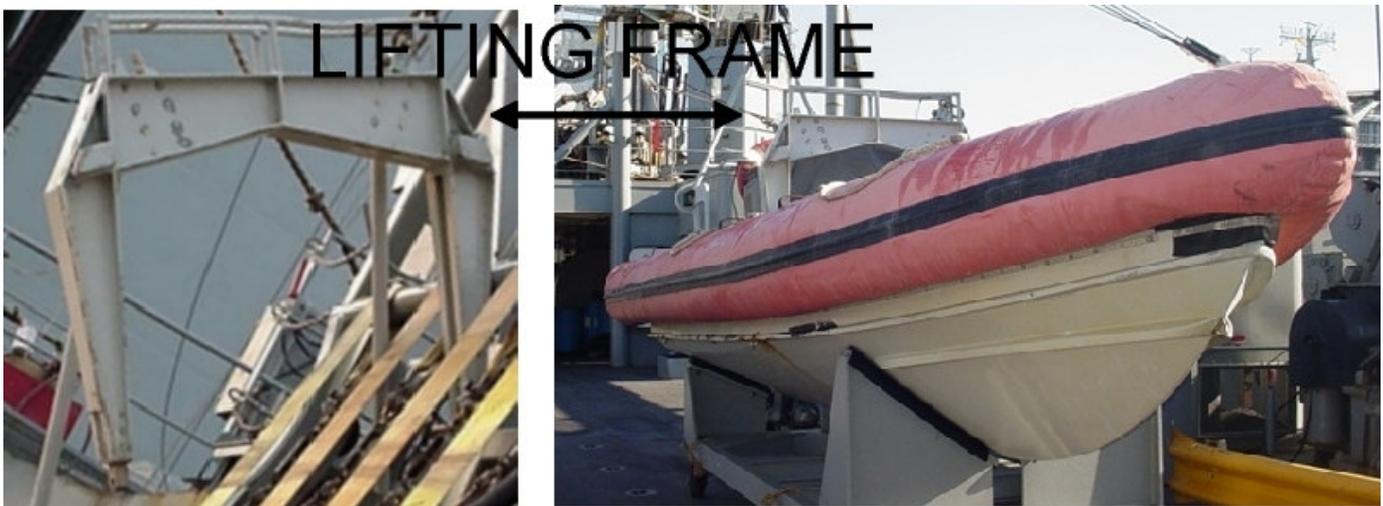
Recently a large deep draft vessel was hoisting aboard its rigid hull inflatable (RHI) rescue boat when it's lifting frame, an inverted u-shaped component, separated from the brackets that attached it to the deck. As a result, the boat fell back into the water and its attending crewmember was ejected. The uninjured crewmember was promptly recovered and damage to the rescue boat was negligible.

Each side of the lifting frame is fastened to the deck by a bolt and nut. It appears that due to vibration the nuts securing the bolts backed off. While the boat was being lifted the bolts also backed out of their respective holes. Although the frame was fitted with non-weight bearing struts (not visible in the photographs) they were unable to handle the load and parted as the boat fell.

An investigation revealed no specific maintenance requirements or manufacturer recommendations for periodic inspection of the lifting frame bolts. A vessel officer reported that limited visual inspection took place monthly but indicated that a "hands-on" equipment check did not occur.
