United States Coast Guard

SAFETY ALERT - LIFEBOAT RELEASE MECHANISMS

January 27, 2004 Washington, DC

POTENTIAL SERIOUS SAFETY HAZARD NORSAFE CAMSAFE LIFEBOAT RELEASE MECHANISMS

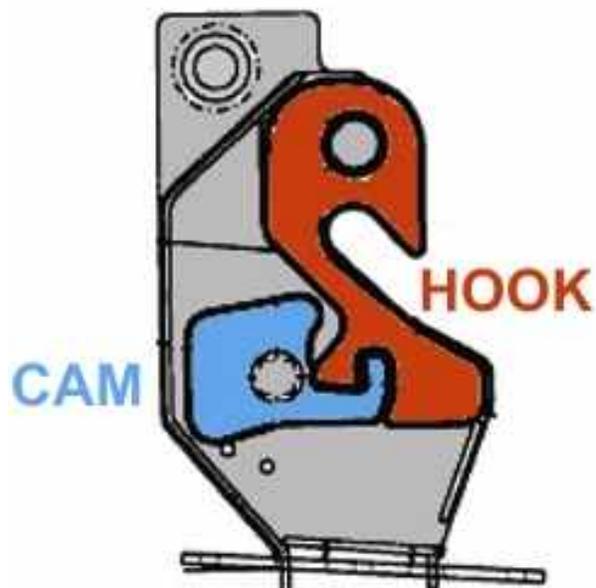
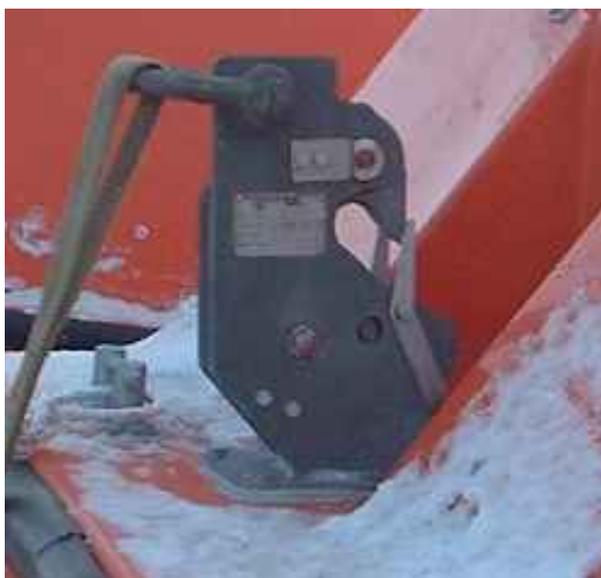
Satisfactory engagement and locking of the release device is dependent upon successful mating between the male and female portions of the cam and hook, respectively, as shown in the following drawing.

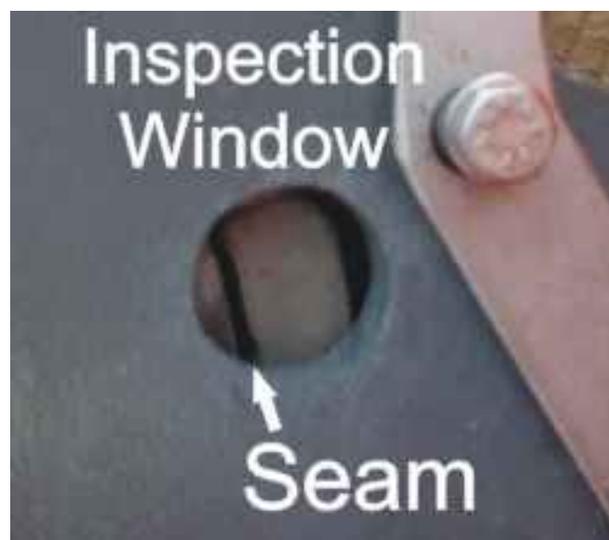
When properly engaged, the seam between the edges of the mating components will be clearly visible in the inspection window located on one side of the release mechanism. Observation of the components within this window will enable confirmation of complete cam-to-hook engagement and look as depicted on the right.

It is important to note that this window is impossible to see from inside the lifeboat and the associated lifeboat and release mechanism manuals are not clear on what the viewer should look for to ensure proper engagement.

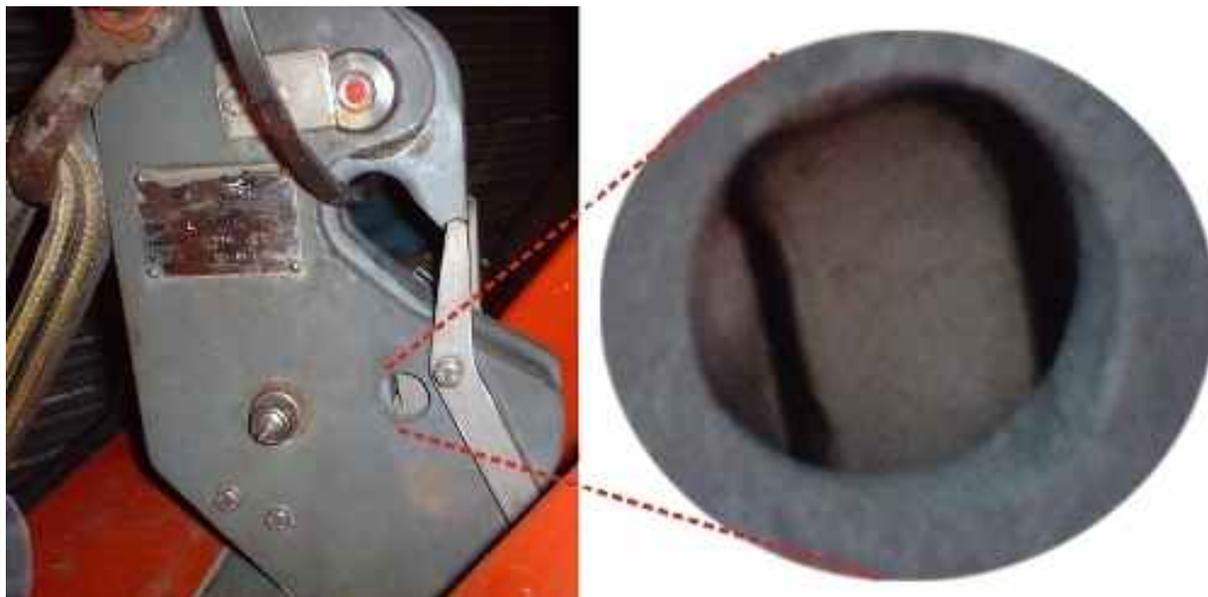
2. A properly engaged cam and hook will look like this:

1. With the lifeboat in the STOWED position, and MAINTENANCE PENDANTS FITTED, check the inspection window of the hook (which may be outboard) to determine whether the cam and hook are completely engaged.

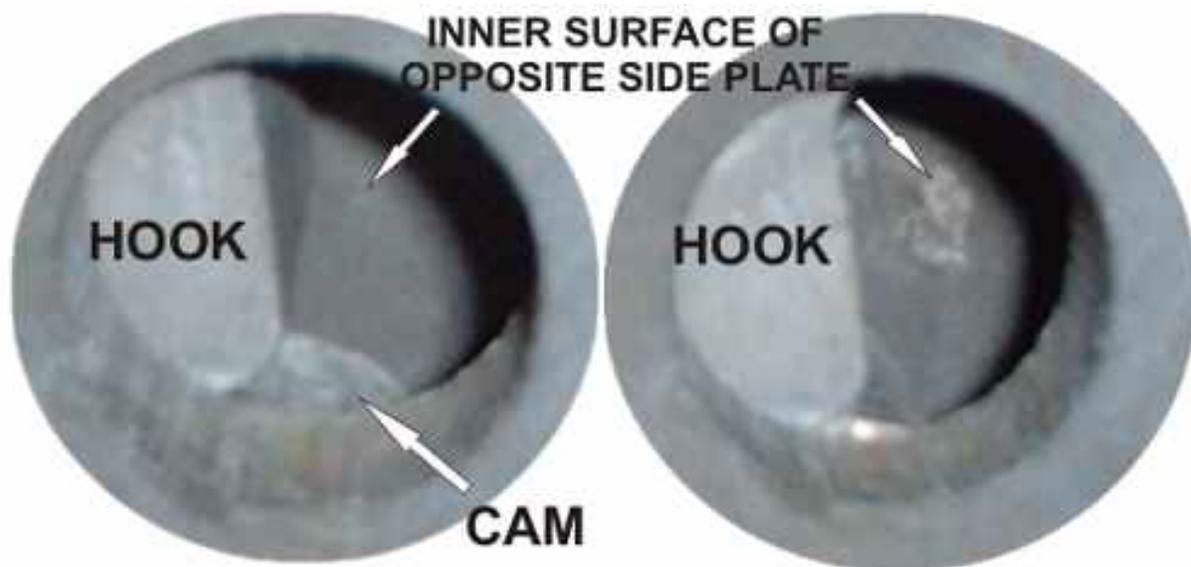
3. An improperly engaged hook and cam may look like this:

IMPORTANT - The inside surface of the opposite side plate (or half) of the release mechanism will be visible, unless a significant portion of the hook is out side the side plates.

4. If the cam and hook are not completely engaged, the load of the boat must be temporarily transferred from the release mechanism and on to the maintenance pendants. Next the release lever at the helmsman's station is reset while the hook is pushed into place by hand to ensure the cam and hook are completely engaged. The load may then be returned to the release mechanism after confirming complete cam engagement through the inspection window.
