NASA SAFETY CENTER  
SYSTEM FAILURE CASE STUDY

MAY 2013 VOLUME 7 ISSUE 4

# The Case for Safety

## The North Sea Piper Alpha Disaster

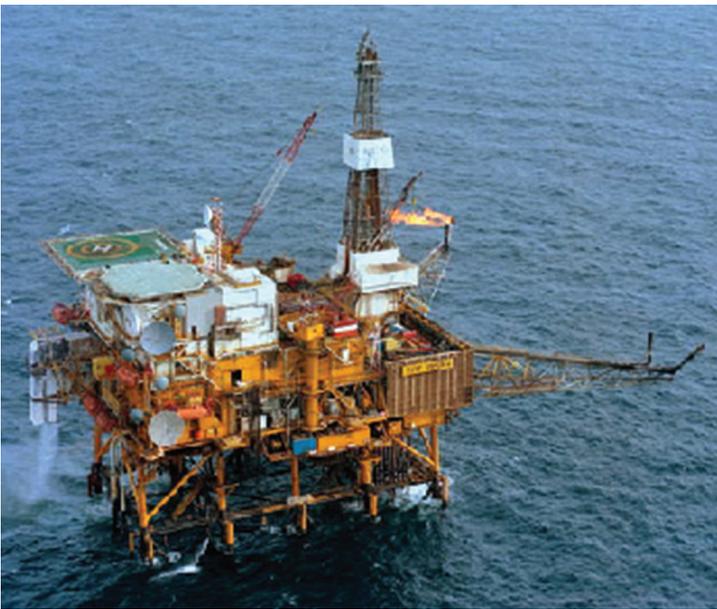
Figure 1. Piper Alpha before the fire. Source: BBC.

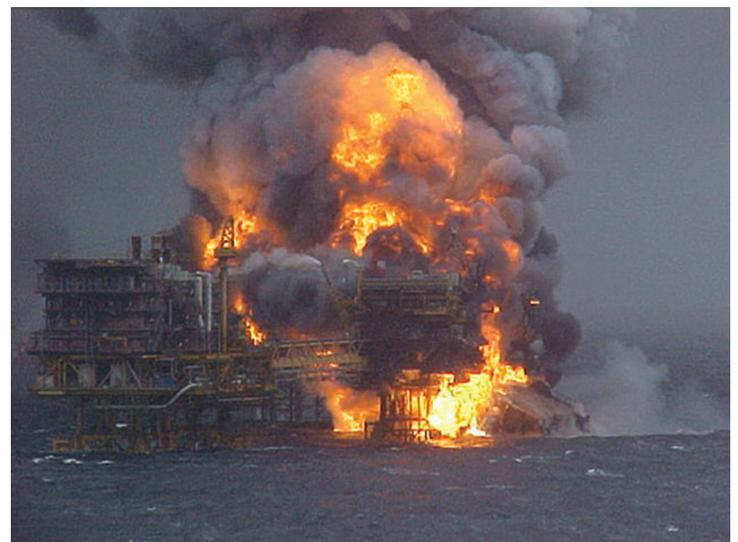
Figure 2. The smoke reached hundreds of feet above Piper Alpha, preventing rescue helicopters from approaching. Source: Technologism.net.

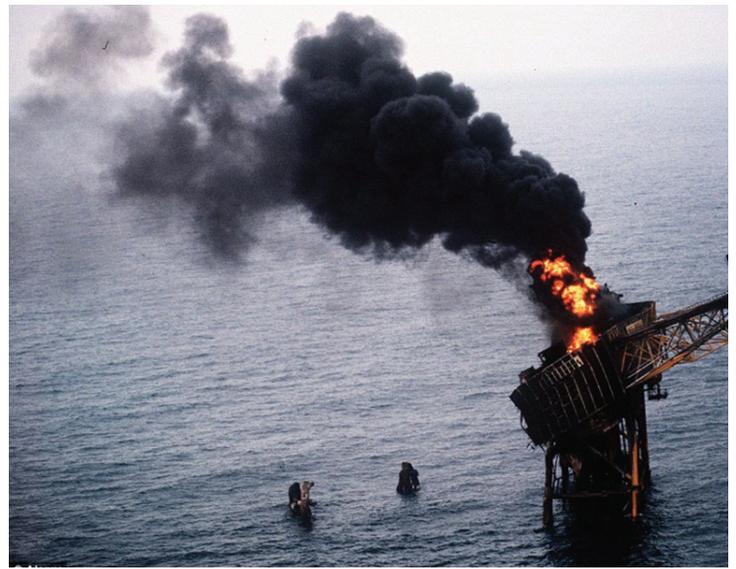
Figure 3. The remaining oil wells module continued to burn for weeks until famed firefighter, Red Adair, and his team extinguished the remains. Source: BBC.
