## Did I push the right button?

A drillship had a recent near-miss while drilling an exploratory well in the Gulf of Mexico. The event provided several lessons learned for vessels with dynamic positioning (DP). The vessel was conducting what seemed to be a simple maintenance procedure on a thruster. However, human errors with a mix of ergonomics got involved and resulted in a position loss within five feet of a “yellow” condition. The incident was caused due to the proximity of buttons to one another as well as the number of alarms a DP operator (DPO) receives.

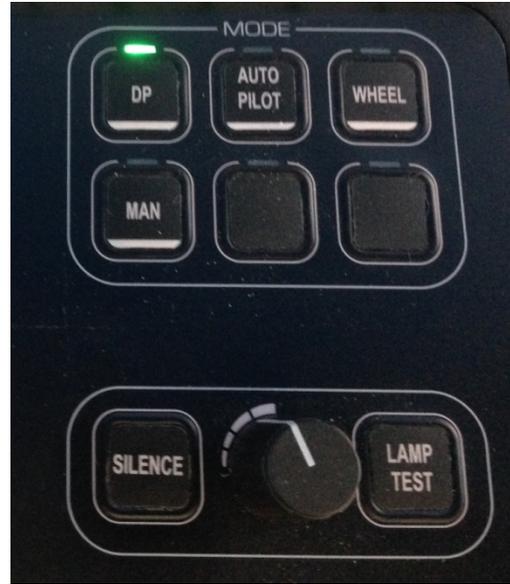
On Thursday a work permit was signed to take a thruster offline to perform some maintenance. The technician cleared taking the thruster offline with the DPO. When the technician took the thruster offline, the DPO received a series of alarms. The DPO silenced the alarms individually as required by the system. The DPO accidentally double-pressed the “manual” button while reaching across the console and not verifying which button was being pushed. A double-press of the manual button places all thrusters onboard in manual control. The DPO then received the alarm for manual control of all thrusters. The DPO realized the mistake and placed the thrusters back into “DP” mode, which brought the vessel back on location within about a minute after a thirteen foot excursion.

Figure 1: The “Man” and “Silence” buttons are roughly  $\frac{3}{4}$  of an inch apart. Also, white lines on buttons require double push within 5 seconds.

- Do my work permits adequately identify the risks?
- Does my well specific operating guideline take into account well control operations?
- Should certain controls on a DP system be protected from accidental activation? (A cover was later added in this case)
- Is there good communication between the drill floor and the bridge during simultaneous operations?
- When the bridge receives multiple alarms, is the DPO taking the extra second to recognize the alarm before the proper action?
