PROCEEDINGS OF THE MERCHANT MARINE COUNCIL

Vol. 13

February 1956

No. 2

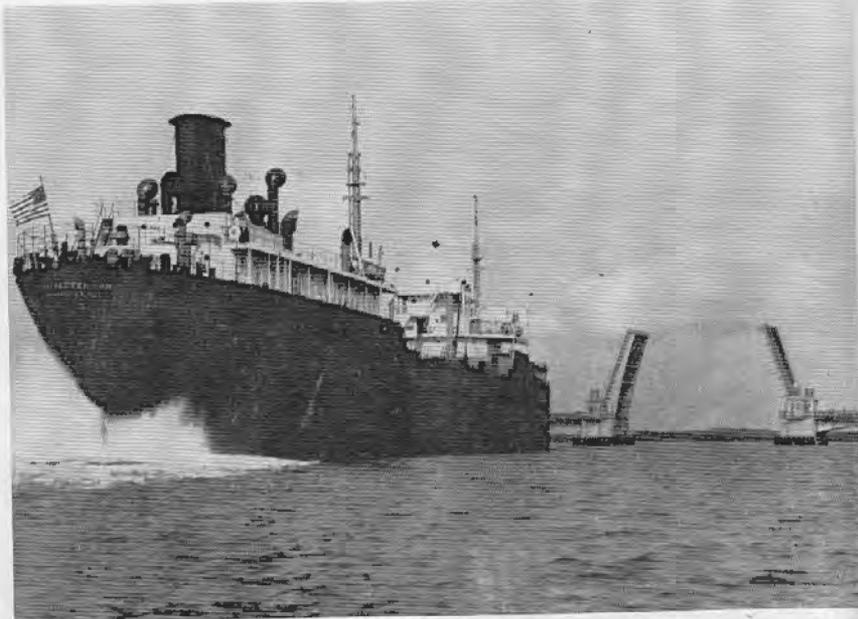
Figure 1. SS *Fort Fetterman* approaches Ashley River Bridge.

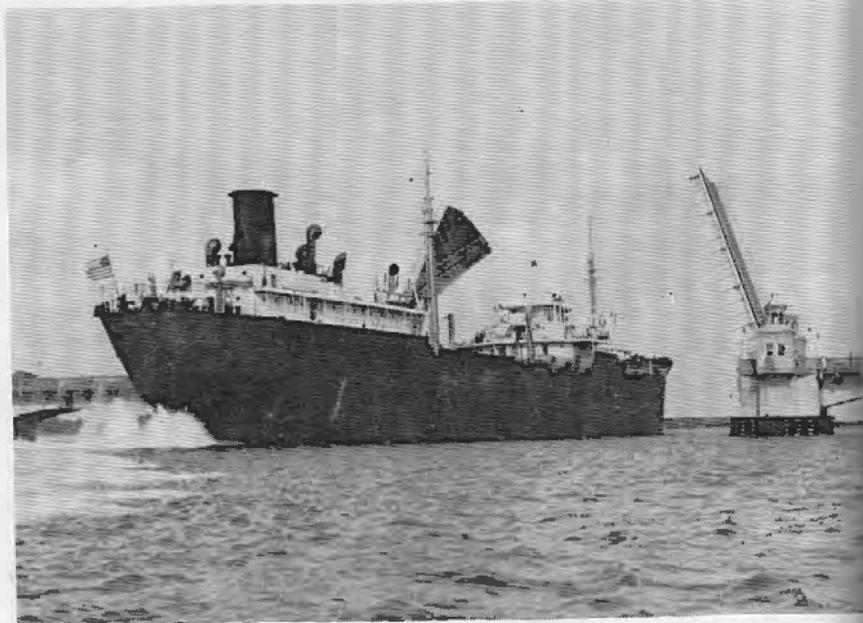
Figure 2. Immediately after contact with ship's port bridge wing, mainmast about to be carried away.

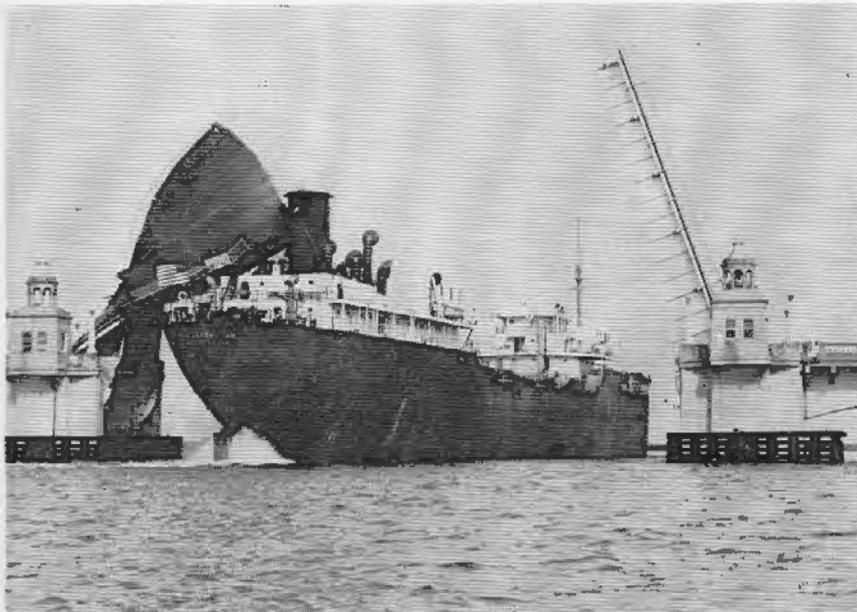
Figure 3. Mainmast down.

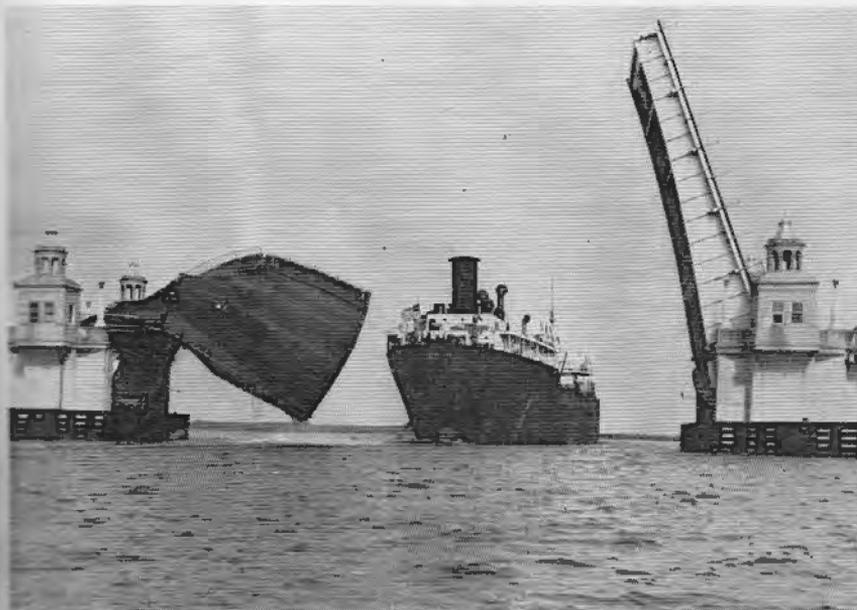
The bridge was originally designed to open to a near vertical position with abutment fenders to be located outboard of any projection. Photographs show, however, that the bascules were not protected by the fenders.

Figure 4. One down—one to go.

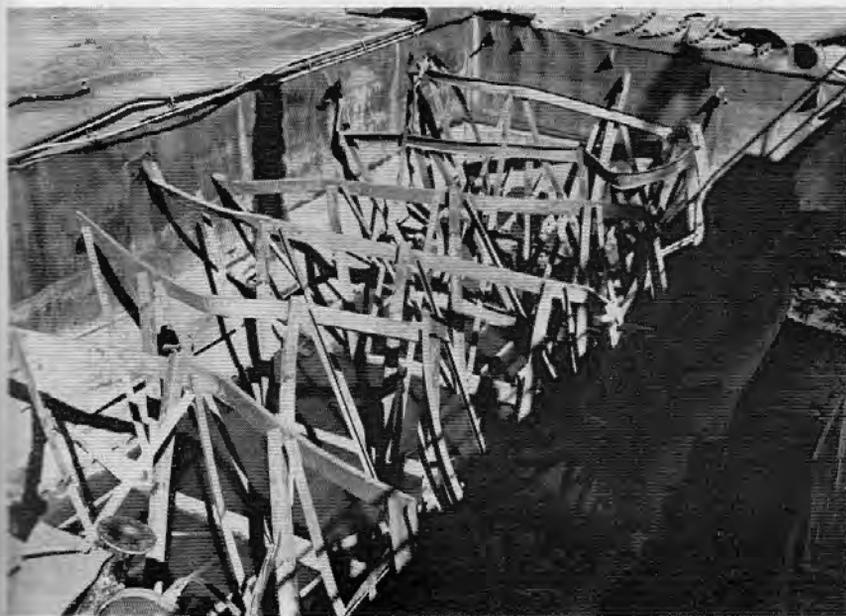
The violent force of the explosion is well illustrated by figure 1. The entire deck plating above the loading tank was ripped cleanly away and hurled clear of the barge. The centerline bulkhead and the bulkhead to No. 2 starboard tank were also badly damaged. The side plating in the vicinity of this tank was blown almost entirely off. All structural strength members of the tank and the adjacent bulkheads were badly distorted or fractured. While the barge was afire, a tug shifted it away from the loading dock and beached it at a safe distance from the terminal.

Figure 1. Showing section of deck plating ripped from No. 1 starboard tank.

To return to the casualty, it was the consensus of the company management, the operating personnel, and the investigators, that the explosion was triggered off by a discharge of static electricity, although the exact cause or location of the spark could not be determined. A review of this and similar cases would indicate the necessity of good bonding practices whenever a petroleum cargo is to be loaded or discharged. The practice of preventing unnecessary contacts of the cargo hose with the deck, rail, or other parts of the vessel while cargo is flowing would also seem to be desirable. The importance of maintaining a tight closure of manhole openings or ullage openings with an effective flame-screen whenever it is necessary for the covers to be off, is obvious. That flames, open lights, smoking, galley fires, or any other potential sources of ignition not be permitted within range of the fumes generated by cargo transfer is beyond argument. *Eternal vigilance is the price of freedom from dangerous and costly explosions.*
