PROCEEDINGS

OF THE MARINE SAFETY COUNCIL

October 1972

The Loss of the *Texaco-Oklahoma*

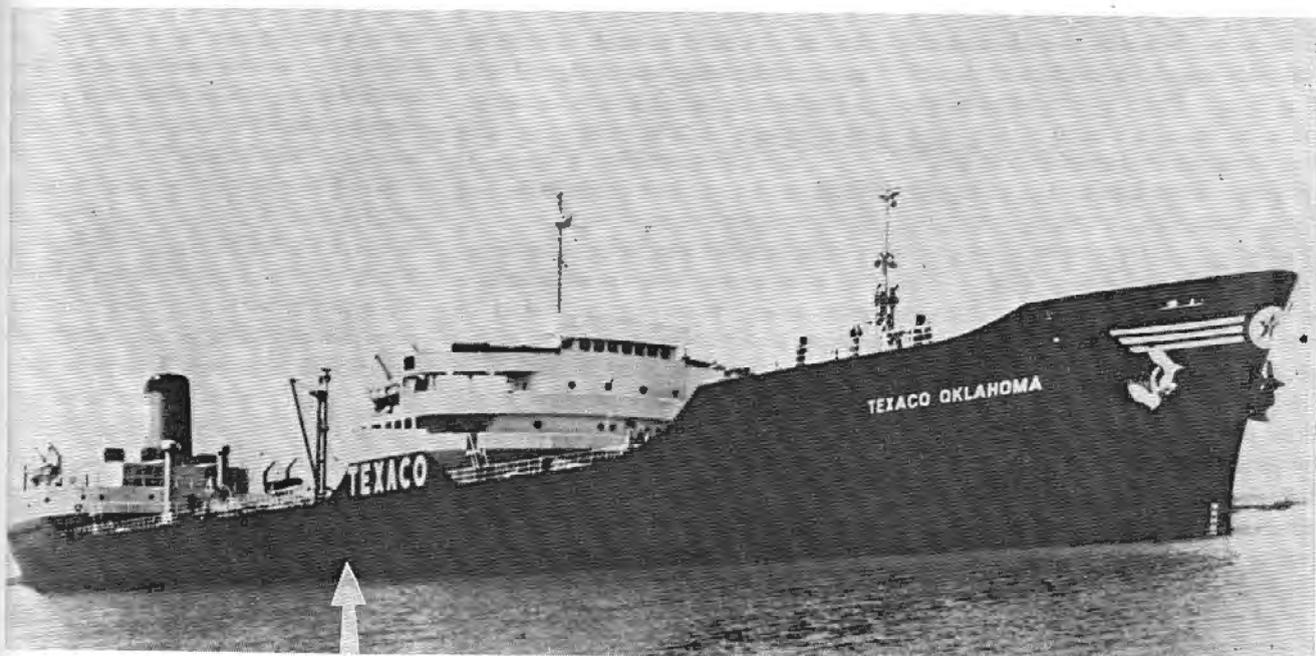
The SS Texaco-Oklahoma prior to her loss with 31 deaths. The approximate location of the fracture is indicated by the arrow.

1. The cause of the casualty to the extent determinable was a massive structural failure due to stresses imposed on the hull girder as the ship labored in extremely heavy seas. The failure occurred in way of the No. 5 cargo tank within 50 to 60 feet of the midpoint of the vessel. This is an area where maximum bending stresses are anticipated. The actual stress ex-

perienced was undoubtedly a summation of several stresses. In addition to bending these included torsion, hydrostatic loading, and impact loading. It is probable that, due to the extreme sea conditions, an unusual combination of these factors occurred which overstressed the vessel and caused the structural failure. It is probable, also that the effect of this extraordinary stress was intensified by the general deterioration which would be expected in a vessel of this age and, possibly, by some previously undetected defect such as minor cracks in the structural members. There was no evidence that the fracture of the vessel was caused by an explosion or a collision with any object or that faulty material construction, or repairs contributed to the casualty.

1. It is recommended that the regulations or directives relating to the inspection of ocean and coastwise tankships be revised to include specific requirements for a special examination to be made of the internals in way of the cargo tanks and the ballast tanks and for gagings to be taken of the shell and deck plating at a certain point in the life of the vessel. It is suggested that for tankships with uncoated or partially coated tanks, this special inspection be made in the year of the fifth biennial inspection. For tankships with fully coated tanks, the examination

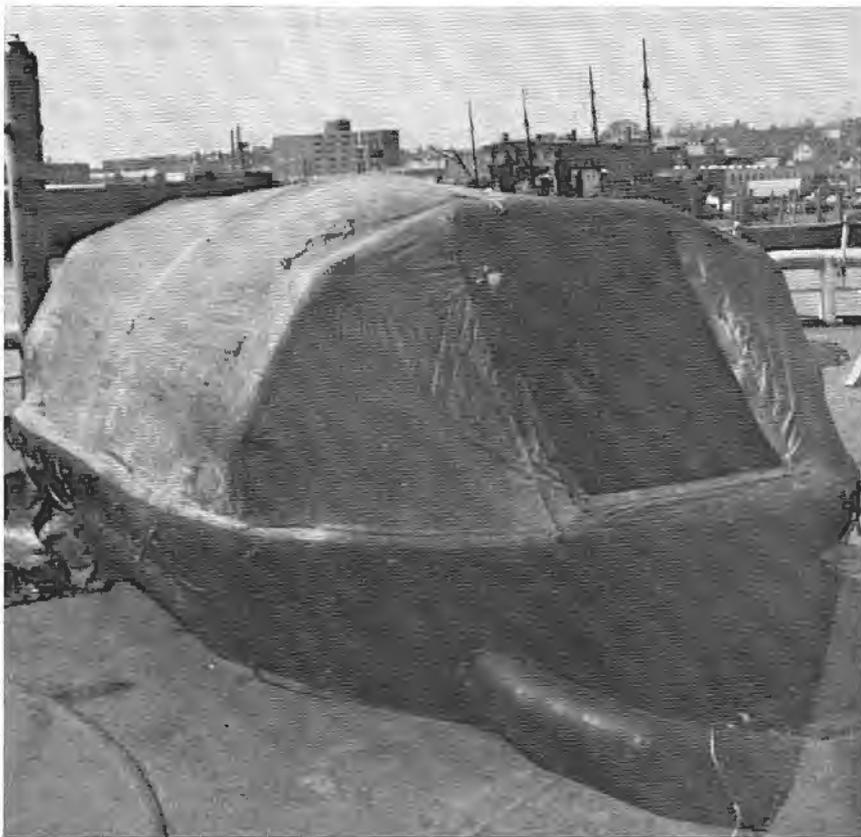
This 15-man inflatable liferaft helped save the lives of 11 of the 13 survivors of the casualty.

3. It is recommended that the specification for the painter presently required as part of the equipment of the U.S. Coast Guard-approved inflatable liferaft be revised so as to provide greater strength.

3. The recommendation that the specification for the painter required as a part of the inflatable liferaft equipment be revised to provide greater strength has already been acted upon as a result of information from previous casualties. At the public hearing in March 1971, the proposal was adopted and will be published as regulation shortly, providing for greater strength in this painter and changing the location of the weak point from the point of attachment to the raft to the point of attachment on board the ship.¹
