PROCEEDINGS

OF THE MARINE SAFETY COUNCIL

Vol. 33, No. 7

ATC 3060 Casualty	122
Another Big Bang Out of Crude Oil	128
Marine Safety Council Membership	134

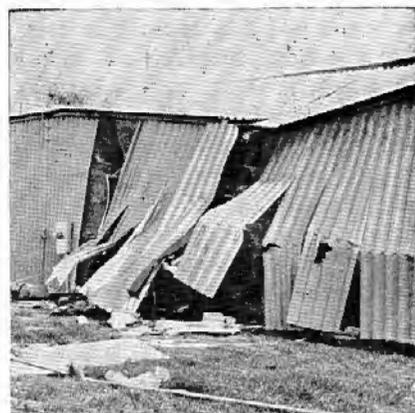
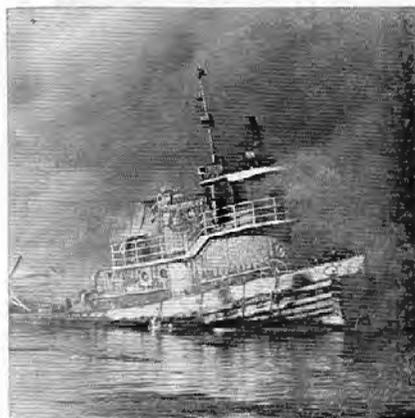
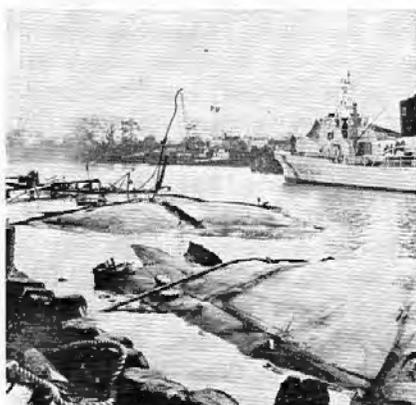
The ATC 3060 became engulfed in high flames and in about 2 minutes a second explosion occurred. Fire spread on the surface of the water and covered the area halfway between the riverbanks. The barge continued to burn and City of Norfolk Fire Department units responded to a two-alarm fire signal at 1528 and extinguished the flames using fog water streams. The barge sank in place with only a small portion of the main deck above the water surface. The fire was fought mainly from the dock area since there are no fireboats in the Port of Norfolk. Coast Guard floating units responding were able to provide only token fire extinguishing capability from the river side of the facility. Coordination between the fire department and Coast Guard units on scene was accomplished through the use of portable transceivers provided by the first Coast Guard personnel to arrive on scene.

rupted by the force of the explosion. The superstructure of the *Frank Jackson* was extensively damaged by the fire. The tug *Southern Cross*, moored alongside and outboard of the *Frank Jackson*, suffered above-deck structural damage from missiles and fire. The tug *Sandpiper*, moored within the floating drydock ahead of the *Frank Jackson* and *Southern Cross*, suffered extensive structural damage from missiles including a large section of plating from the ATC 3060.

Four buildings within the Allied Towing Corp. property were extensively damaged by both blast and missiles. The sidewall of a prefabricated warehouse located about 120 feet from the dock was severely distorted by the blast effect. A similar building on the north side of the property, about 150 feet from the dock, was extensively damaged by a 15- by 13-foot section of side or deck plating which passed completely through the building. The path of the plate section as indicated by the damage to the building showed that the plating probably came from the direction of No. 3 starboard tank. Other buildings within the Allied property complex and nearby buildings had windows broken by the blast and small sections of the barge were found over a wide area—some fragments more than a thousand feet from the barge.

That the primary cause of the casualty was the ignition of volatile vapors within No. 3 starboard tank when hot work (welding) was performed on the side shell of the ATC 3060.

explosion. During all these procedures the tank atmosphere was probably diluted with air to some degree. The localized heat from the welding in No. 3 starboard tank generated additional vapors and stimulated convection currents within the tank which caused further dilution of the vapors with the air from the open hatch, bringing them into the explosive range. In the presence of the intense heat from the localized welding, the ignition occurred.
