***PROCEEDINGS***  
OF THE MARINE SAFETY COUNCIL

# "ABANDON RIG!"

## the loss of the Ocean Express

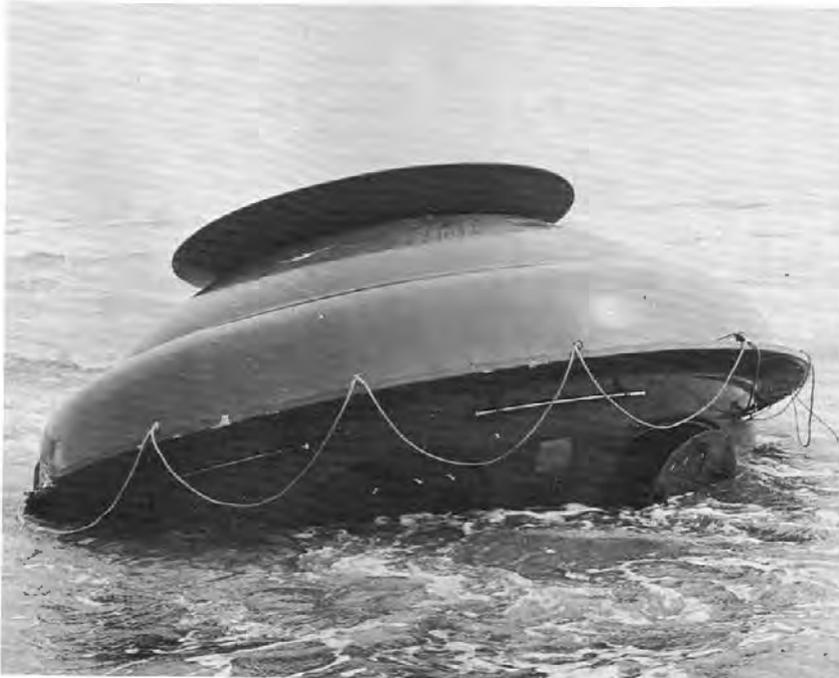
Survival Capsule #2, inverted.

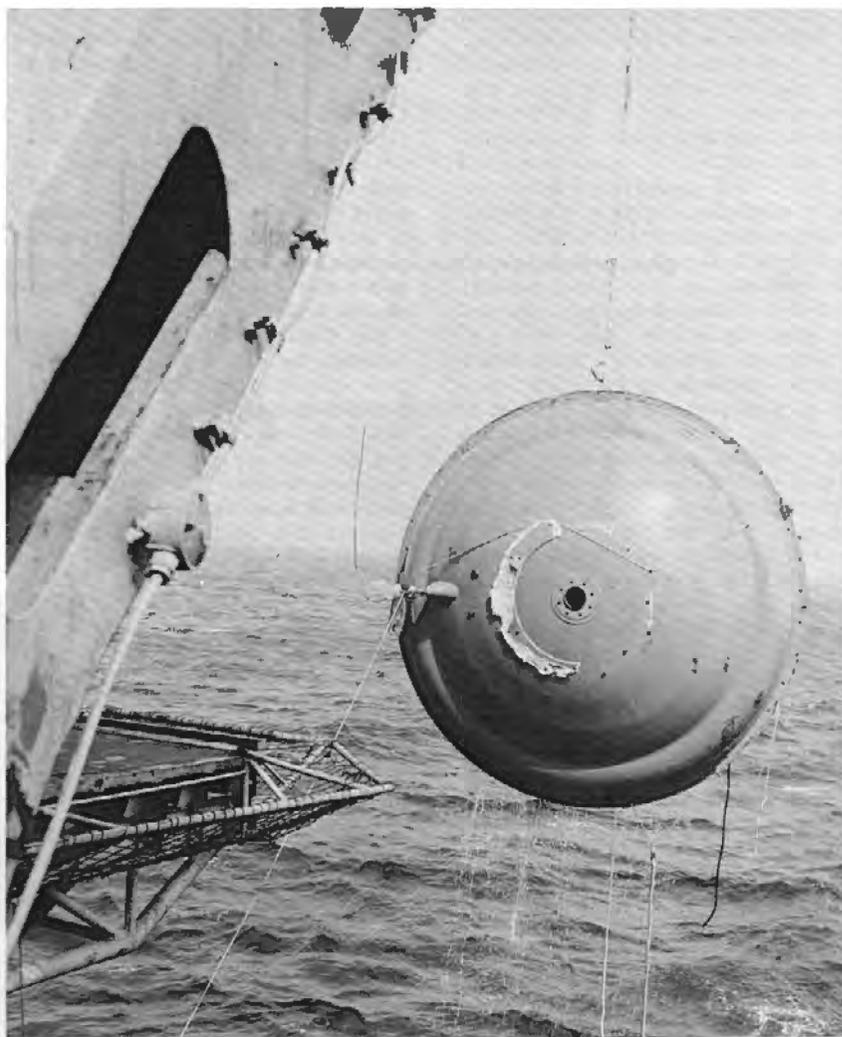
Capsule #3 is retrieved by the USS LEXINGTON

When retrieved, it was intact and all 13 bodies were still inside.
