Proceedings

Vol. 43, No. 11

November/December 1986

The Lift Boat DMC-1

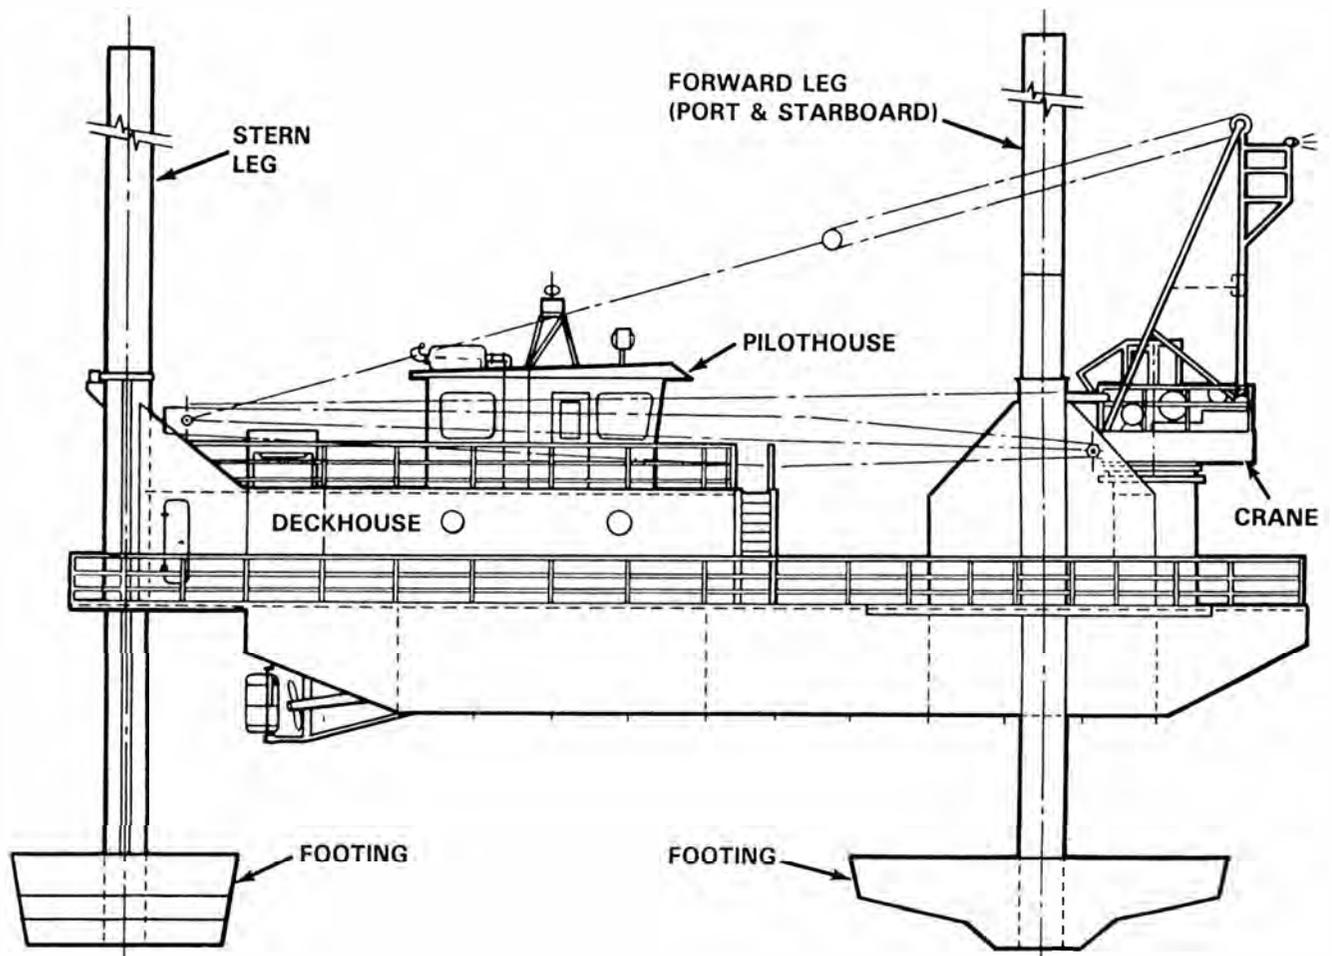
Figure 1.--Outboard Profile of the DMC-1.

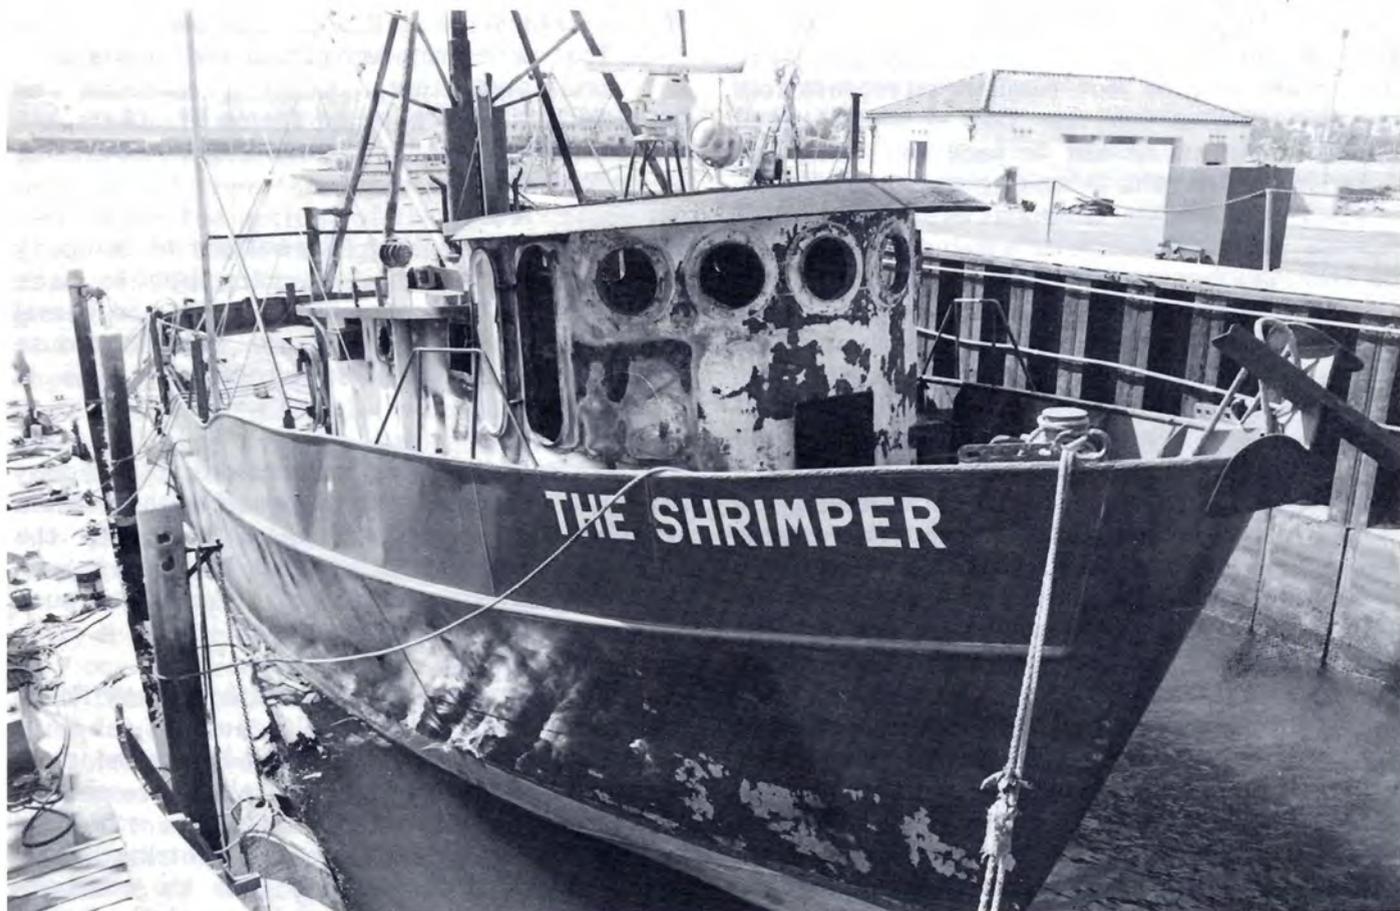
The vessel at dock at Coast Guard Base Terminal Island following the incident.

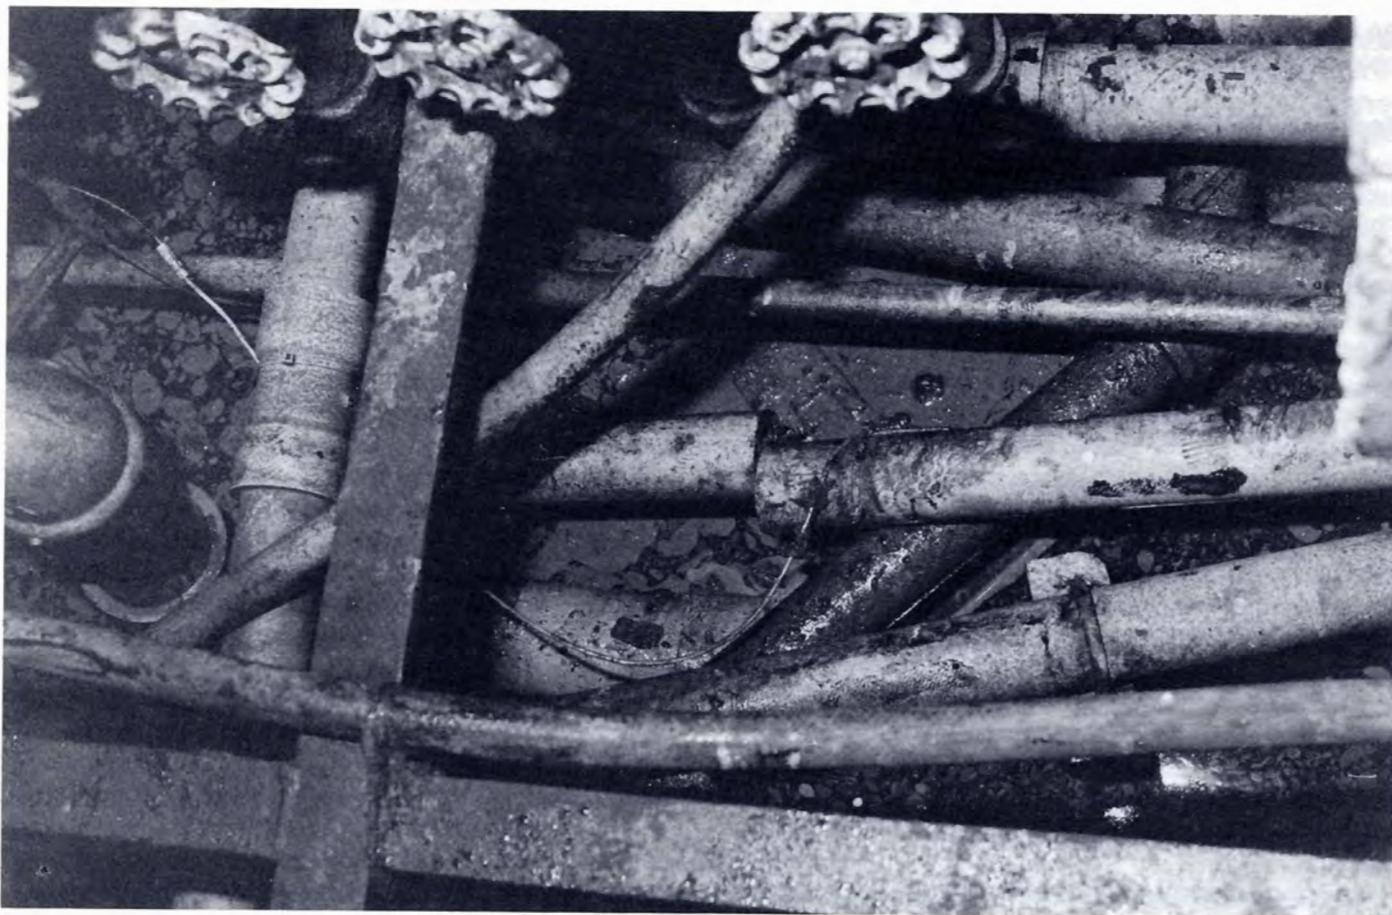
When it was safe to enter the engine room of THE SHRIMP-ER, running water could still be heard coming into the vessel. The source of the water was easily located, coming in through a cut hose attached directly to the open sea chest valve. The sea chest valve was immediately closed by one of the damage control party members, and the vessel stopped taking on water. Further examination by the damage control party revealed that another plastic pipe, directly connected to the sea chest valve, had been cut, and a flange had been intentionally pried away from a pump housing.

A cut pipe near the sea chest.
