Proceedings

of the Marine Safety Council

Vol. 43, No. 3

March 1986

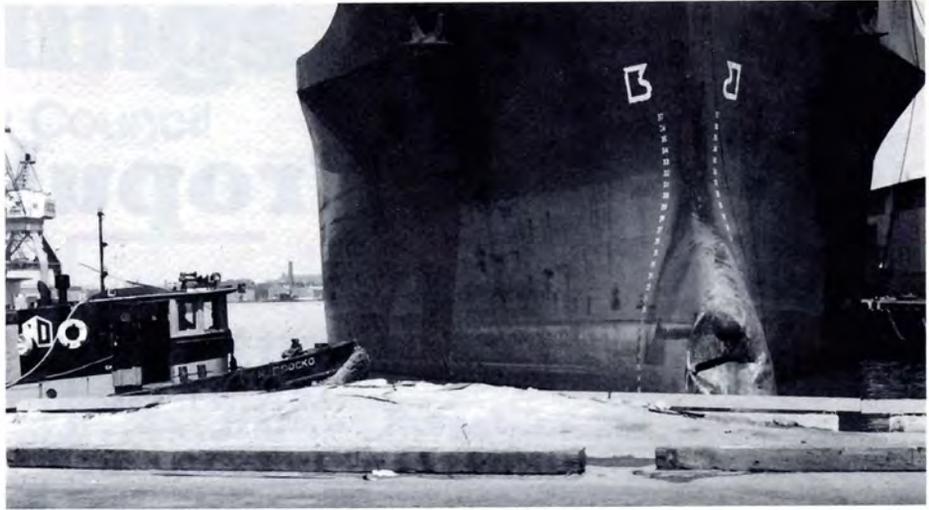
This vessel collided with the pier, damaging both. The captain ordered "stop," but the propulsion control system failed to "full ahead." (Official U.S. Coast Guard photo)

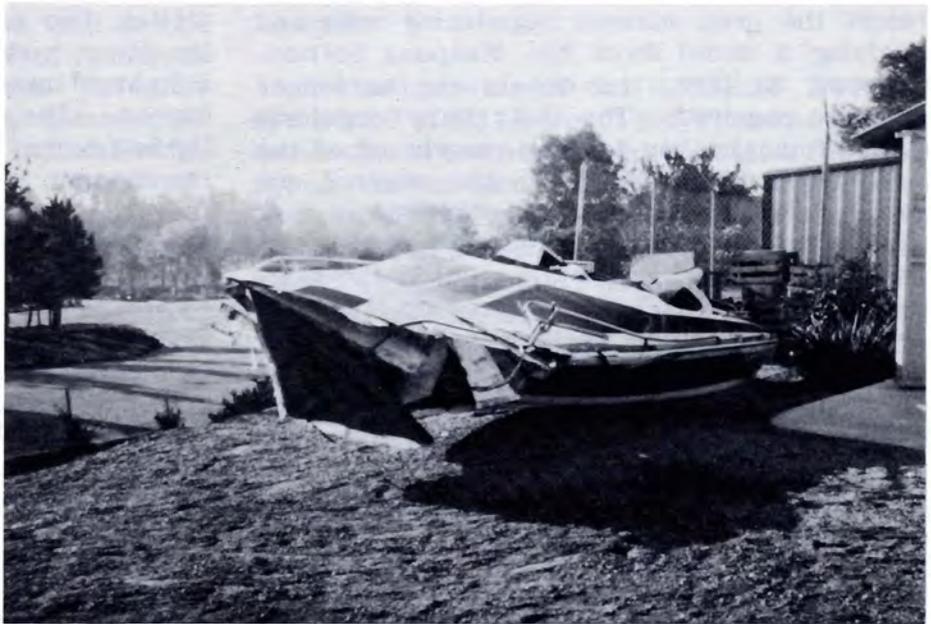
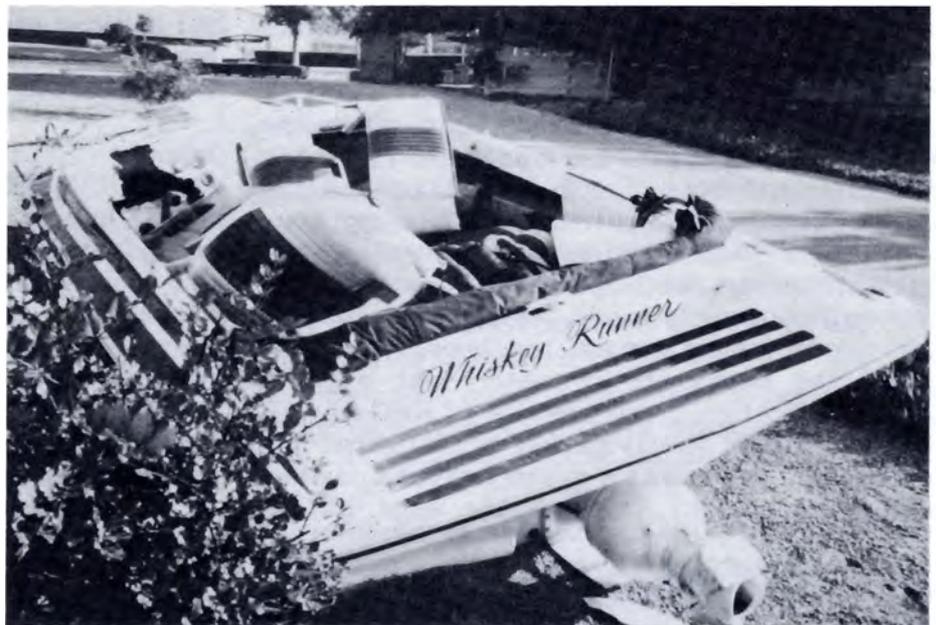
Bow view (top) and stern view (bottom) of the WHISKEY RUNNER. (Photo courtesy of NTSB)

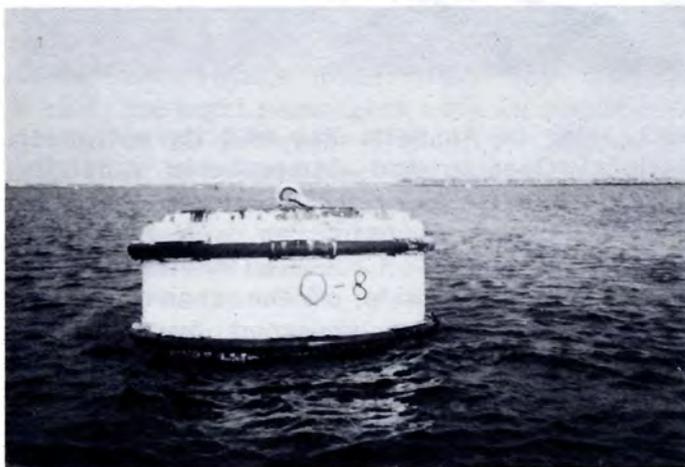
The U.S. Navy mooring buoy which the *WHISKEY RUNNER* struck was about 12 feet in diameter and rose about 5 feet out of the water. It was not lighted. The mooring buoy and others like it in Anaheim Bay are not lighted because the large chains used to moor ammunition vessels would destroy any lights as the vessels swung around the buoy. Furthermore, the buoys are in waters not open to public navigation. The channel is well-marked by various aids to navigation, both lighted and unlighted. There was a green lighted buoy and a fixed red light marking the ends of the

Daytime photograph of U.S. Navy buoy 0-8. (Photo courtesy of NTSB)

The WHISKEY RUNNER struck an unlighted buoy. Although a light on the mooring buoy might have warned the operator of the buoy in time to prevent the accident, it is not practical to put lights on mooring buoys of this type. The buoys are well-marked on charts and are located in a reserved anchorage; further, the entire Anaheim Bay has been designated a danger zone where every boat operator must observe specified restrictions. If the operator had been operating the boat at or below the enforced 5-mph (9.2 mph by federal regulation) speed when it hit the buoy, the damage to the boat and the personal injuries probably would have been minor. If the operator of the WHISKEY RUNNER had slowed the boat to 5 mph (or
