Subj: Helicopter Deployment Aboard CGC DALLAS (WHEC 716);  
report of

3700  
7 August 1968

Subj: Helicopter deployment aboard CGC DALLAS (WHEC 716); report of

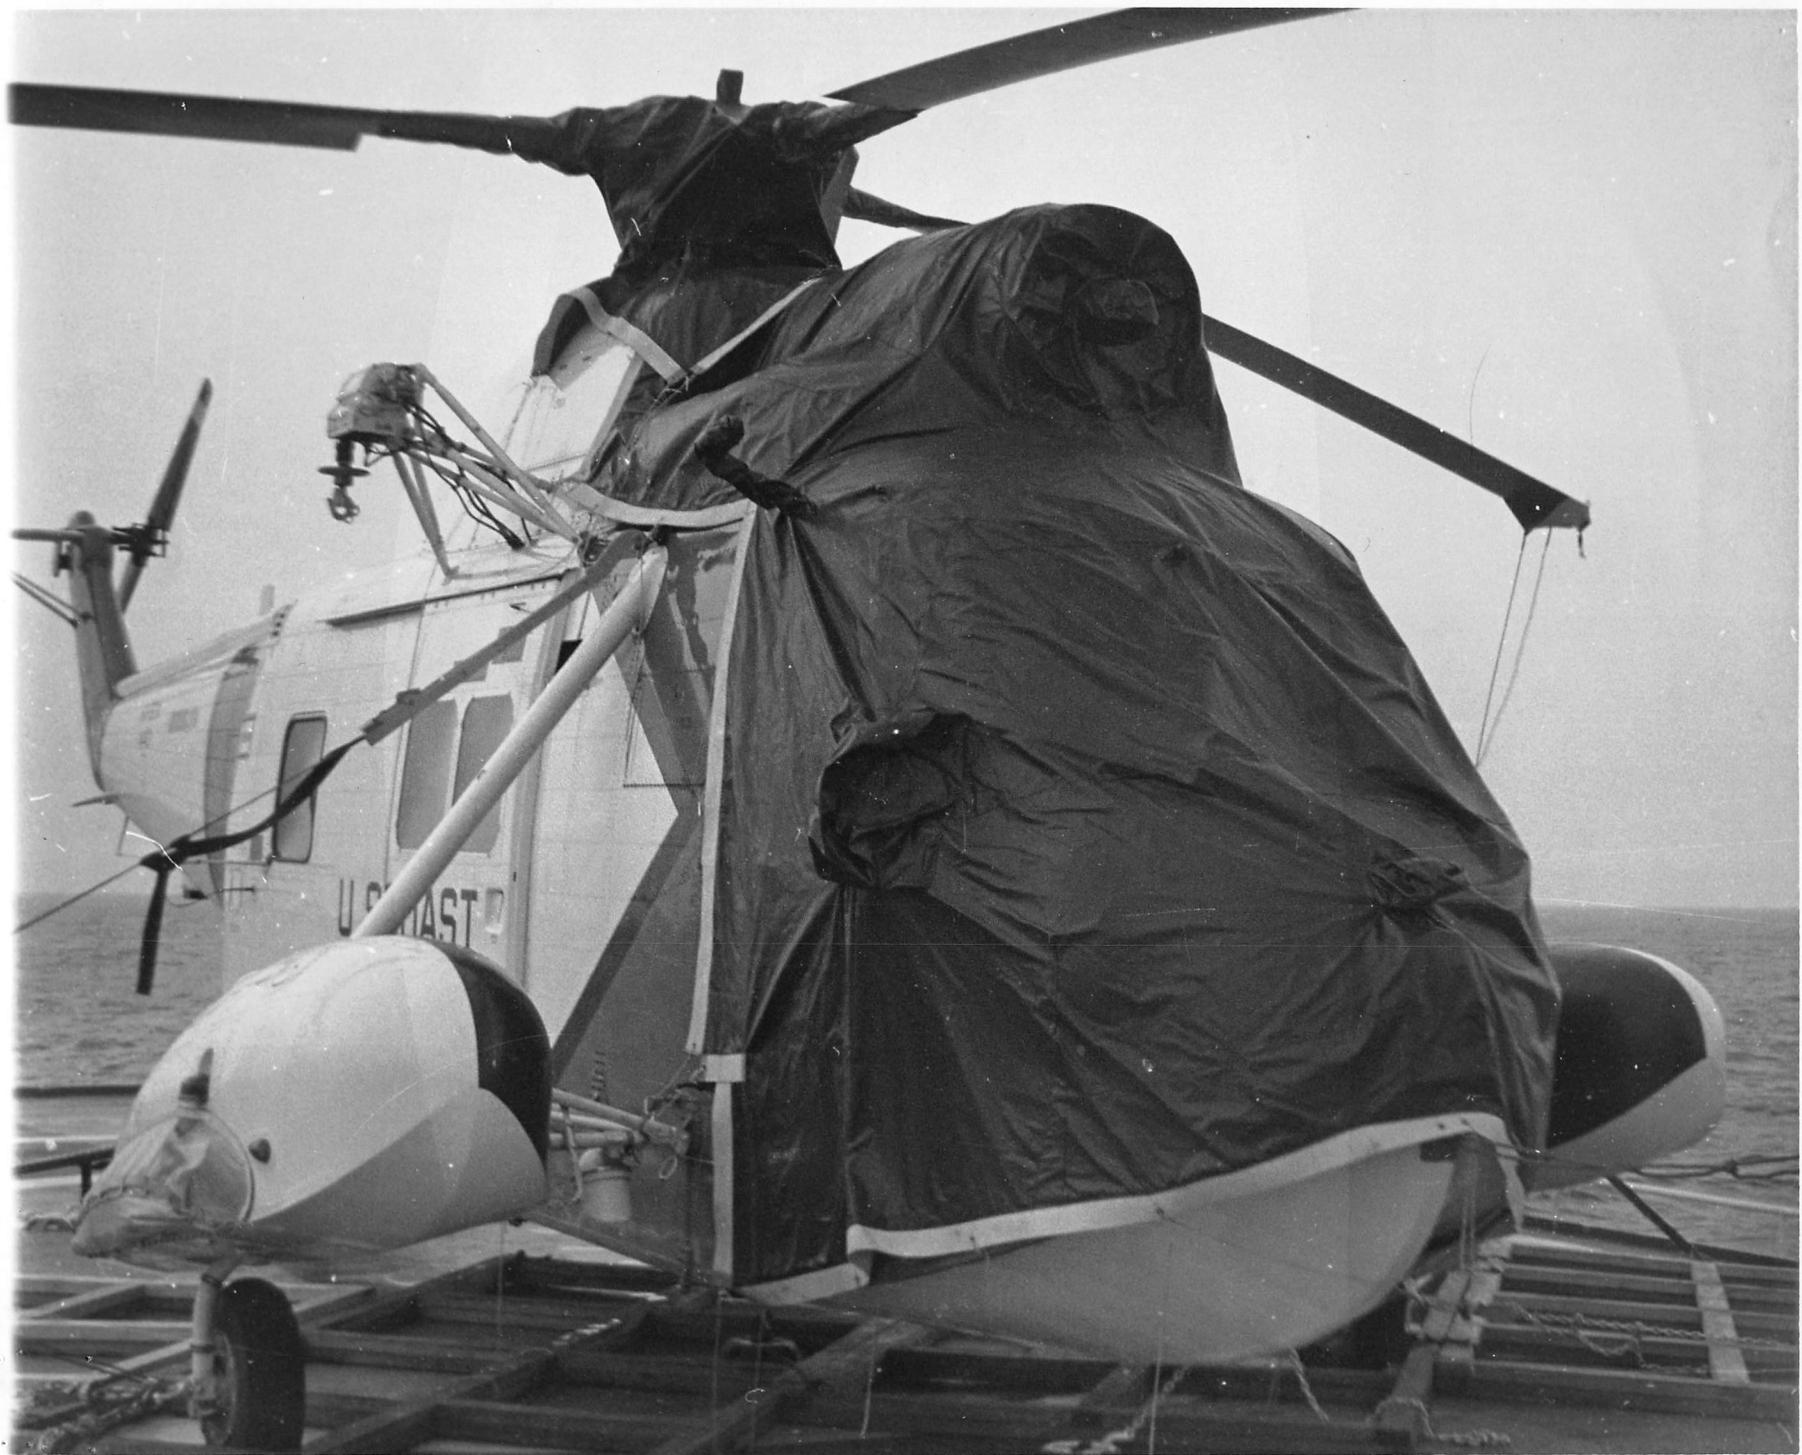
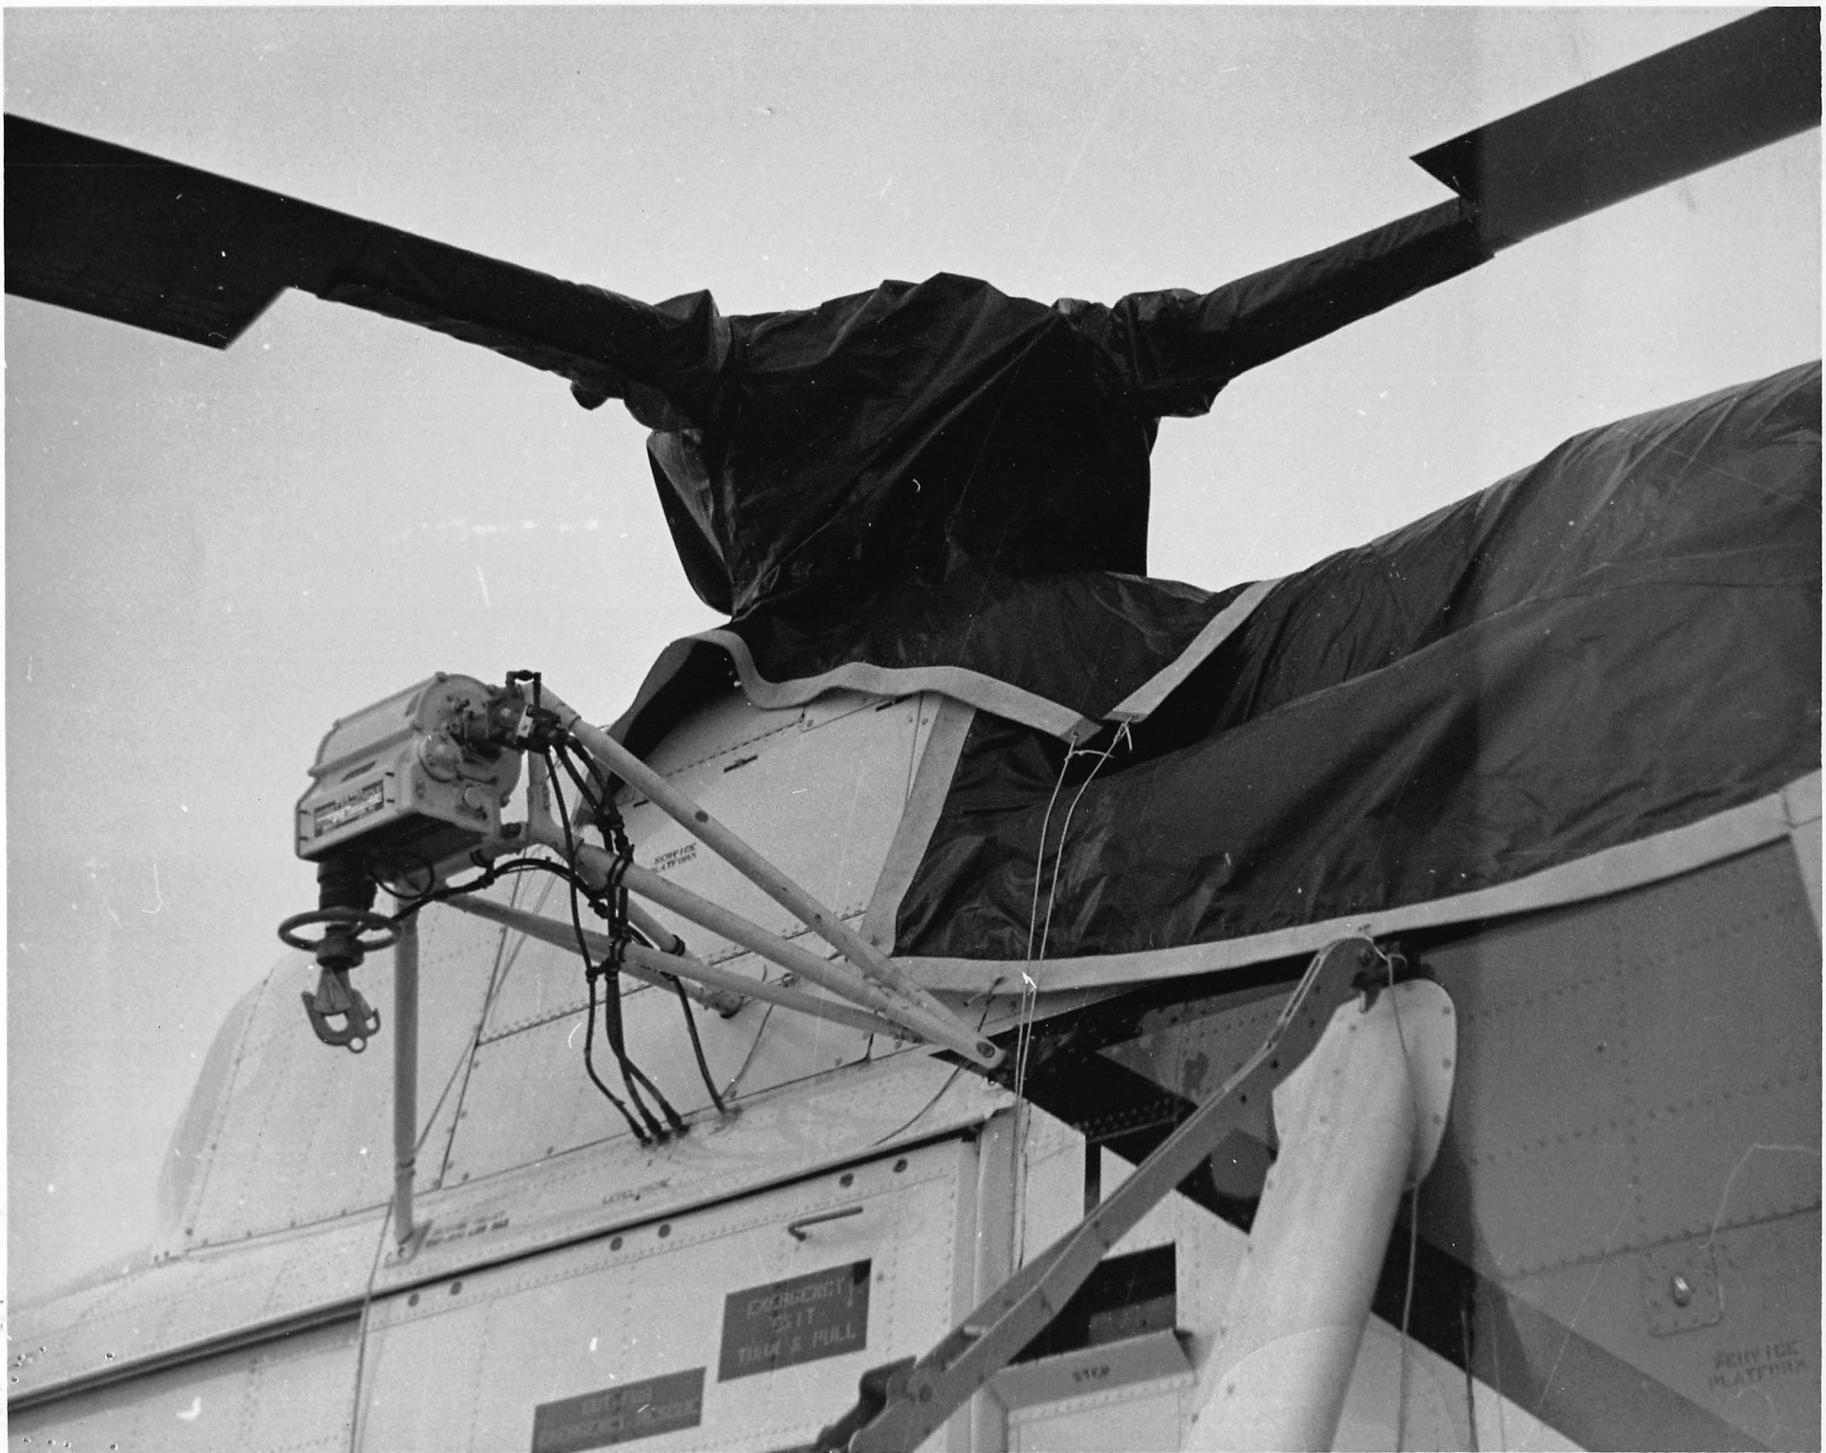
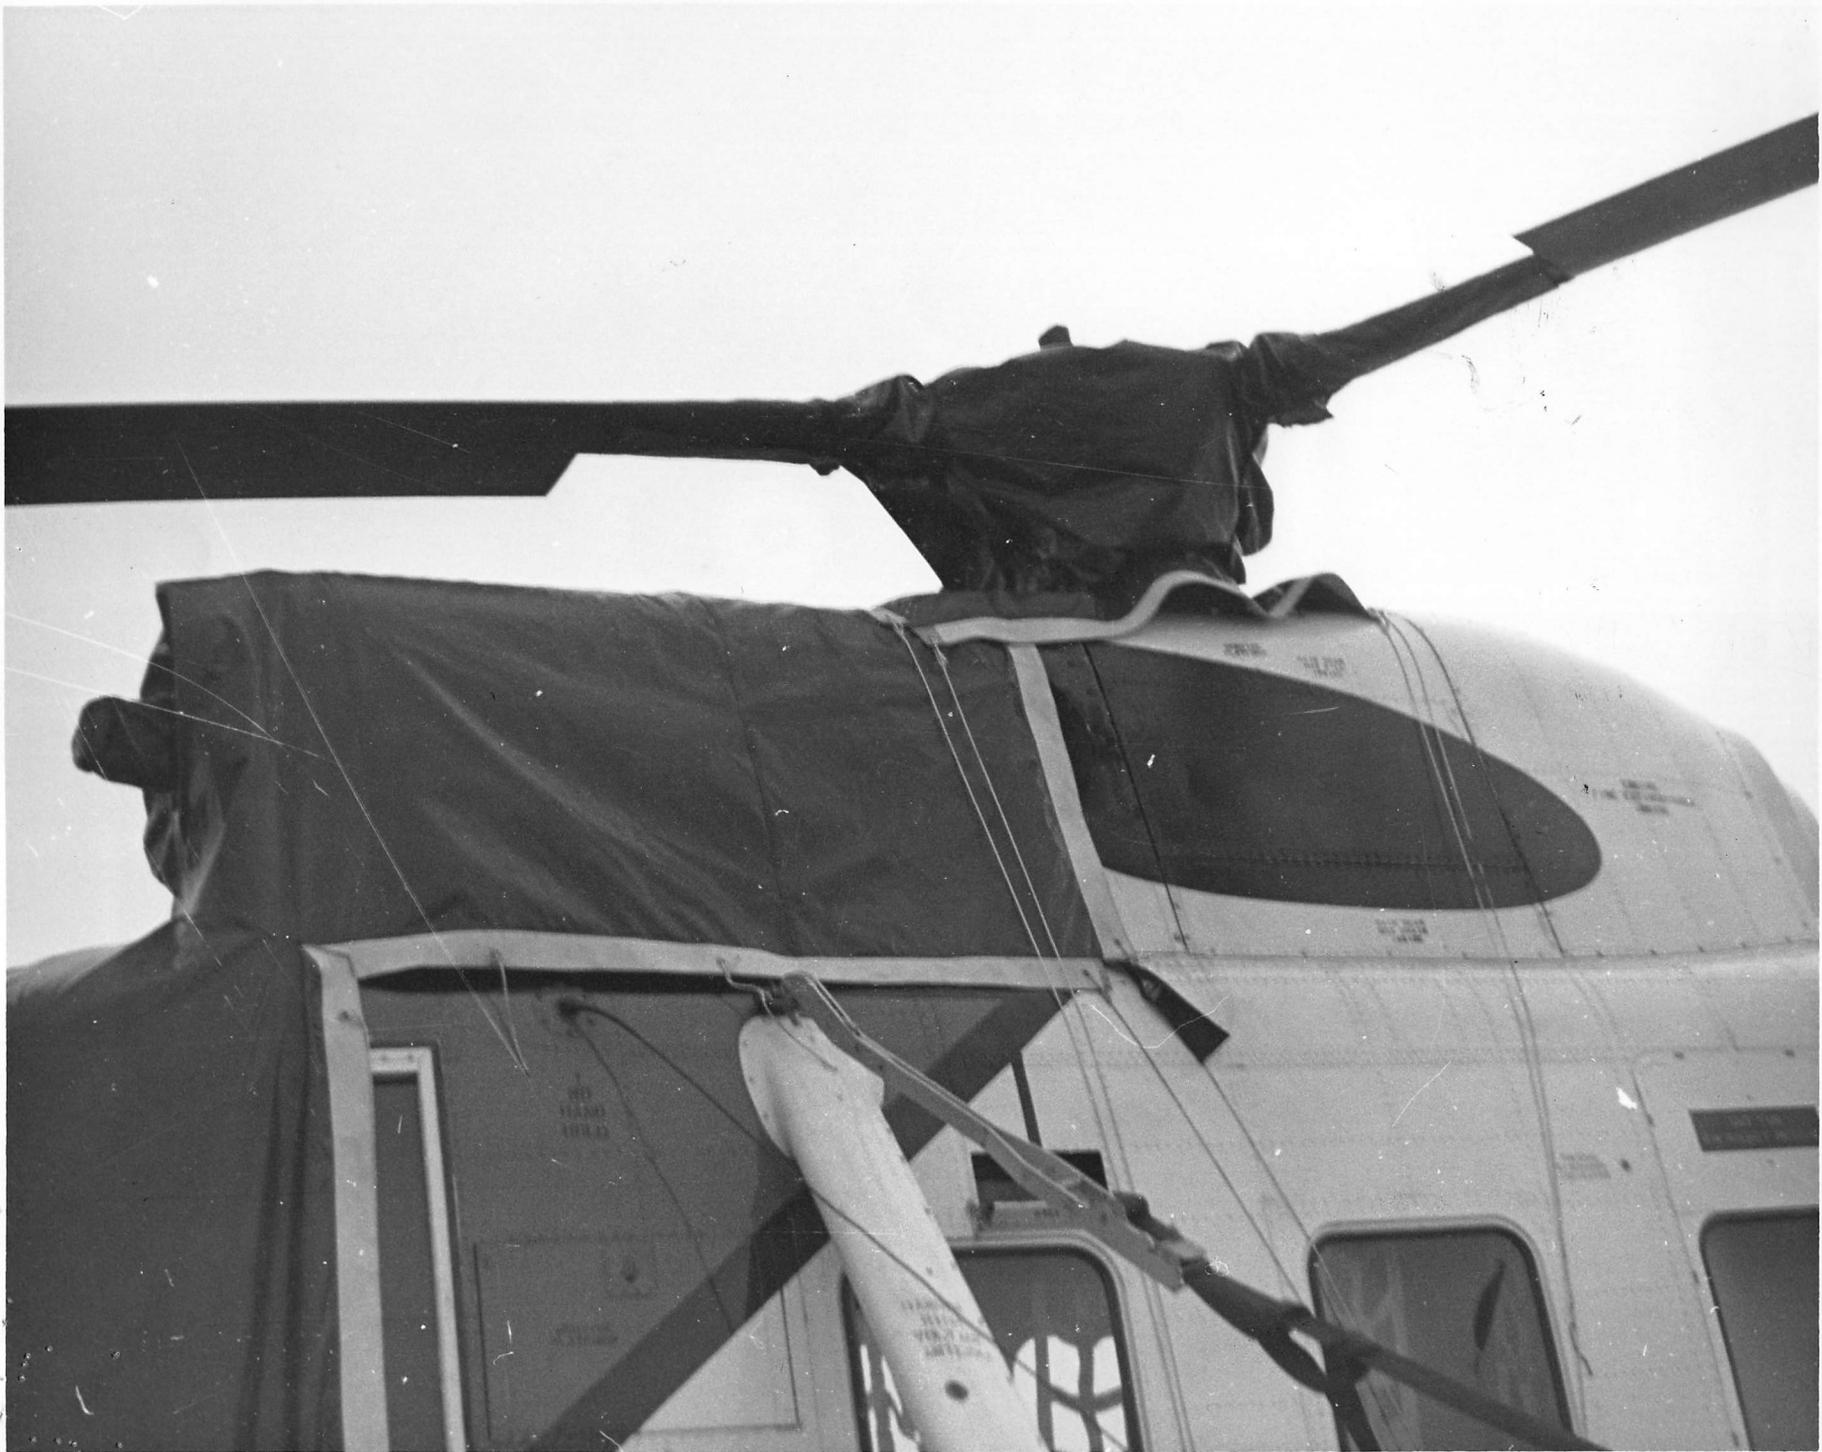
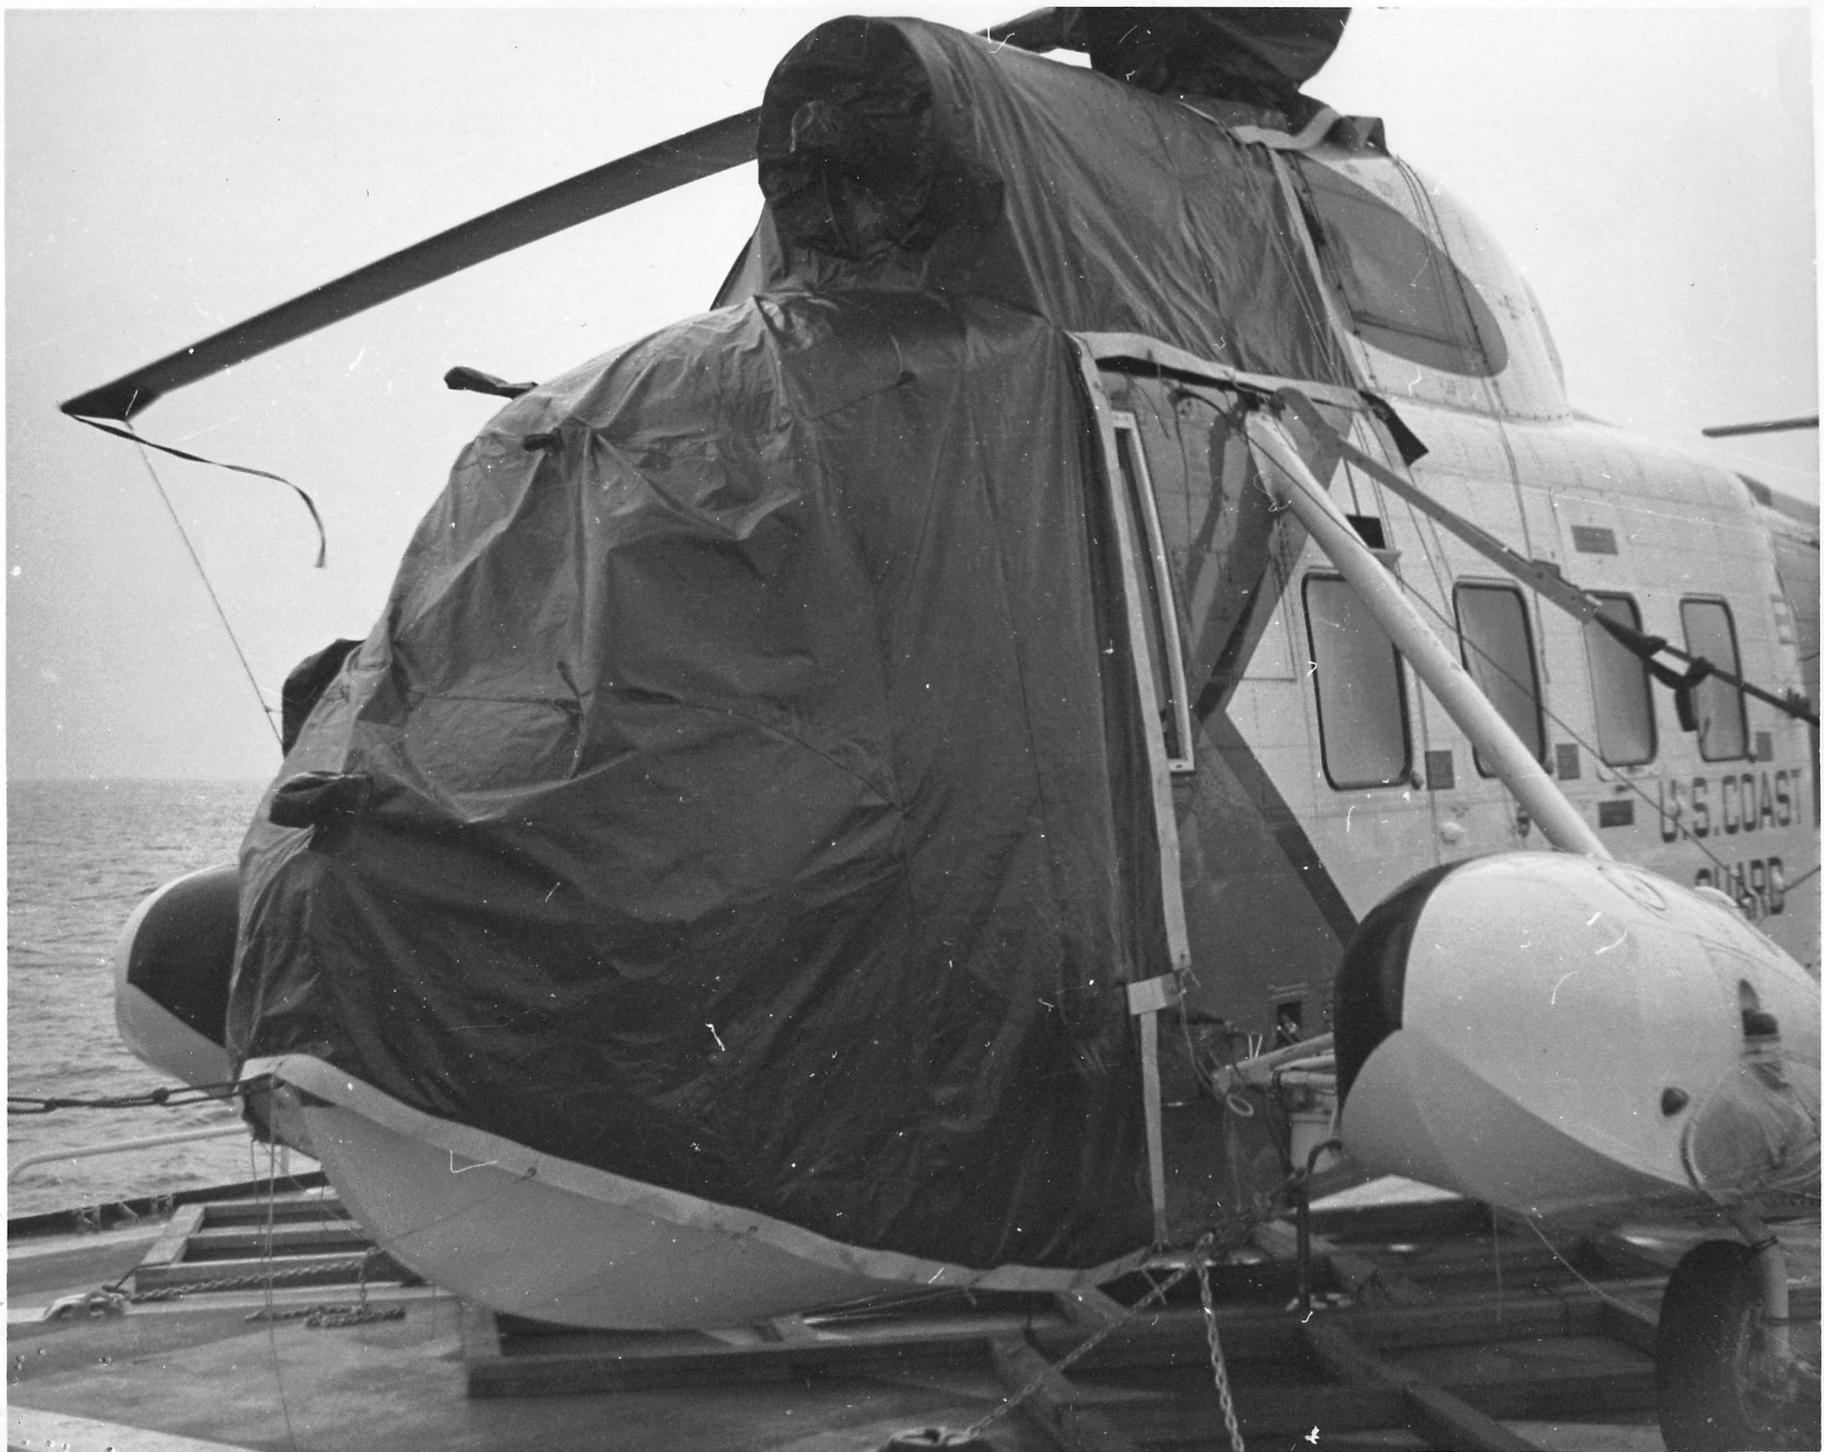
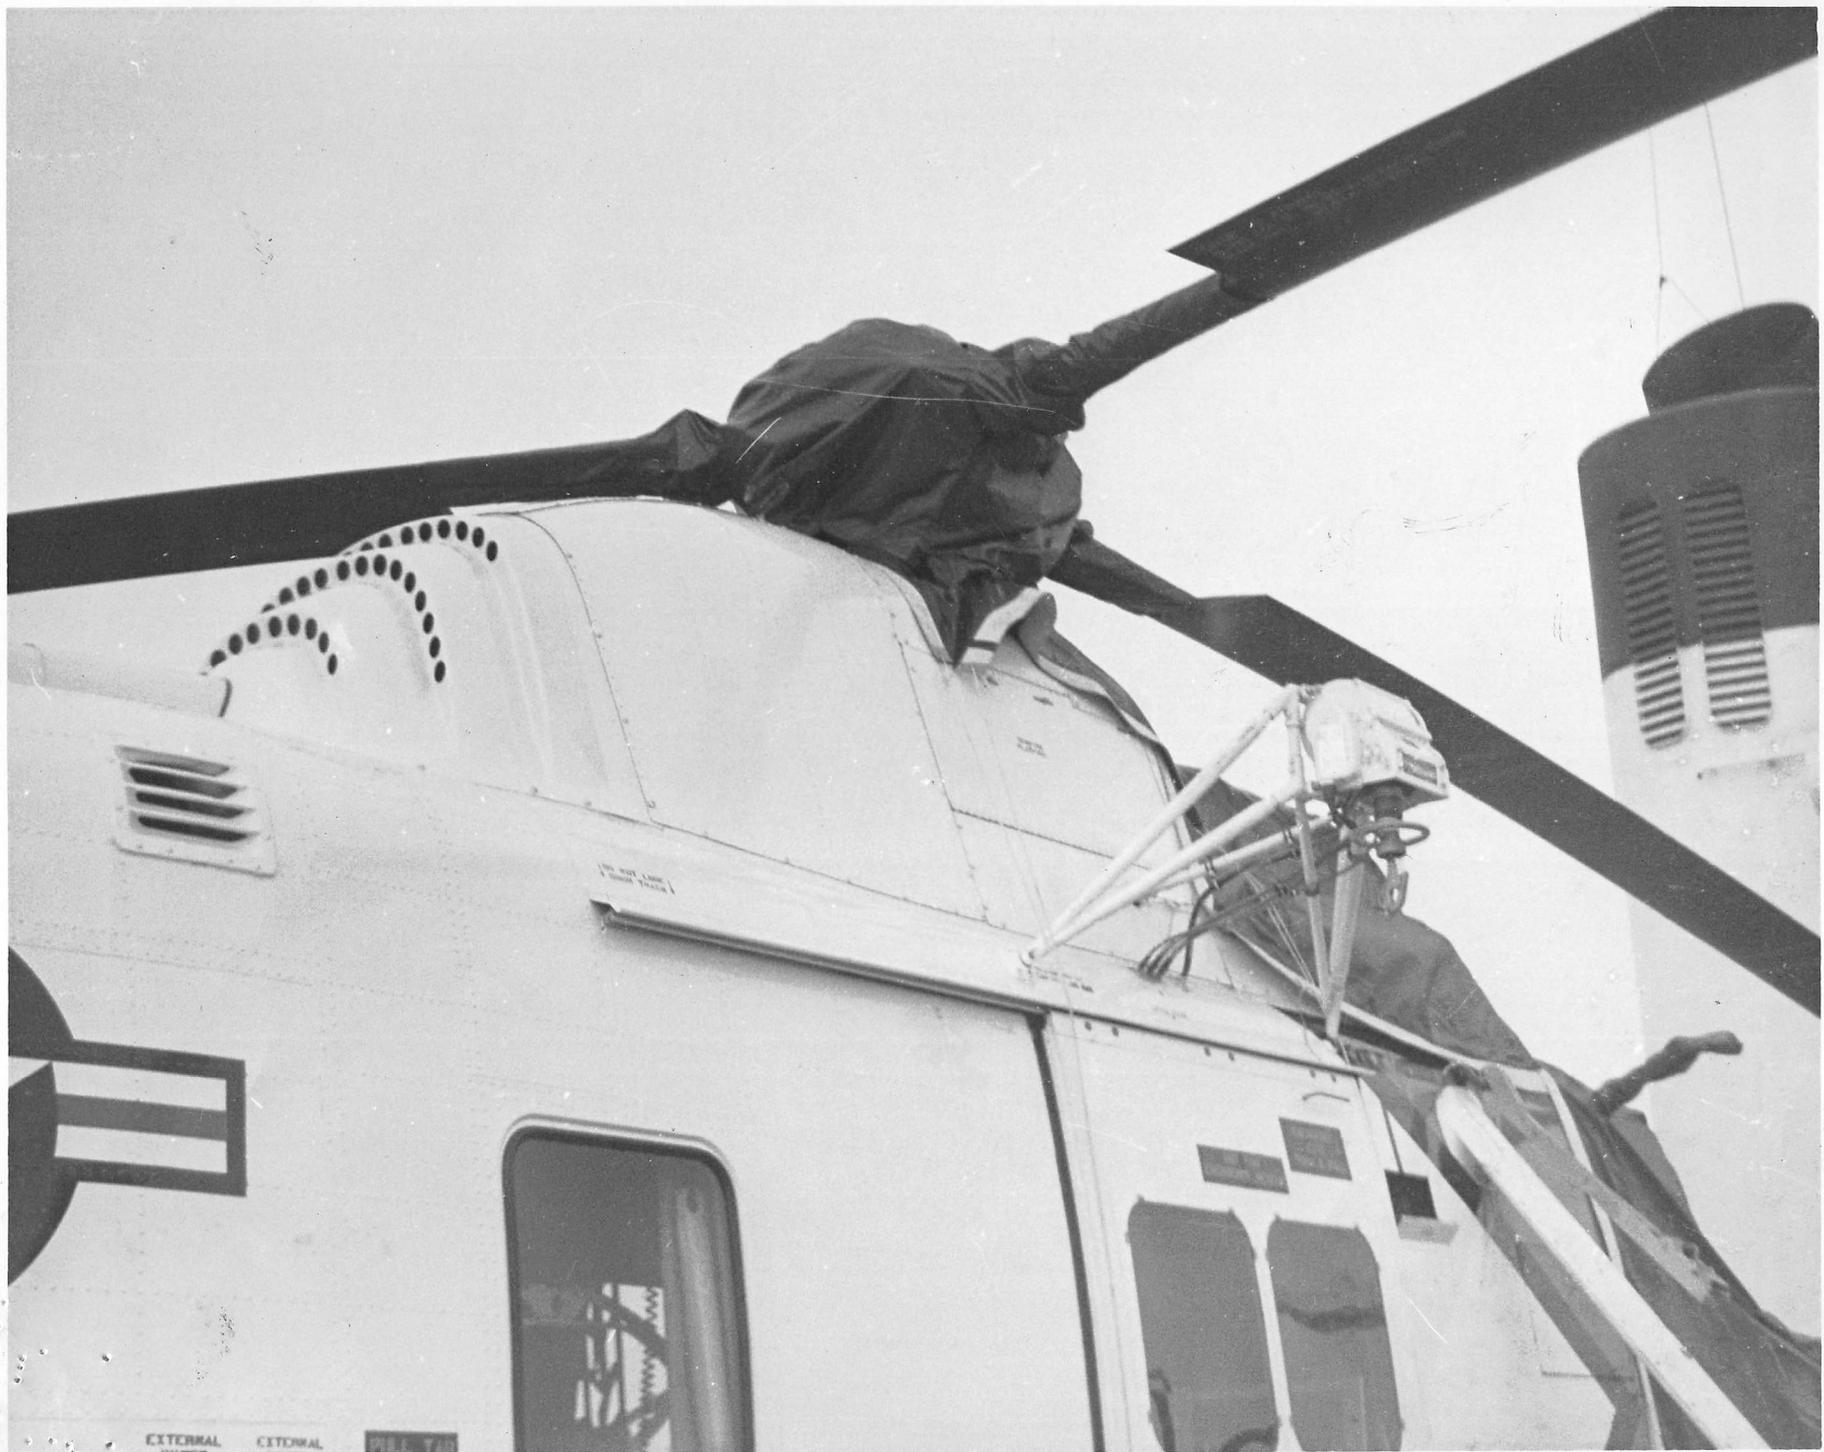
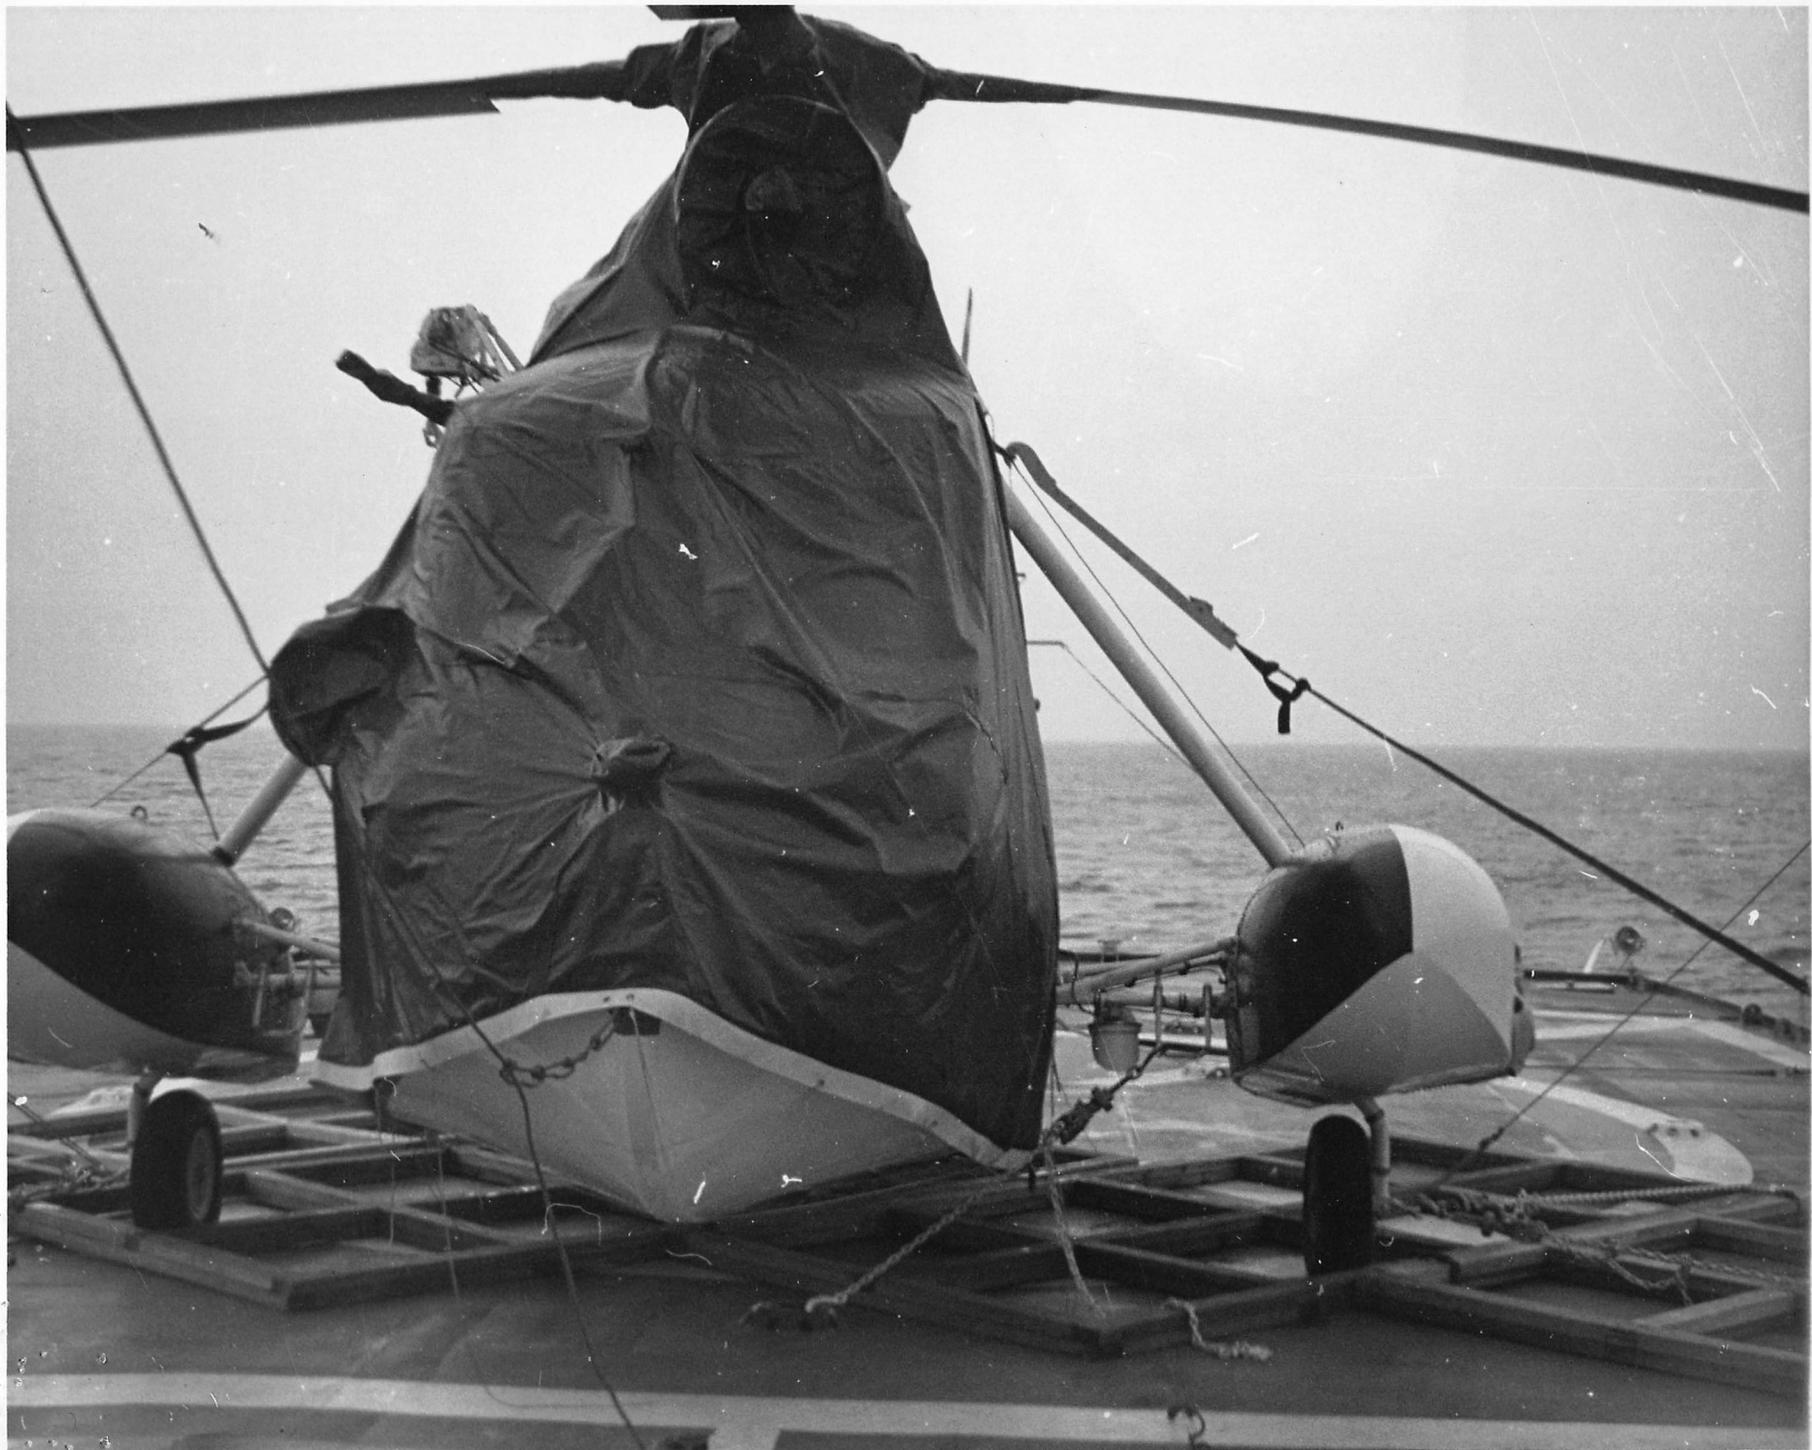
c. After the aircraft was washed, an anti-spray cover provided by CGAS, Salem was placed on the aircraft (enclosure 2). The cover was difficult to install in any kind of wind and it did tend to scuff the windshield, but it did a very effective job of keeping the salt spray off of the engine and transmission area. Some ripping of the cover was caused because of its tendency to balloon and some re-enforcing should be added, particularly in the area of the temperature probe.
