LINDA E Intact Profile

LINDA E Damage Profile

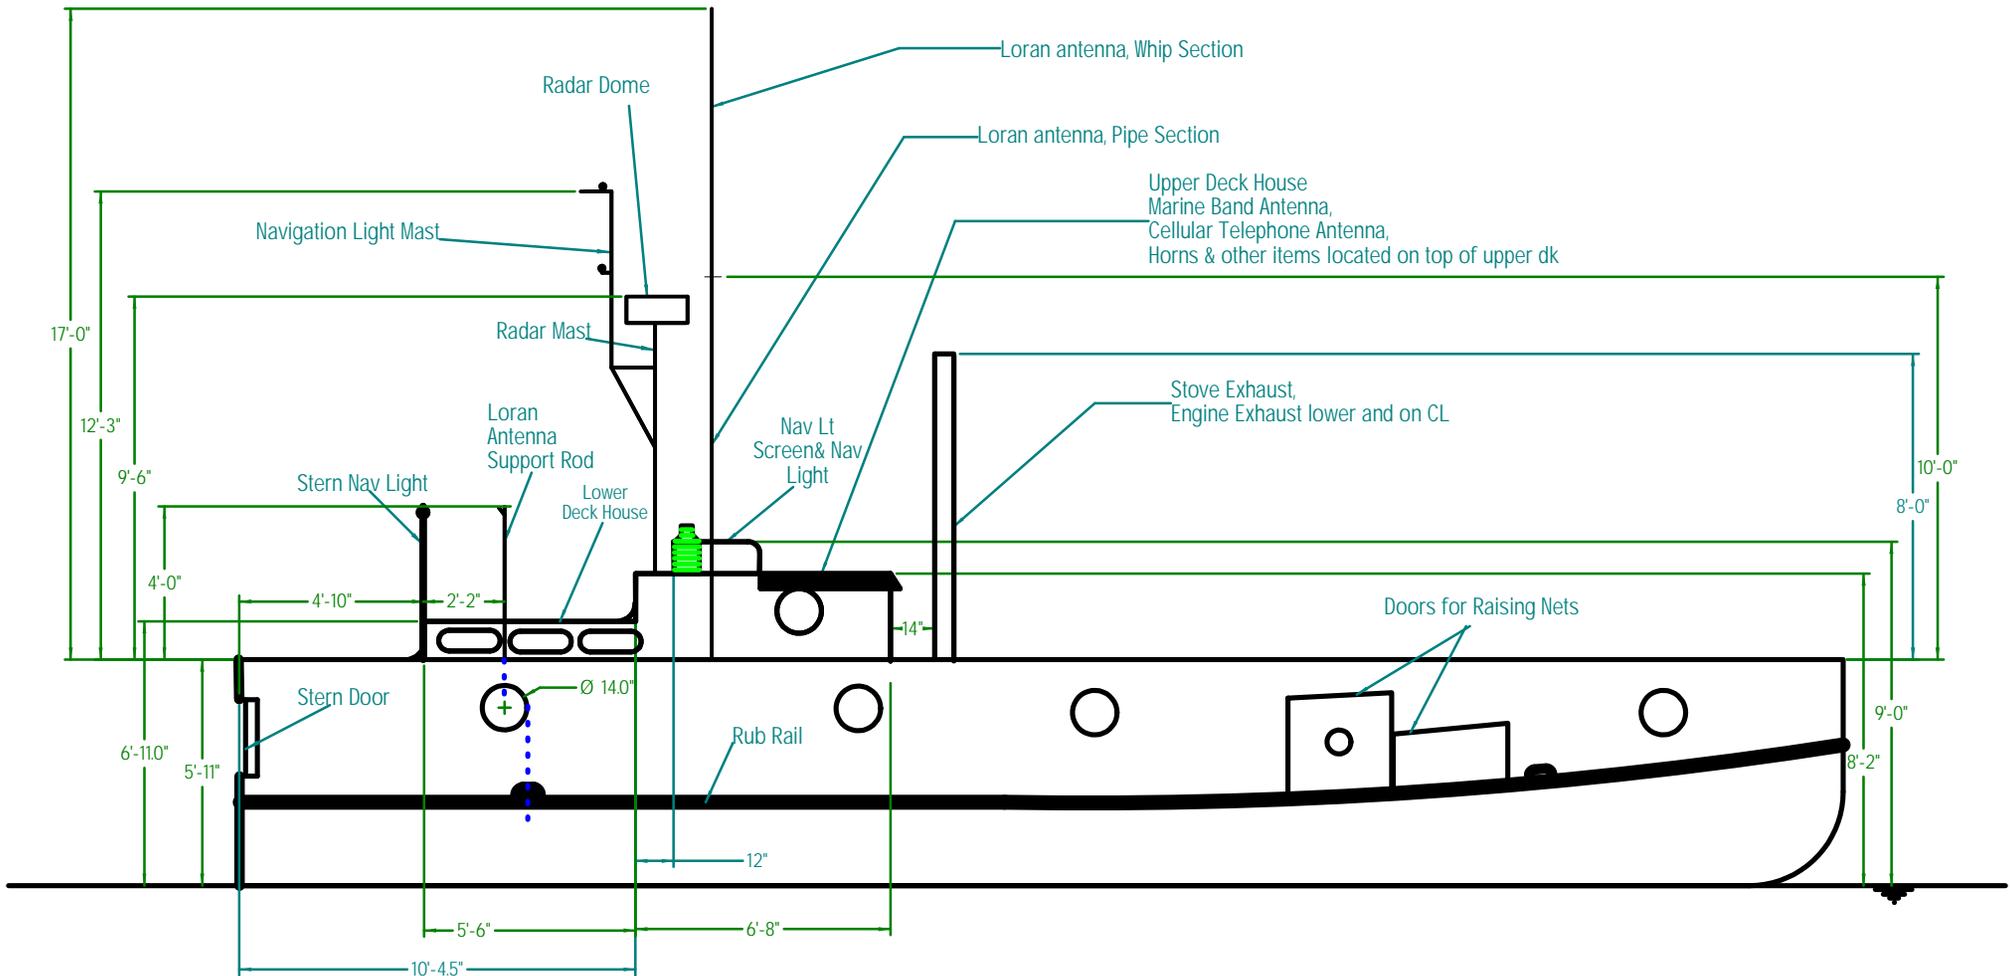
This sketch illustrates significant features on the LINDA E as the vessel appeared on December 11, 1998.

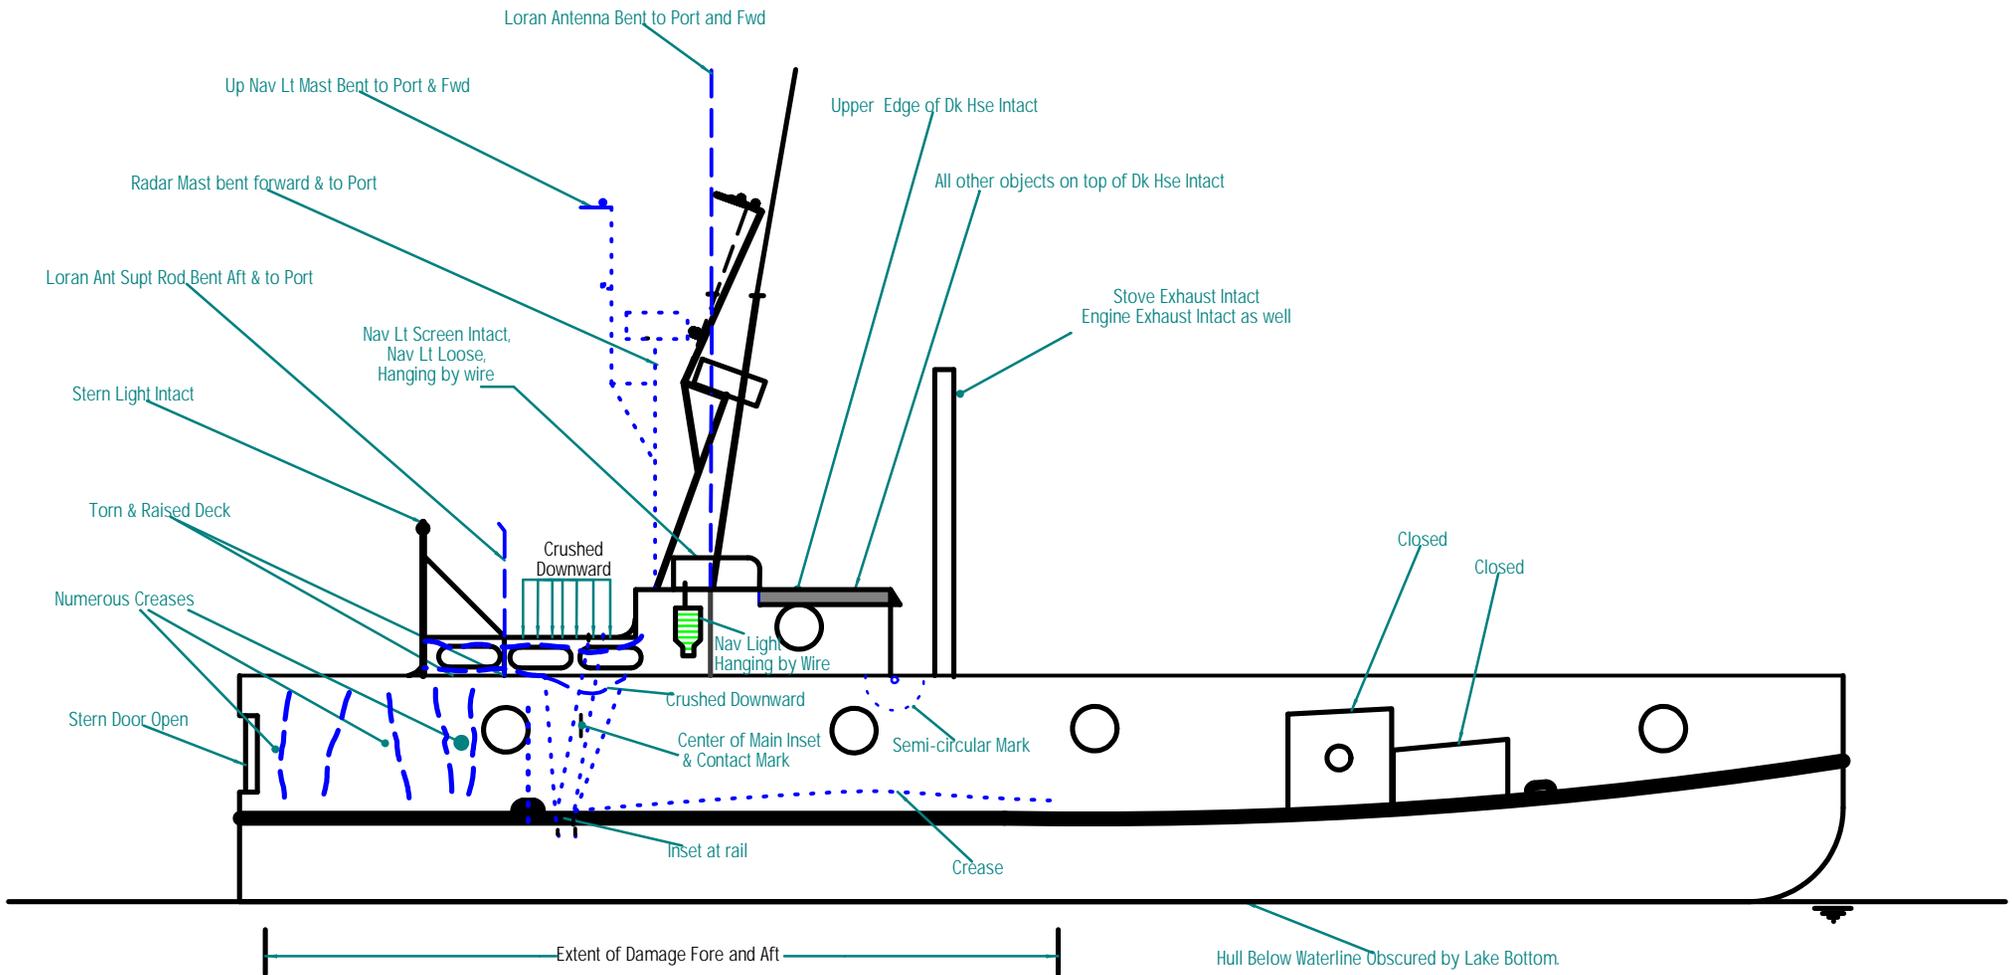
This sketch illustrates the most significant damage observed during the June 21, 2000 ROV Dive. No significant damage noted to port side of vessel.

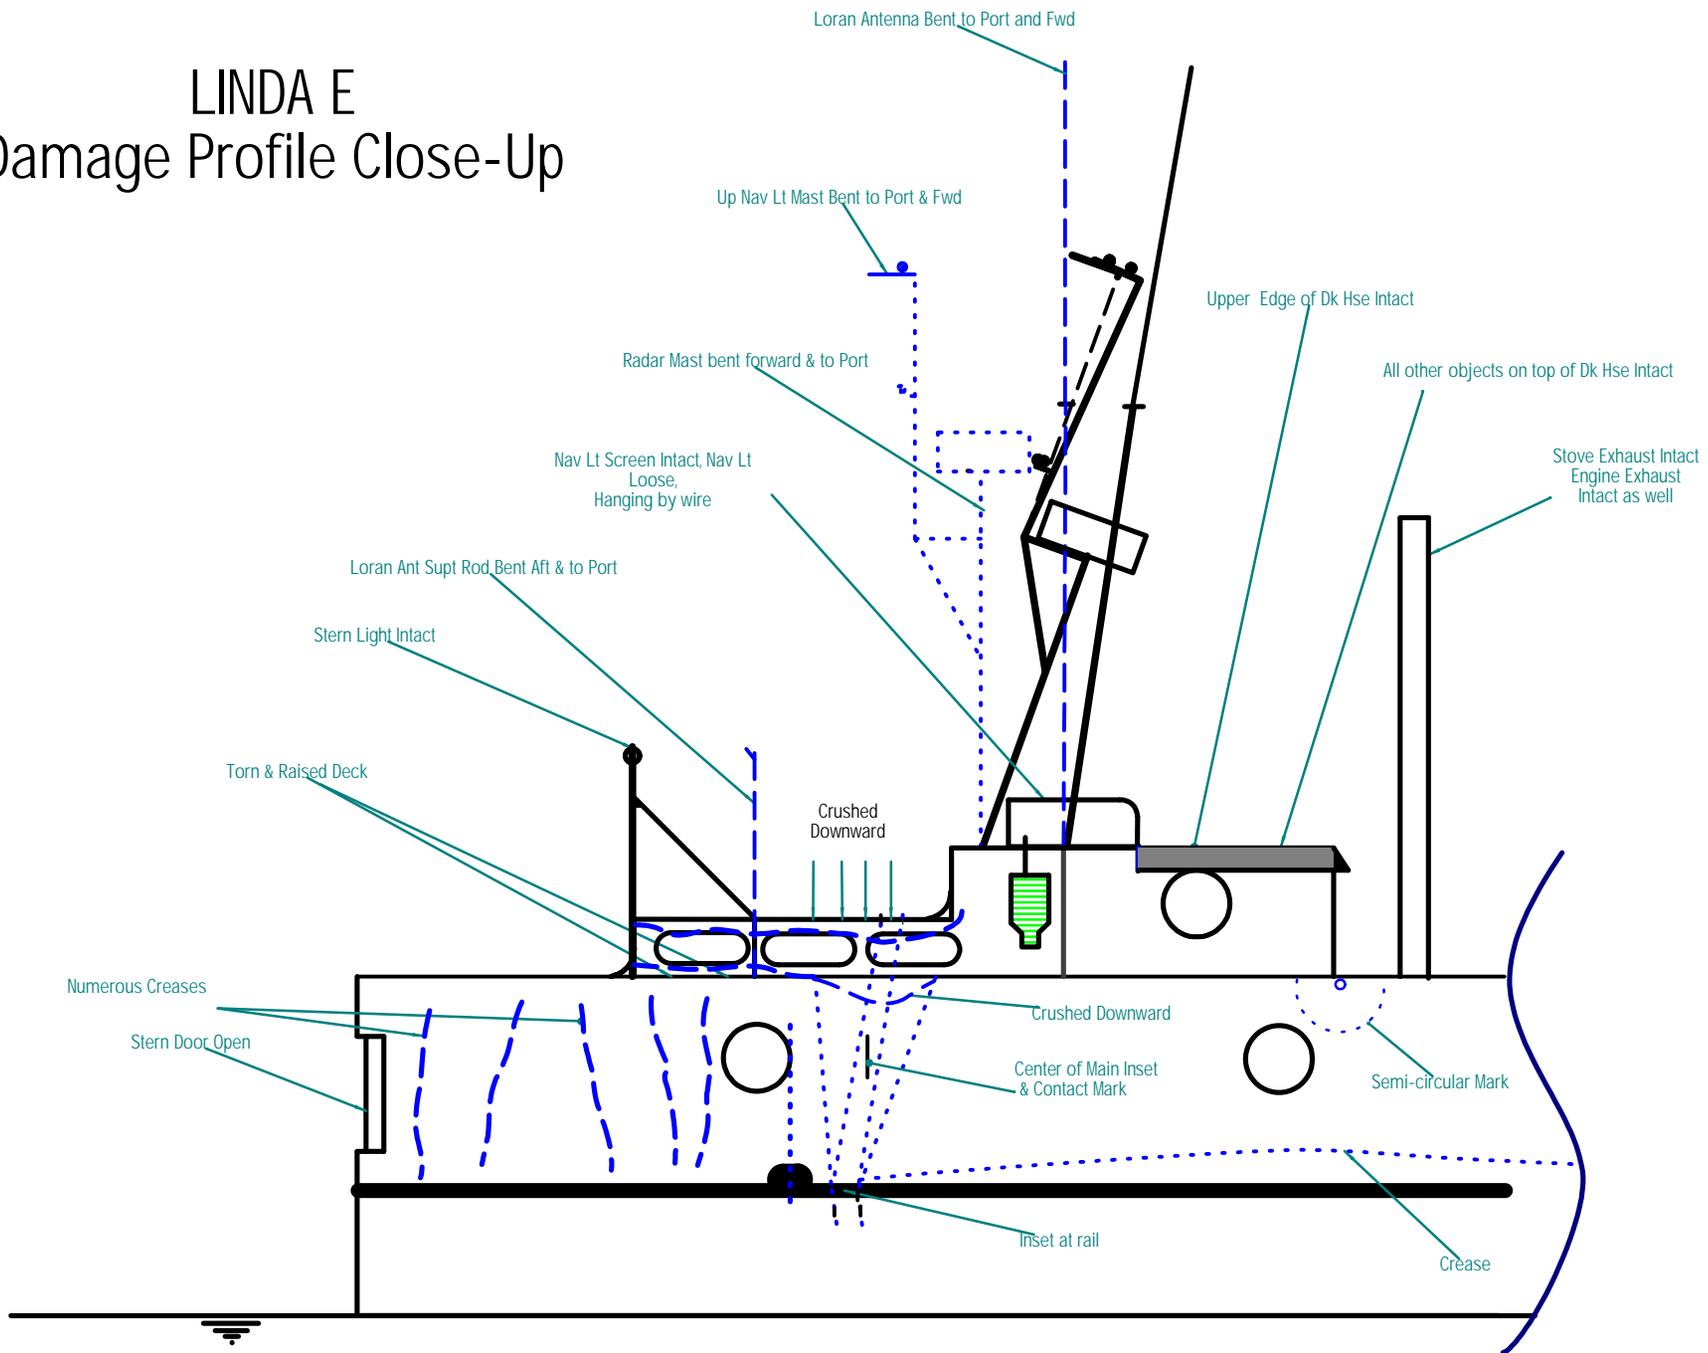
LINDA E Damage Profile Close-Up

This sketch illustrates the most significant damage observed during the June 21, 2000 ROV Dive. No significant damage noted to port side of vessel.

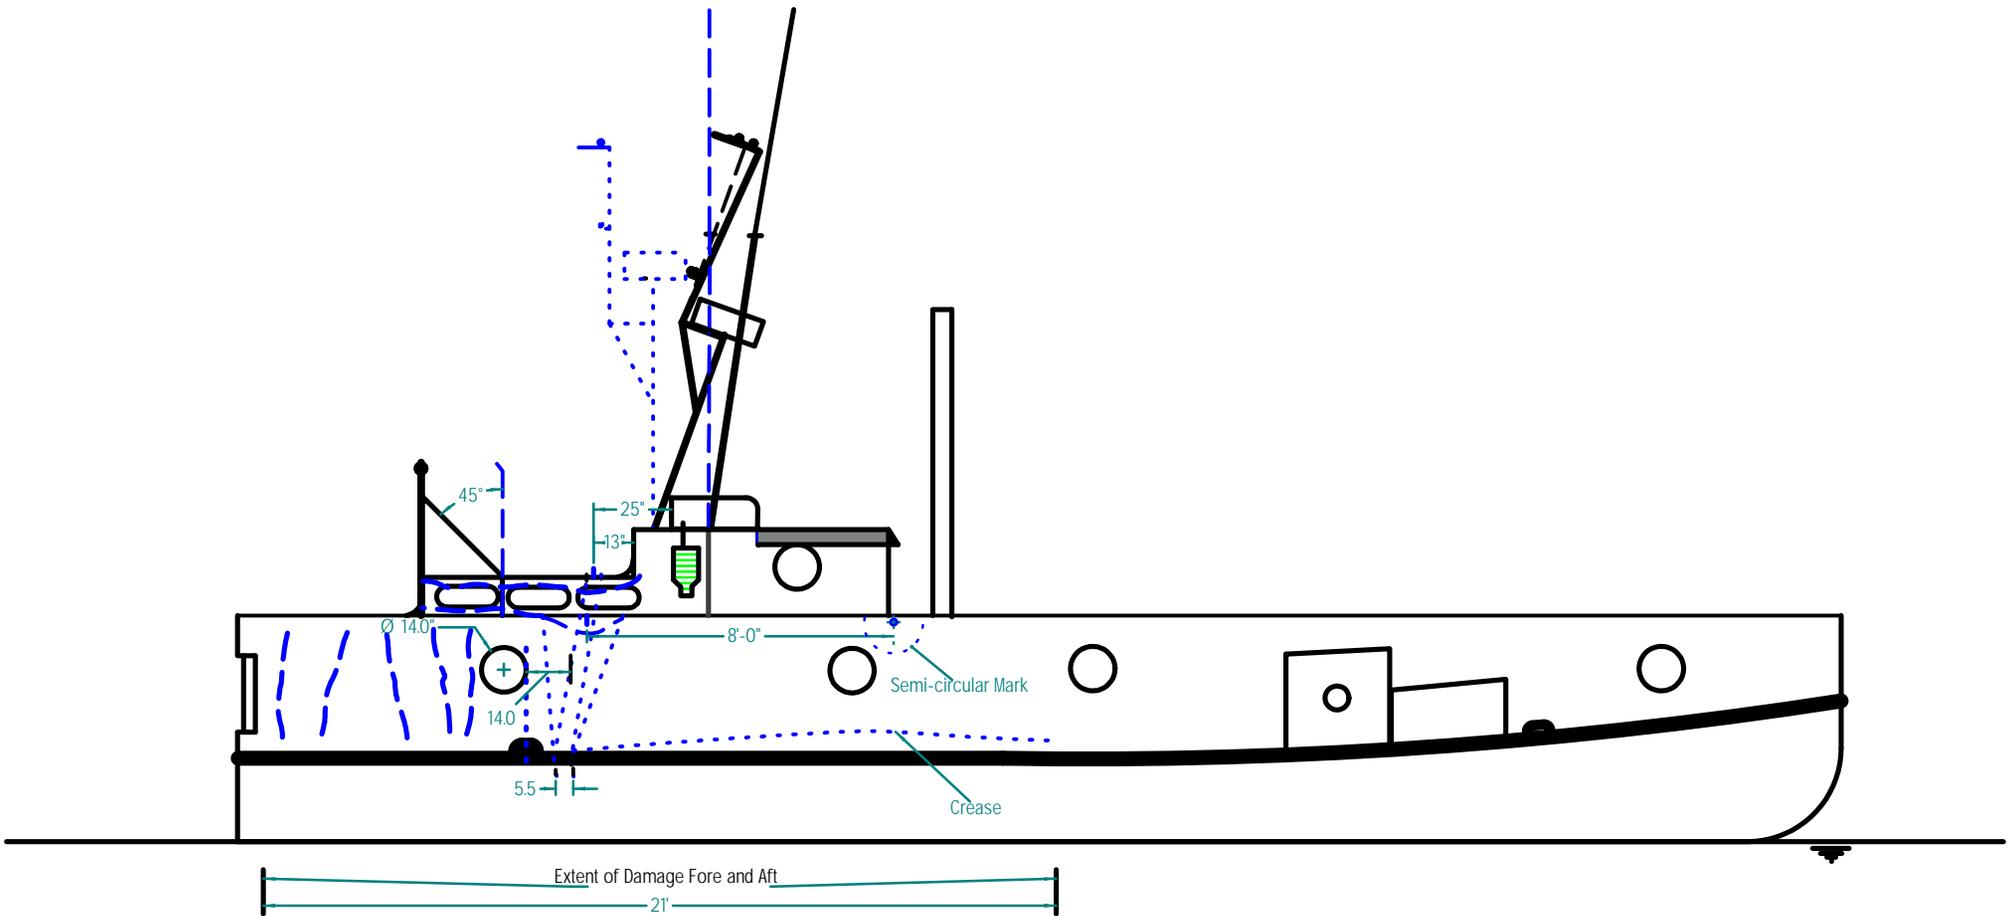
LINDA E Damage Profile Dimensions

This sketch displays a few of the relevant dimensions of markings and damage observed during the June 21, 2000 ROV Dive.
