Photographs of the barge GREAT LAKES taken December 22, 1998

LT Burt Lahn took these photographs of the barge GREAT LAKES on December 22, 1998. Images A, D, E, F, G, H, and I were printed on photographic paper from the original negatives and then scanned into digital format. Images B, C, J, K were developed from the videotape of the GREAT LAKES recorded by LT Burt Lahn on December 22, 1998. The digital images have been annotated for presentation. LCDR Bryan Emond witnessed the conversion and annotation for each image.

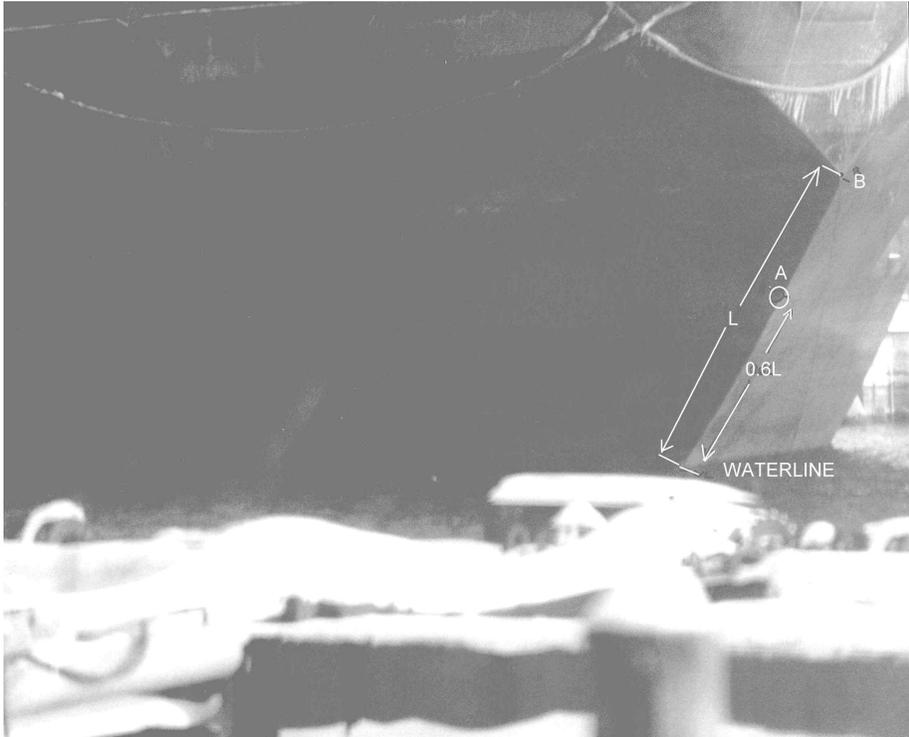
(A)
Starboard
bow of
GREAT
LAKES
showing
relative
location of
reference
point A

Taken from:
Forward &
starboard.

Direction:
Looking aft
and to port.

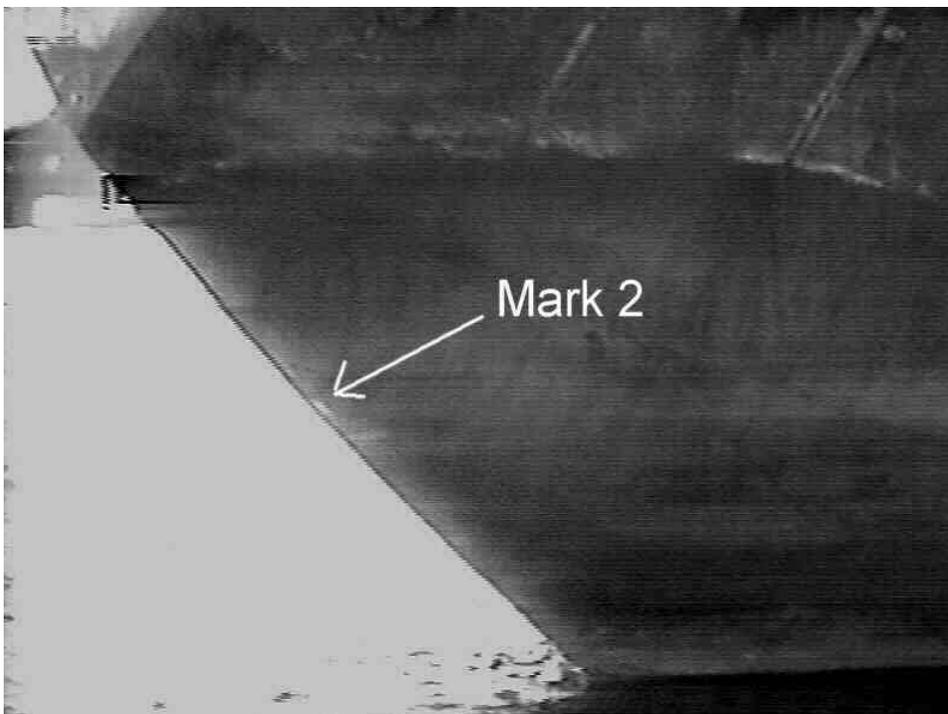
(B) Port
bow of
GREAT
LAKES
showing
location of
mark 2.

Taken from:
Port side

Direction:
Looking to
Starboard

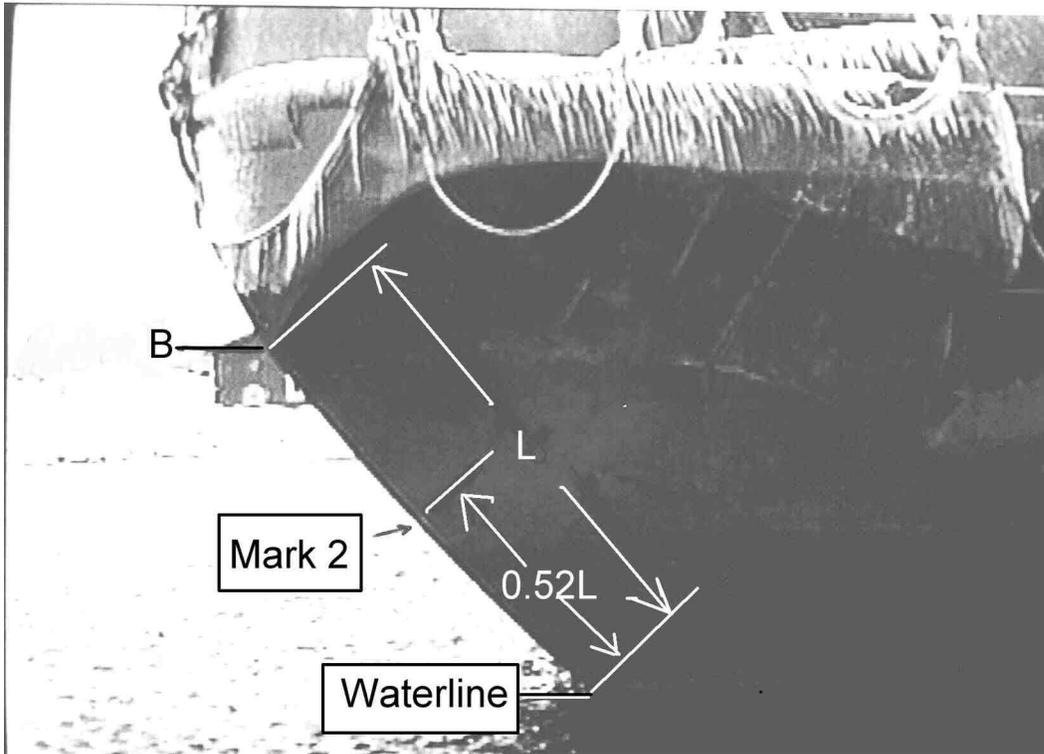
(C) Port bow of GREAT LAKES showing relative location of mark

Taken from: Port Side

Direction: Looking to Starboard

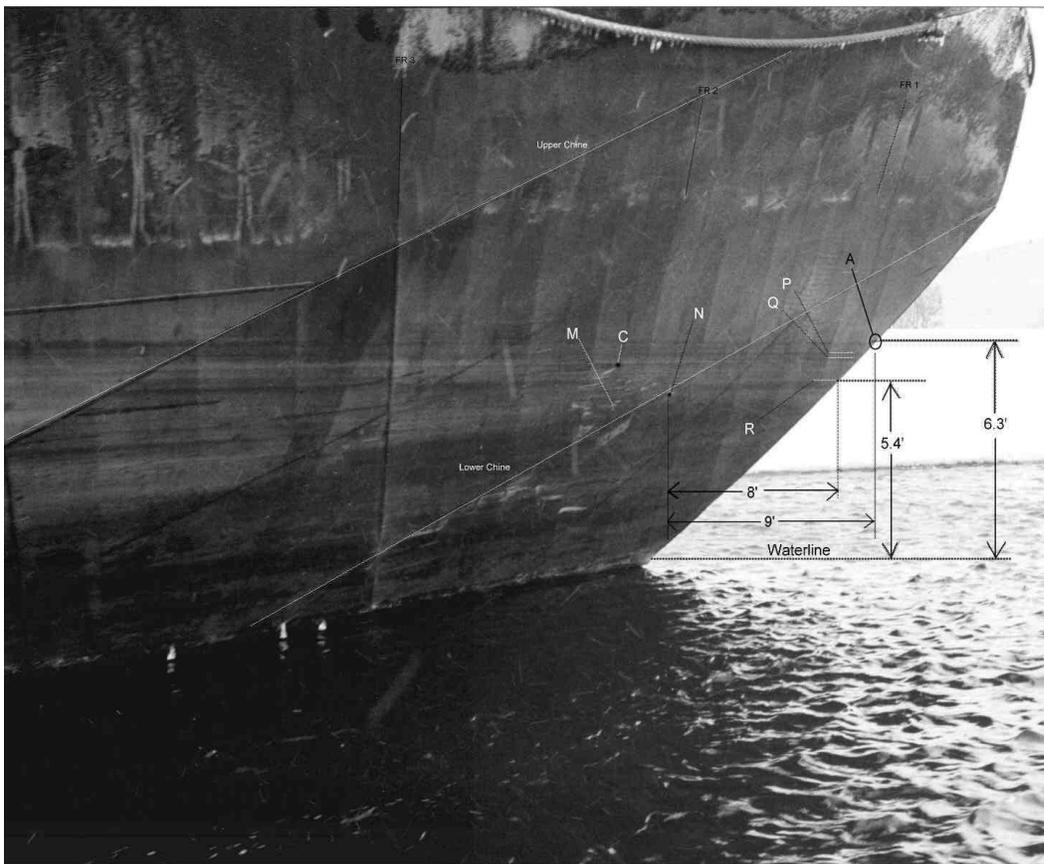
(D) Significant dimensions on Starboard Side. Reference points A, P, Q, & R were used to locate the height of the marks on the stem.

Reference point N indicates the initial scrape that leads to the curved white scrape marks near C and M. Heights indicated based upon December 11, 1998 drafts.

Taken from: Starboard side
Direction: Looking to port
(From 35mm)

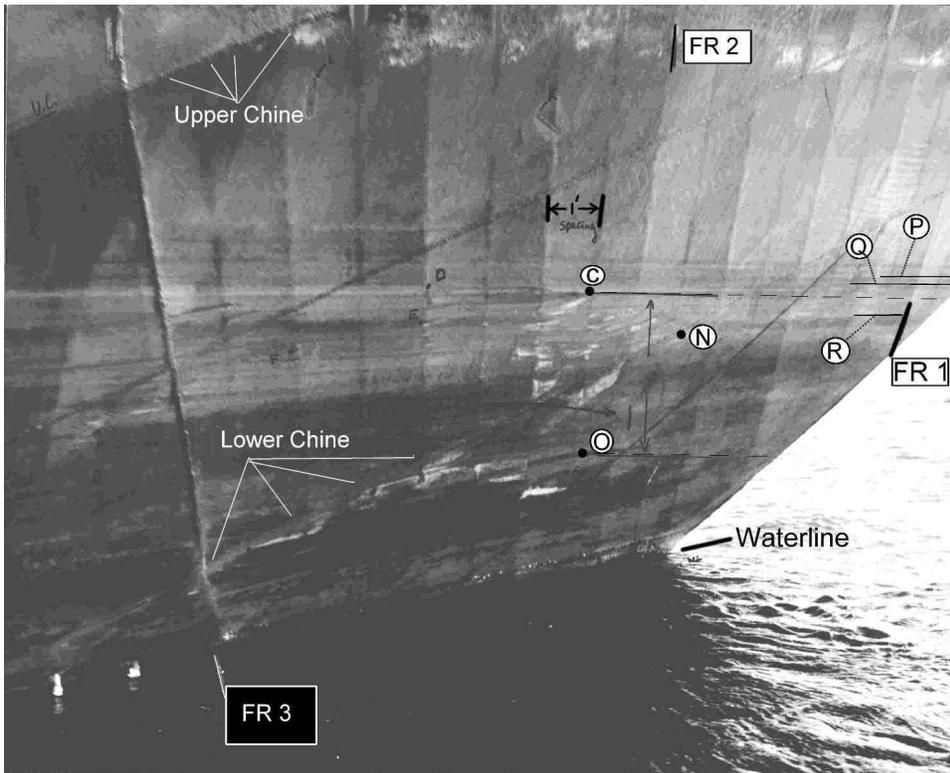
(E) Closer view of significant markings. Upper and lower chine highlighted for easier viewing.

Taken from:
Starboard Side

Direction:
Looking to port and slightly forward

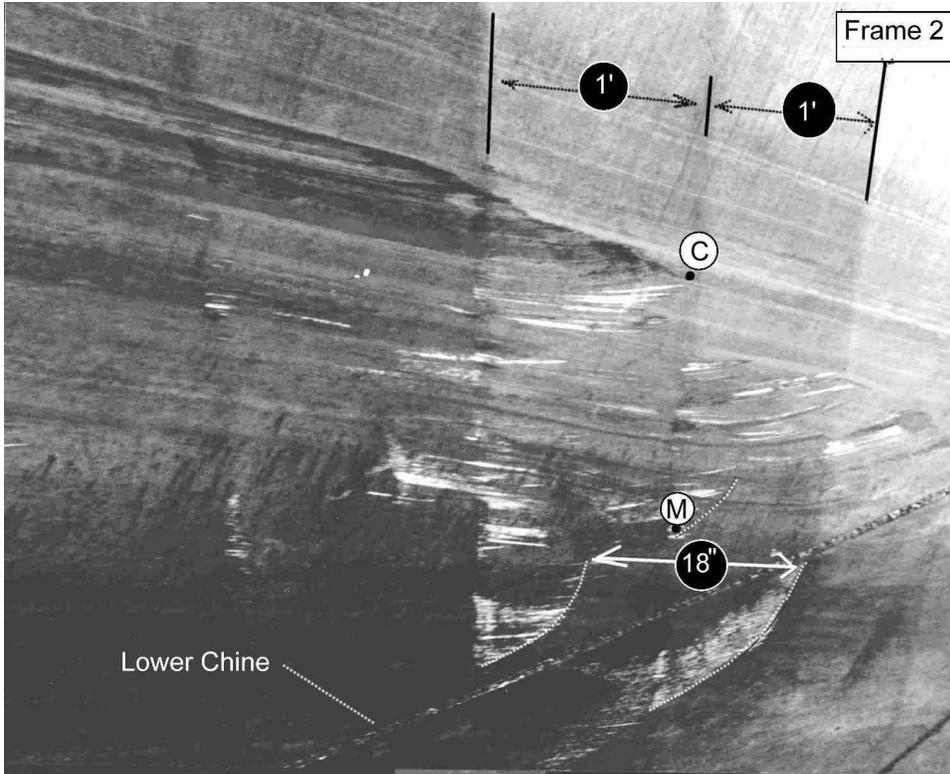
(F) Close-up view of curved white scrape marks. Estimate of distance between starting points of mark are based upon 1' stiffener spacing.

Taken from:
Starboard side

Direction:
Looking forward and to port

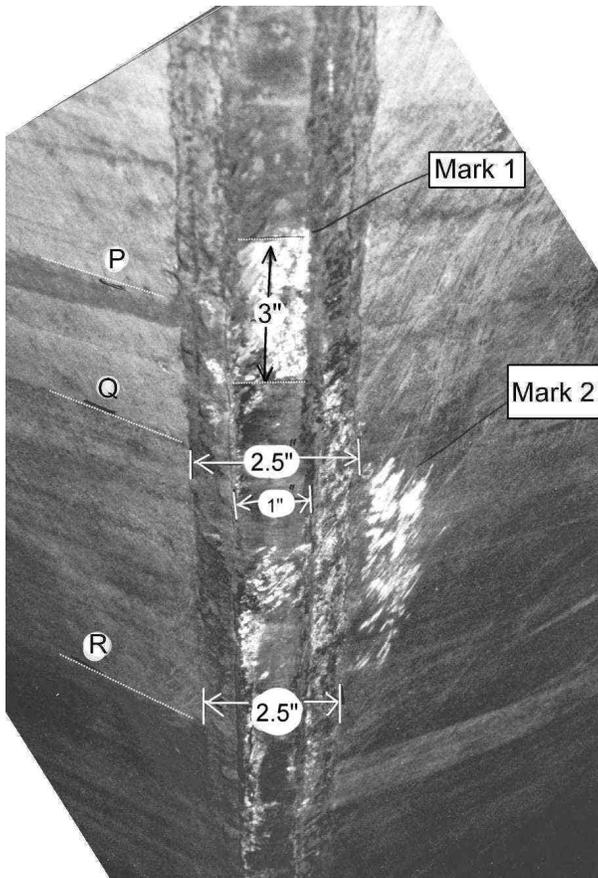
(G) Close up view of marks on stem of GREAT LAKES. Reference marks A (off camera) P, Q, and R were used to establish the height and location of these marks.

Taken from: Forward of Barge

Direction: Looking Aft

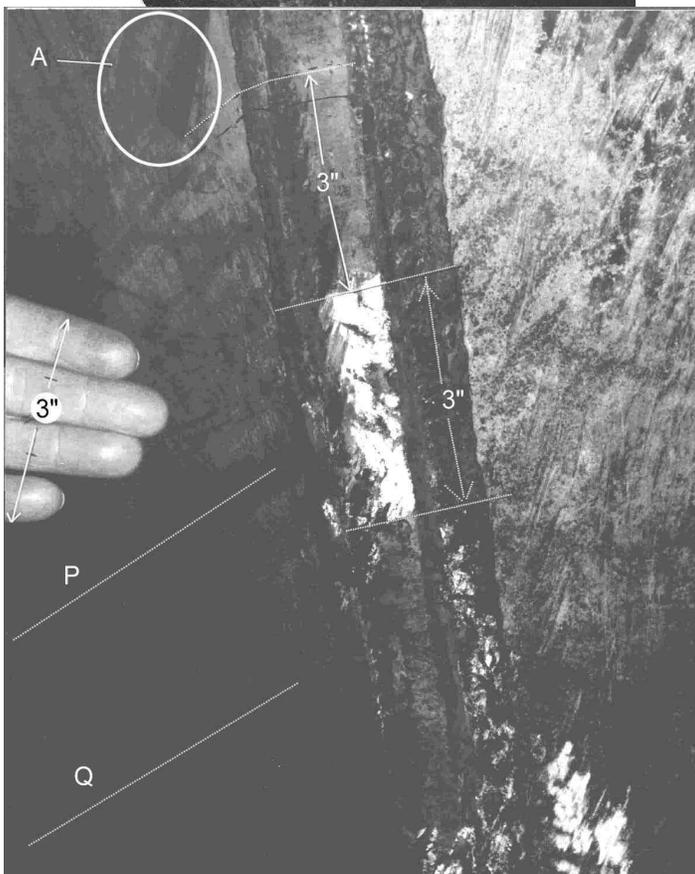
(H) Extreme Close up view of marks on stem of GREAT LAKES. Reference marks A, P, Q, and R (off camera) were used to establish the height and location of these marks.

Taken from: Forward of Barge

Direction: Looking Aft

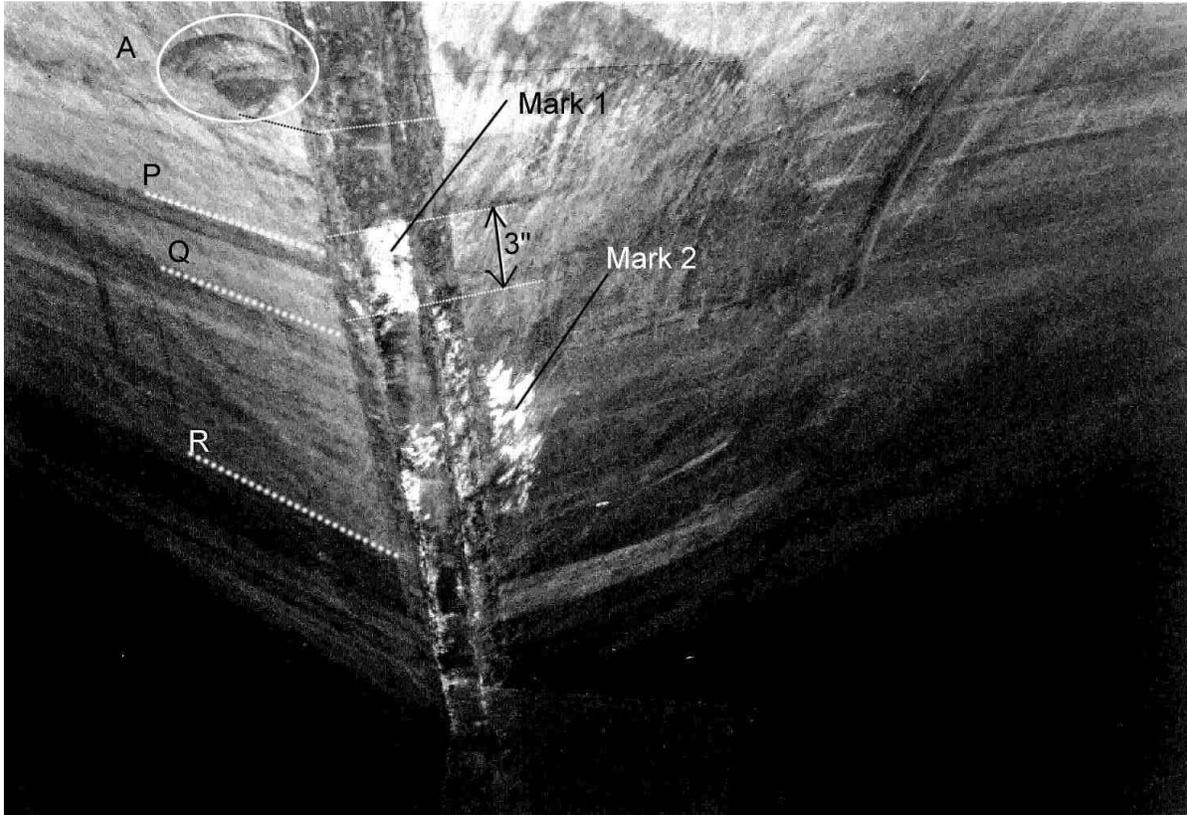
(I) White marks on the stem of the tank barge GREAT LAKES with reference points.

Taken from: Forward of Barge

Direction: Looking Aft

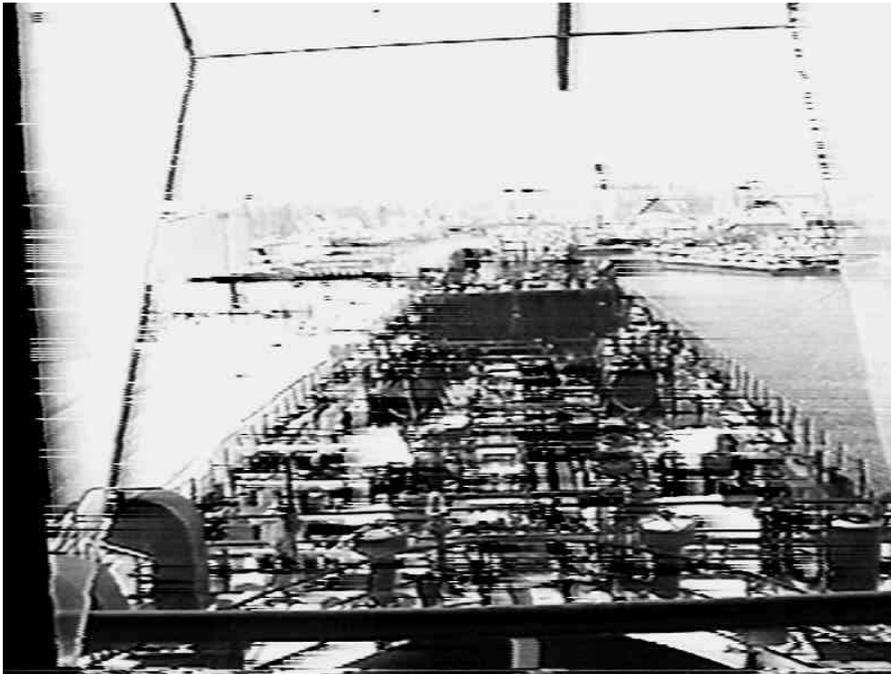
(J) View from upper pilothouse of tug MICHIGAN looking forward over the tank barge GREAT LAKES while at a ballasted condition.

Taken from:
Pilothouse

Direction: Looking forward
