The Aids to Navigation Bulletin

National Aids to Navigation School

Spring/Summer 2010

Volume 37, Number 2

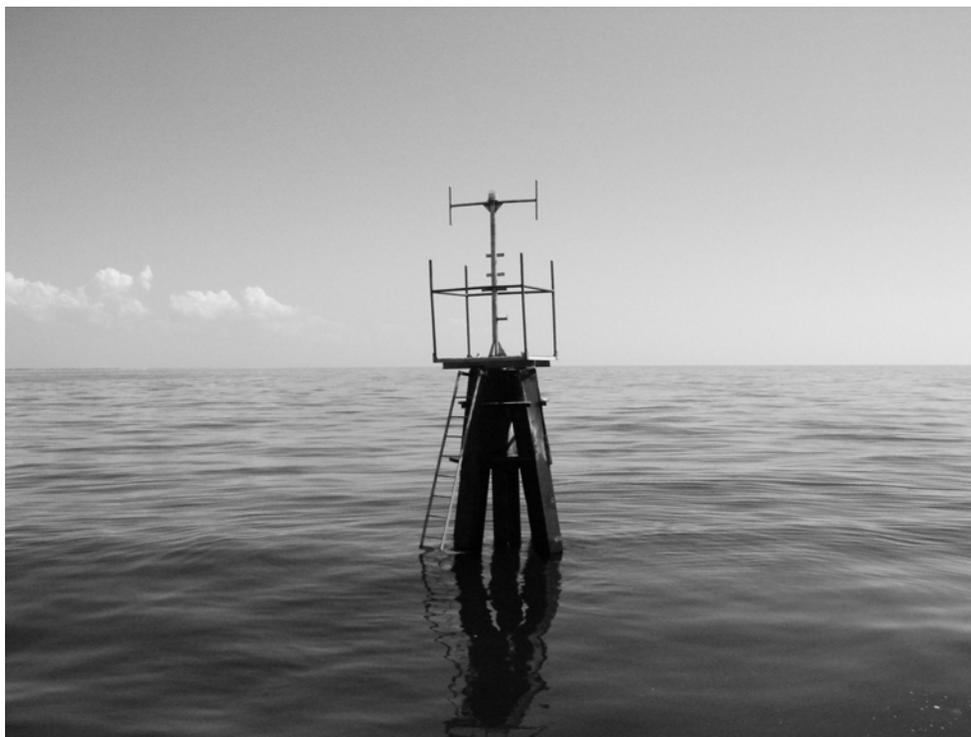
The newly constructed tower

USCGC VISE recently completed installation of a 5-pile tower off the entrance of Tampa Bay shipping channel for the Tampa Bay Physical Oceanographic Real-Time System (TB-PORTS). This structure replaced an earlier one that was destroyed by an allision with an unknown vessel. The structure supports electronic instruments that measure wind speed/direction, visibility (fog), waves, and currents. Measurements from this site and from others around the bay are transmitted to shore by radio every six minutes and are provided to the maritime community via the internet (<http://ompl.marine.usf.edu/PORTS/>) and by an automated telephone response system (1-866-TB-PORTS).

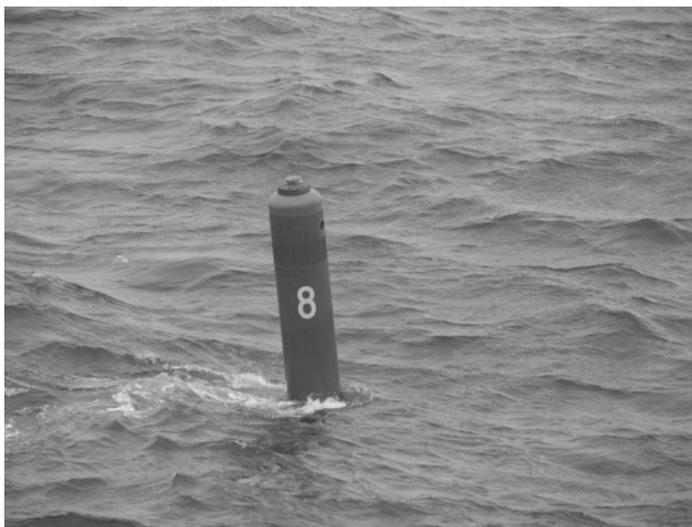
A Sabik ice spar when first commissioned

In the fall of 2008, HICKORY replaced six of the eight 2NR and 2CR seasonal buoys in Port Moller with "year round" prototype Sabik SVV-500 ice spars. The buoys developed by the Finnish company Sabik are designed to survive in heavy seasonal ice due to several characteristics. The 28-foot long buoys are constructed with polyethylene plastic hulls filled with polystyrene foam, a design Sabik advertises capable of withstanding static ice pressure, extended submersion below an icepack, and the vibrations of grinding ice. At the top, like an eraser on a 20-inch diameter pencil, sits a waterproof LED lantern. A massive alkaline battery capable of powering the lantern continuously for five years acts as ballast at the base of the buoy. A tilt switch turns the lantern off when ice pushes the buoy over. Inlaid retro, internal radar reflectors, and a three inch diameter lifting tube for use with synthetic slings are additional attributes the manufacturer boasts alongside its 30-year history of weathering ice on the Baltic Sea.

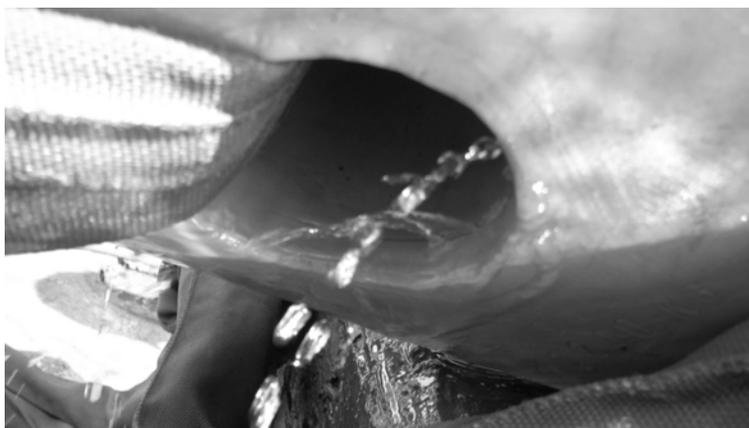
A failed lifting tube on a Sabik ice spar

In May 2009, HICKORY returned to Port Moller to observe how the buoys had survived the icy winter. At first, a couple of the buoys appeared to be missing and the ones that remained appeared to be riding low in the water with only two or three feet of freeboard. At slack tide the missing buoys resurfaced but began sinking again as soon as the additional force of the current began pushing on them. All six Sabik buoys were picked up and examined. All six were found water-logged and with significant hull cracking in and around the lifting tube. Two of the buoy lanterns still functioned but the others had been penetrated by water. Without enough replacement buoys on hand or even in inventory at homeport, HICKORY's best option was to leave the water-logged ice spars in place until the fall decommissioning trip. When HICKORY returned in October, marking the one year anniversary of the prototype buoys, the aids' buoyancy had deteriorated further. Two of the buoys were found permanently submerged regardless of the tidal and current states; three buoys were submerged most of the time but resurfaced with about one foot of freeboard during slack current; and one lone buoy maintained at least a few inches of freeboard at all states of tide.

In order to recover the failed Sabik buoys, HICKORY devised a safe and special way to hook each buoy through the lifting tube and haul them aboard. Using a lifting pennant with a standard buoy reeving device was not an option, even if the buoys were floating at their designed waterline, because neither could fit through the lifting tube that passed through the entire buoy. In the spring, a special Sabik reeving device was used, which was both flexible enough to deform but stiff enough to support and guide an endless sling through the lifting tube like a big coat hanger. However, in the fall with even further diminished buoyancy, the lifting tubes were too far beneath the buoy deck sill to safely reach. To overcome this ob-

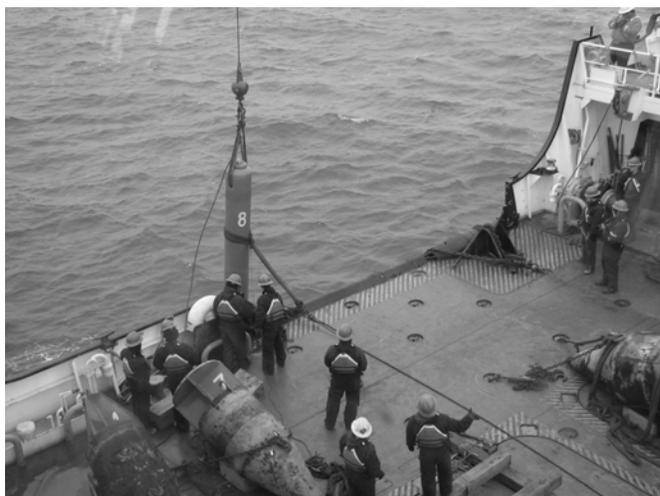
A Sabik ice spar being recovered in Port Moller

Recovery of the four partially floating ice spars was difficult because the buoys moved erratically in the swift current, perhaps due to instability as a result of being water-logged. They would move approximately ten feet, rapidly swirling side to side as well as submerging and resurfacing repeatedly in a matter of seconds. Comparatively, a 2CR in the same conditions would only deviate by a few feet from its location at max excursion. Once the lifting sling could be fetched up with a boat hook and transferred to the crane whip, vertical control of the unstable buoy was gained. As the buoy was pulled out of the water, a second sling rigged to a cross-deck and passed back through itself to choke around the buoy body was used to establish horizontal control. After the four buoys prepped by the small boat were recovered, attention turned to finding the two missing hulls.

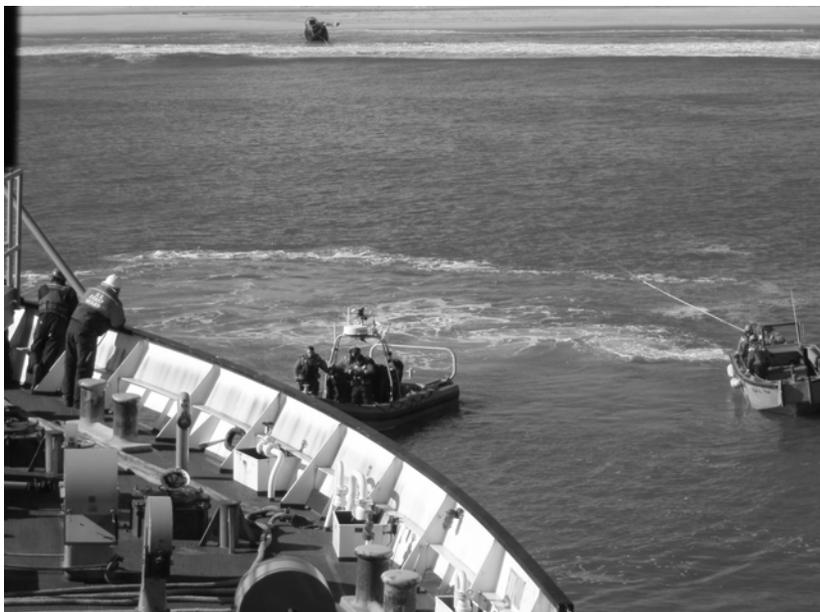
ELM's small boats conduct soundings and prepare the buoy to be towed

The buoy recovery was initially attempted with shoreside personnel and the cutter's small boats. With the help of Coast Guard Station Indian River and Delaware Department of Natural Resources, a front-end loader pushed the 8X26 into the surf line. ELM's surface swimmer brought a towline from one of the small boats and it was hooked to the buoy. It became apparent the small boat was not powerful enough for the job, and the cutter commenced an approach on the buoy, using the other small boat as a guide for soundings along the route toward the beach. A 15 knot breeze from the west compensated for an along-shore current, allowing the ship to approach on a heading roughly perpendicular to the beach. Once the small boat had connected a line from ELM to the towline already connected to the buoy, a precisely controlled strain was taken on the towline by using the DPS system offsets. Slowly the buoy was

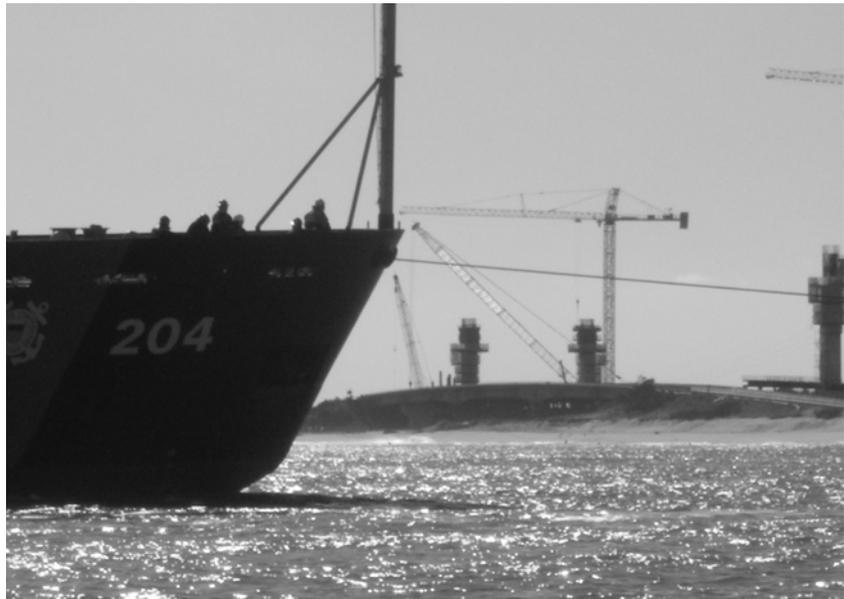
A view of the towline from ELM's bow

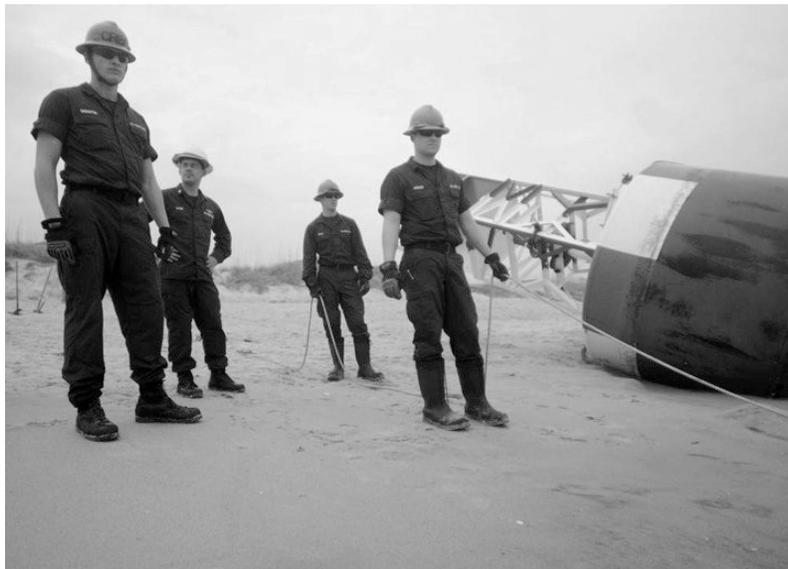
The crew of BAYBERRY makes the buoy ready for towing

During the month of January 2010, a 12,100 pound 8x26 LWR broke free of its mooring and washed ashore on Carolina Beach, North Carolina. Removal of the aid was achieved through a joint effort between CGC ELM (WLB 204), the unit with primary responsibility for the buoy, and CGC BAYBERRY (WLI 65400). The ELM is homeported at CG Sector North Carolina, Atlantic Beach, North Carolina. The BAYBERRY is homeported at CG Station Oak Island, Caswell Beach, North Carolina. The BAYBERRY serves as a secondary unit for the ELM.

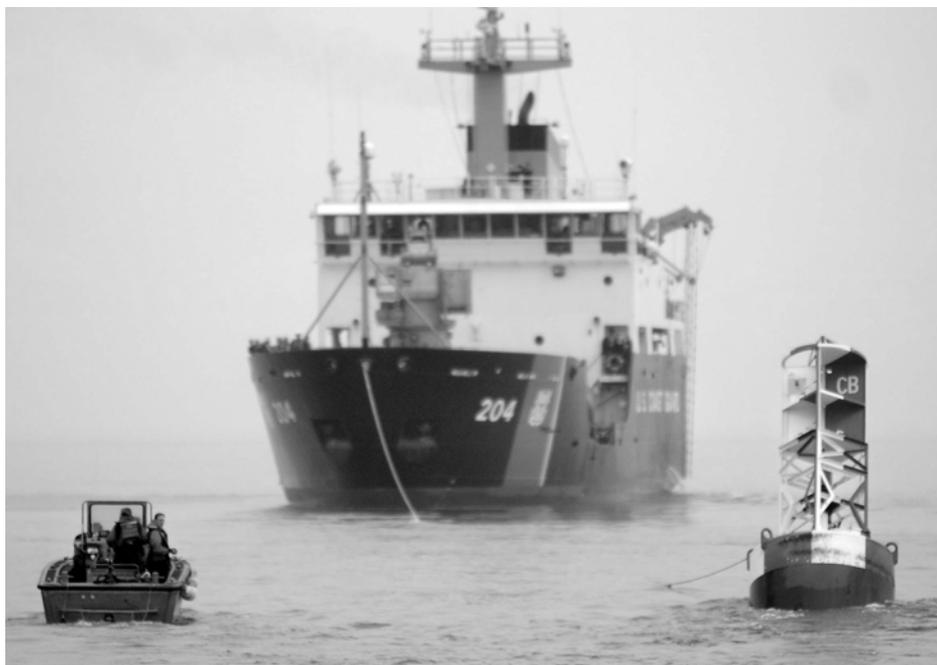
ELM tows the buoy safely back into water

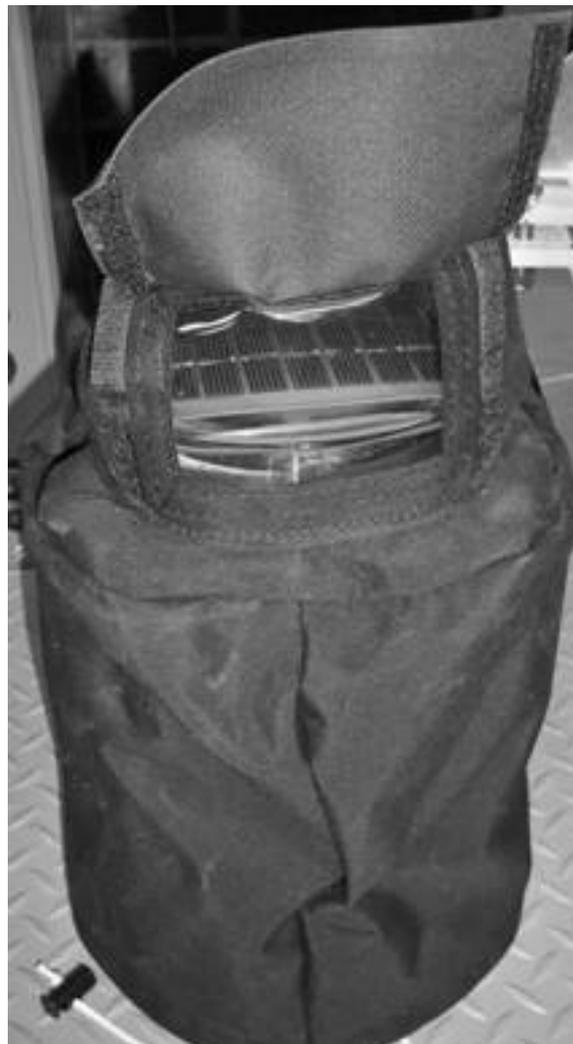
There are currently two sizes; small for the 701 and 701-5 lanterns, and large for the 702, 702-5, and 704-5. They are designing a cover for the 708 which will be even larger. Current pricing is \$65 for the small and \$68 for the large. They do take credit card orders. Covers are available from:

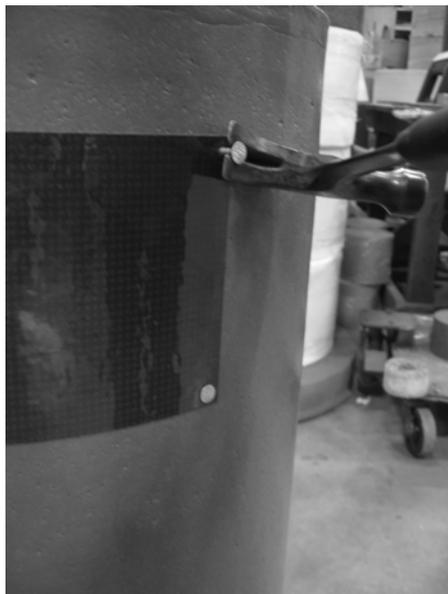
The idea is basically the same as using a big push pin in a bulletin board. The nails that Gilman uses are 1.75" x .145" Ring Grip. These aluminum nails are easy to put in and remove and take much less time to install compared to using adhesives. A standard claw hammer can be used for installation and removal, and a flathead screwdriver also works well for removal. Nails can be used over again, either in the same hole or a new one. Since the nails are aluminum, they are lightweight and will not rust and discolor the retro panel.

New buoys from Gilman will start being delivered to the Coast Guard using this method of securing the retro. In addition, field units are authorized to use this method for retro application on existing buoys (color panels and numbers/letters).

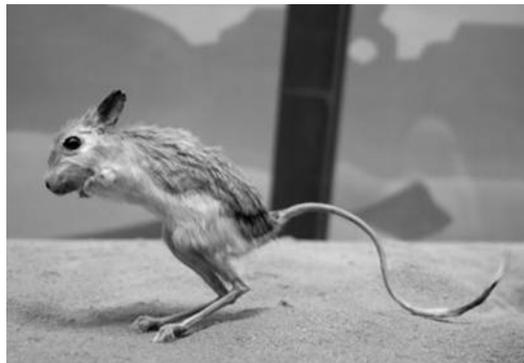
The dreaded Jumpy Mouse—this is a problem that you may encounter on your Toughbook when using AAPS. Suddenly your mouse isn't controlling the cursor, which is running all over your screen for no apparent reason. Many of you have experienced it; some of you have managed to avoid it, but you may find yourself faced with it one of these days. Unfortunately, since the upgrade to Image 6, the fix that follows must be done by someone with **Administrator** privileges.

- Click “Start” – “Control Panel”
- Double-click “Mouse”
- Choose the “Hardware” tab
- Make a note of the mouse or mice listed. You may want to p-touch this information somewhere on your Toughbook.
