# The Aids to Navigation Bulletin

National Aids to Navigation School

Winter 2008

**Volume 35, Number 2**

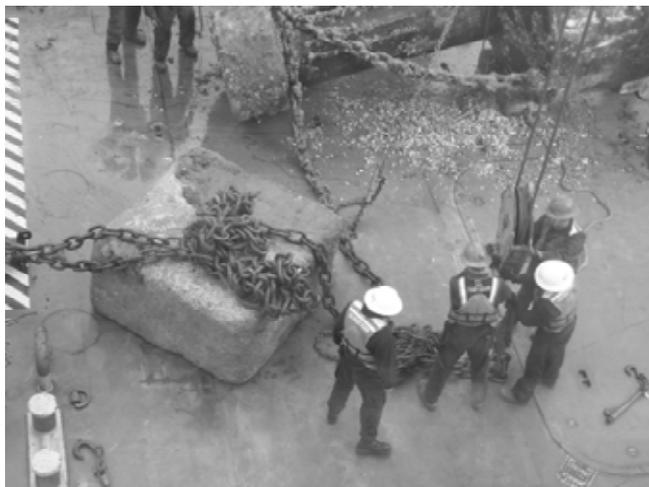
*The “CH” buoy’s knotted mooring*

When the AMIO mission was complete and after a well-earned port call in Miami, JUNIPER began its trek home just behind Noel’s path of destruction. The Chesapeake Bay Entrance Lighted Whistle Buoy “CH” was found off station, and with its primary unit unable to respond, JUNIPER agreed to re-locate the buoy, which marks the center of a precautionary area where four major traffic lanes converge. JUNIPER found the aid 500 yards off station with a badly knotted chain.

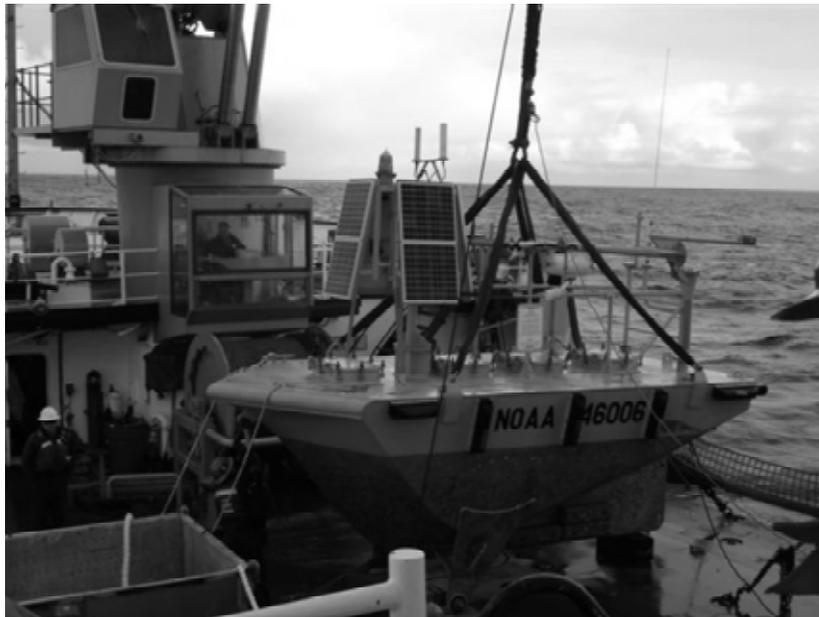
Recently, ASPEN was tasked with setting a standard 19,000-lb, 6-meter NOAA weather buoy approximately 500 nautical miles west of Eureka in just over 13,000 ft of water. The weather was an 8-10ft swell, plus a wind chop caused by the 10-15 kt winds; a very typical day in the North Pacific. Conditions were deemed manageable, and preps for setting the buoy commenced. To attach the main block to the sea catch quick release, a safe working load of 13k basketed synthetic sling was chosen. With the basket configuration on the sling, the manufacturer's stated 26k capacity would be sufficient for the 19k buoy.

*NOAA buoy just prior to picking up*

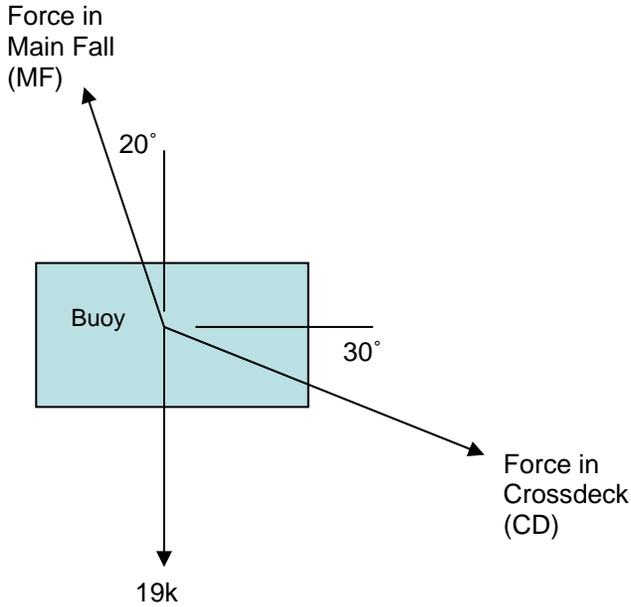
The force on the main fall and all rigging gear in line is a combination of the load being lifted, the amount of outboard lead on the main, and the crossdeck load added to the system. As shown below in the free body diagram of the system that ASPEN was lifting, the load on the main fall was significantly greater than the dead weight of the load it was lifting.

$$\sum F_x = 0$$

$$-MF\sin(20) + CD\cos(30) = 0$$

After an analysis of the failure, there were two primary causal factors noted. The first was the increased force developed between the opposing forces of the main and the cross deck, and the other was the type of surface that the sling basketed through on the quick release.

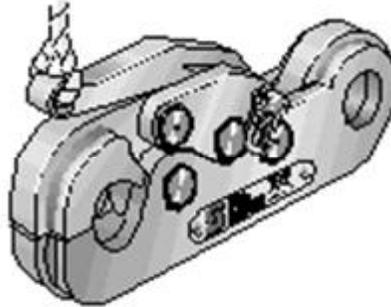
The synthetic sling that was rigged was basketed around the eye of the Sea Catch quick release which has somewhat blunt edges. To gain a true double load on a basket rig requires the sling to slide to exactly even the load on both sides of the sling, similar to a pulley. The blunt edges can prevent this and slightly overload one side while the other side is taking less stress. Additionally, the blunt edges can cause a stress concentration which also contributed to the sling failure.

*Sea Catch quick release device*

The sling parted exactly where I would have expected it to given the description of bunching at the quick release hook. Pinch points like this will significantly reduce the working load limit of a synthetic sling even to a point of less than half the WLL. I've pull tested many synthetic slings to destruction at rigging shops around the country and have had it proven time and again that pinching or bending a sling around even a moderately sharp object will result in (very) early failure.

ASPEN was correct in their observation, "to gain a true double load on a basket rig requires the sling to slide to exactly even (on) the load on both sides of the sling, similar to a pulley." If one side of the basket hitch is tighter than the other it will take a majority of the load. In this case, a 13K sling and a 19K buoy may sound like a recipe for an early failure, but there was a safety factor that should have prevented this accident.
