The picture shown represents the geographic location of a vessel and the radar presentation at the same time. Which statement is TRUE?

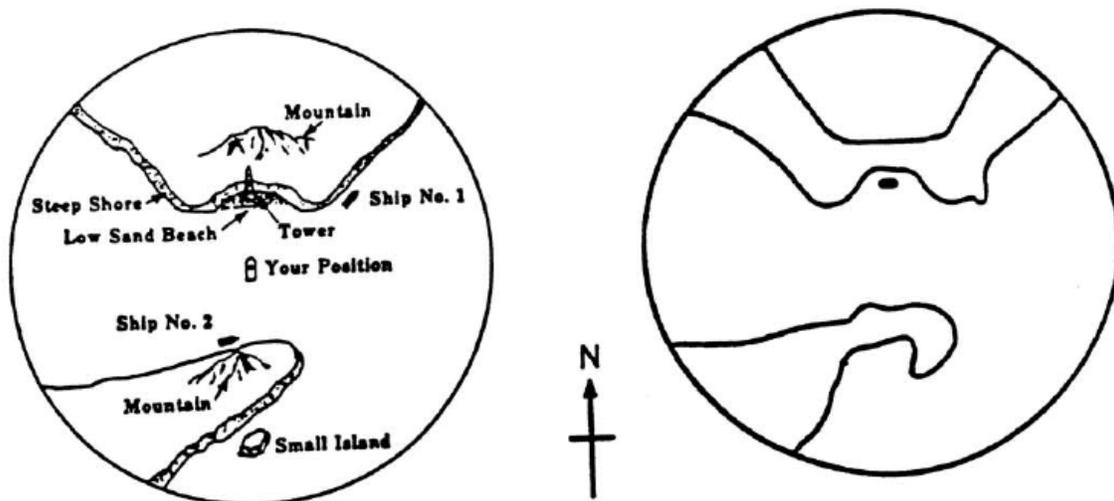
Incorrect. Ship No. 1 is combined with the landmass due to distortion caused by the radar's beam width. The distance between the ship and land is less than one-half the beam width therefore they appear as one object. The vessel is in line of sight and not within the "shadows" of the headland.

Incorrect. The small island is not detected due to the "shadow" created by the mountain directly astern of the vessel and is not a limitation caused by beam width. The radar paints the prominent mountain on the radar screen and no other targets that may lie in its "shadows".

Correct. The tangent bearing to the headland to the south-southeast is a left tangent bearing therefore the correction of one-half the beam width must be added. Fixes by tangent bearings is one of the least accurate methods of navigation. Tangent bearings are inaccurate due to beam width distortion and must be corrected using an estimate of one-half the horizontal beam width.

Incorrect. Ship No. 2 is painted as a "bump" in the landmass on the radar screen. This is due to a combination of beam width and pulse length distortion. Because of beam width distortion a shoreline that is straight or nearly straight will often appear as crescent shape on the radar screen with the distortion increasing as the beam width increases. Conversely, the ability of radar to separate targets close together at the same range is called resolution in range which is related primarily to pulse length.
