United States Coast Guard

SAFETY ALERT - LIFEJACKET SNAP HOOKS

May 5, 2004. Washington, DC

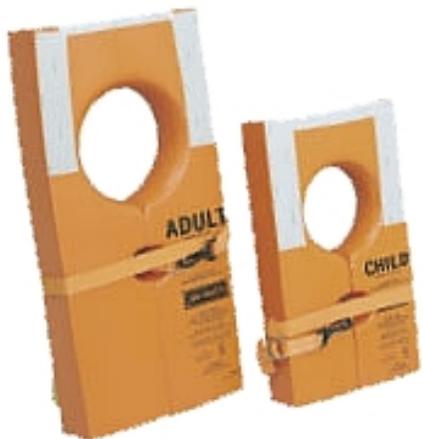
Model Nos.	US Coast Guard Approval Nos.
601 Adult	160.055/115/0
603 Child	160.055/116/0

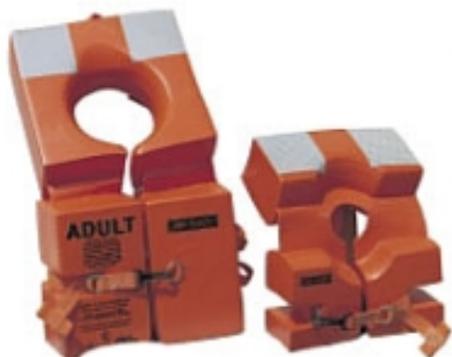
Model Nos.	US Coast Guard Approval Nos.
SO-1 Adult SOLAS	160.155/1/0
SO-2 Child SOLAS	160.155/2/0
