# Asleep at the Wheel

*A routine transit comes to a crashing halt.*

## Lessons Learned

**from Casualty Investigations**

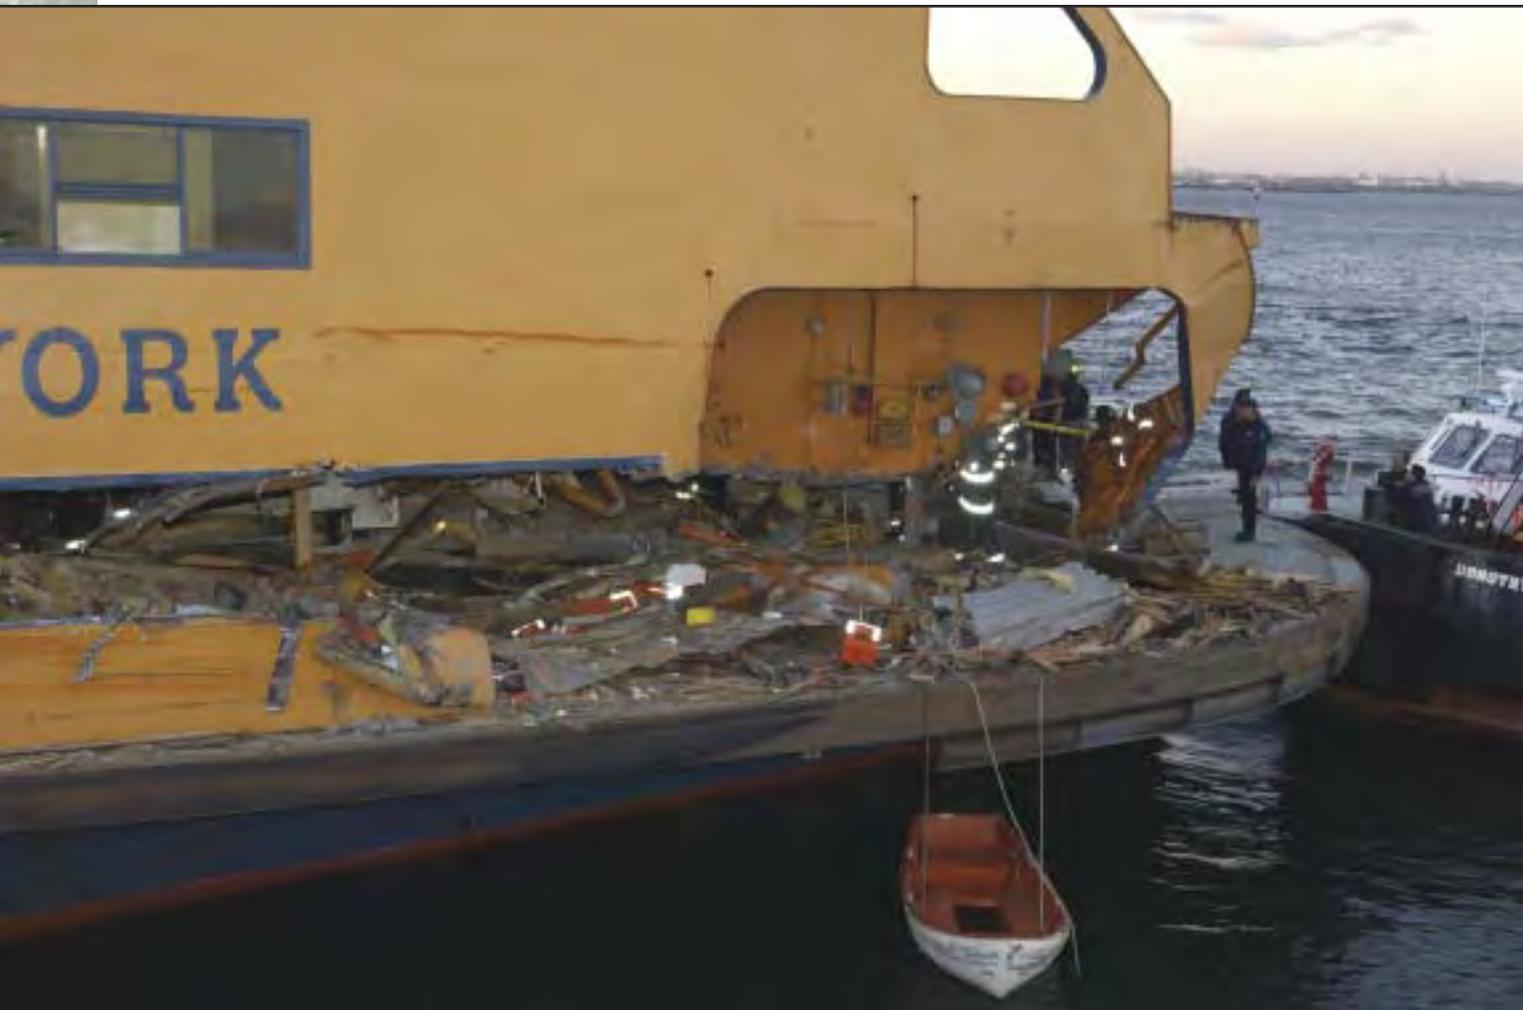
Post-accident view of the ferry. USCG photo.

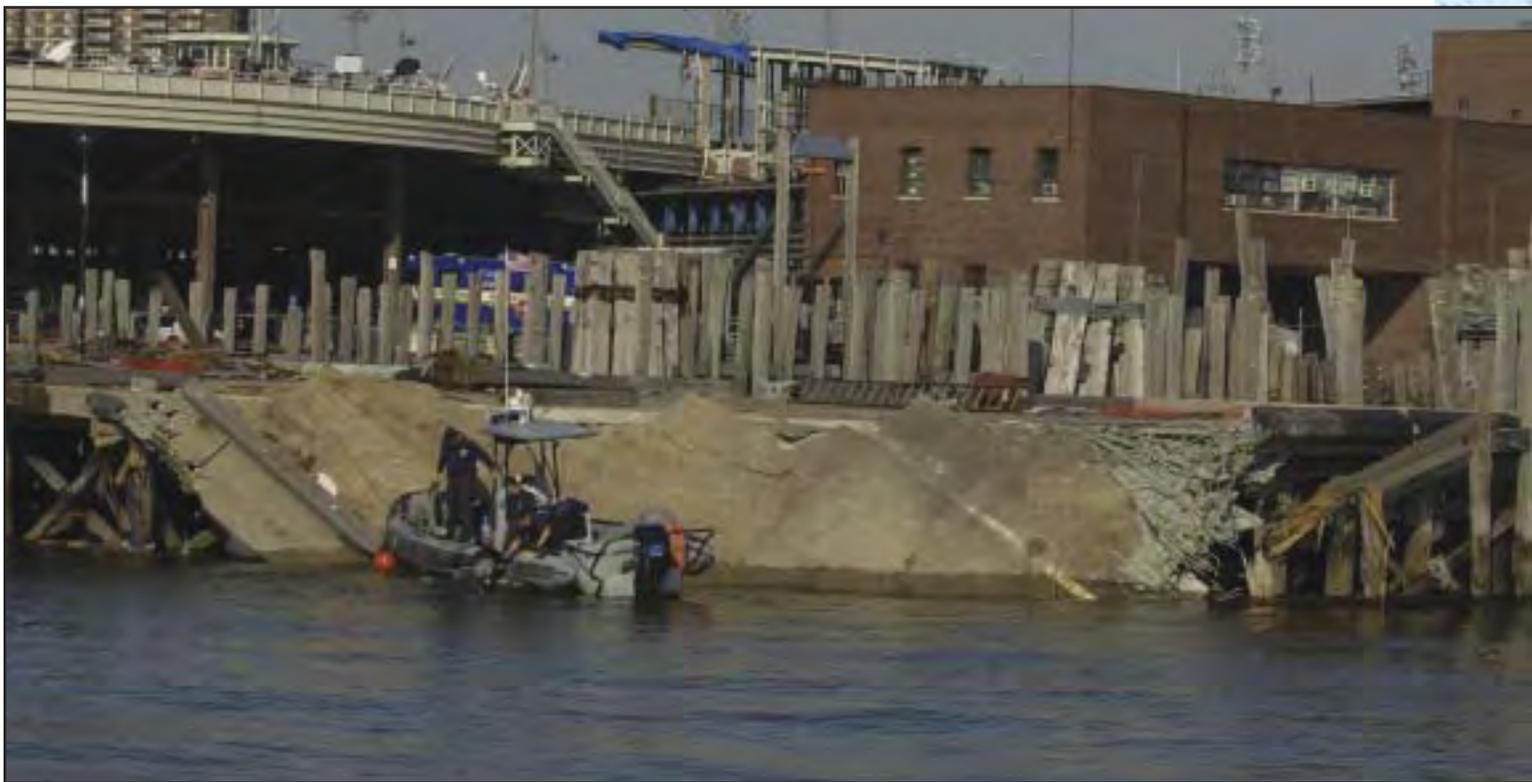
Approximately 1,500 square feet of the maintenance pier surface collapsed into the harbor. USCG photo.

The ferry had struck the concrete maintenance pier at an oblique angle and continued to move forward, allowing the concrete to tear a 210-foot-long gash into the main deck on the vessel's side. Approximately 1,500 square feet of the surface of pier B-1 collapsed into the harbor.

... Pier B1 ... is a pier approximately 1,000 feet long and 50 feet wide. The impact occurred on the southeast corner of the pier and approximately 1,500 square feet of the pier collapsed into the harbor. The damage to the pier did not appear to extend beyond the area of the collapsed section and the pilings that were sheared off."

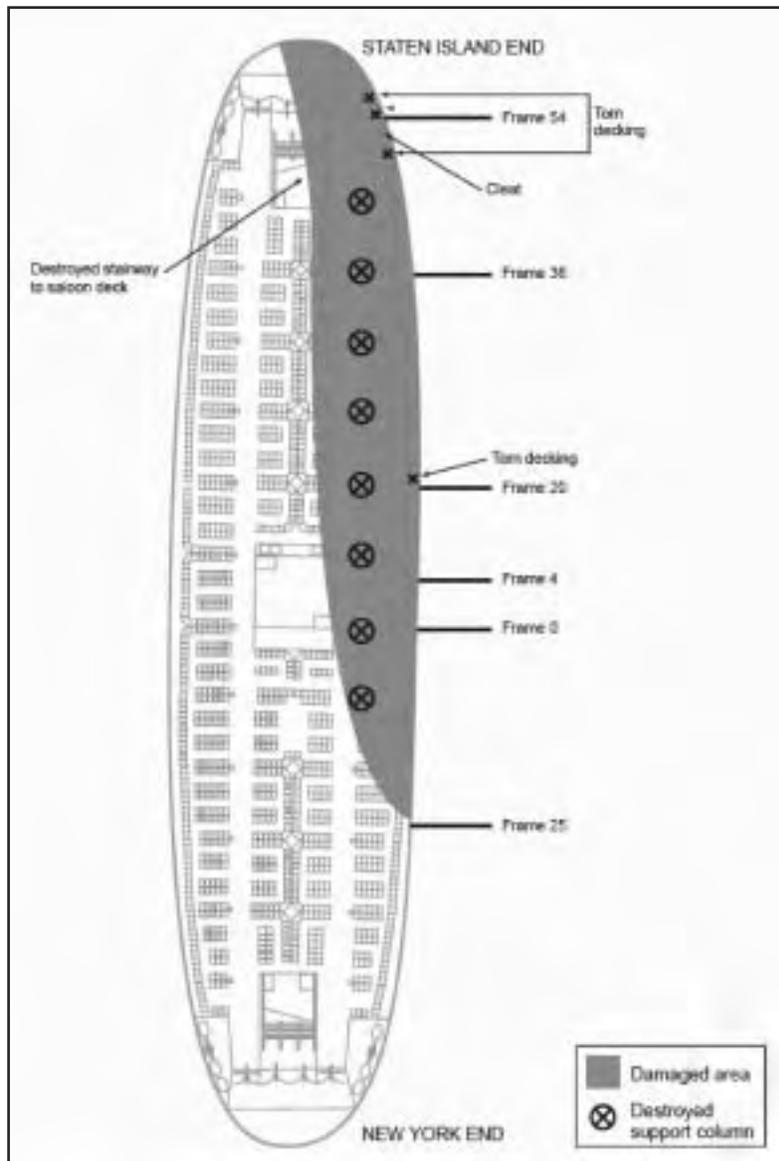
"The [vessel] allided with the southeast corner of the B-1 maintenance pier at the St. George ferry terminal on Staten Island. The [vessel] a made contact with the pier on the Staten Island end, New Jersey side of the vessel. The most significant damage was on the main deck of the vessel. The damage extended from the bow of the ferry from the outer edge on the New Jersey side to a point about 3 feet past the centerline and extended for approximately 210 feet towards the New York end of the vessel. ...

Plan view of the ferry's main deck highlighting damaged areas. Graphic courtesy of NTSB.

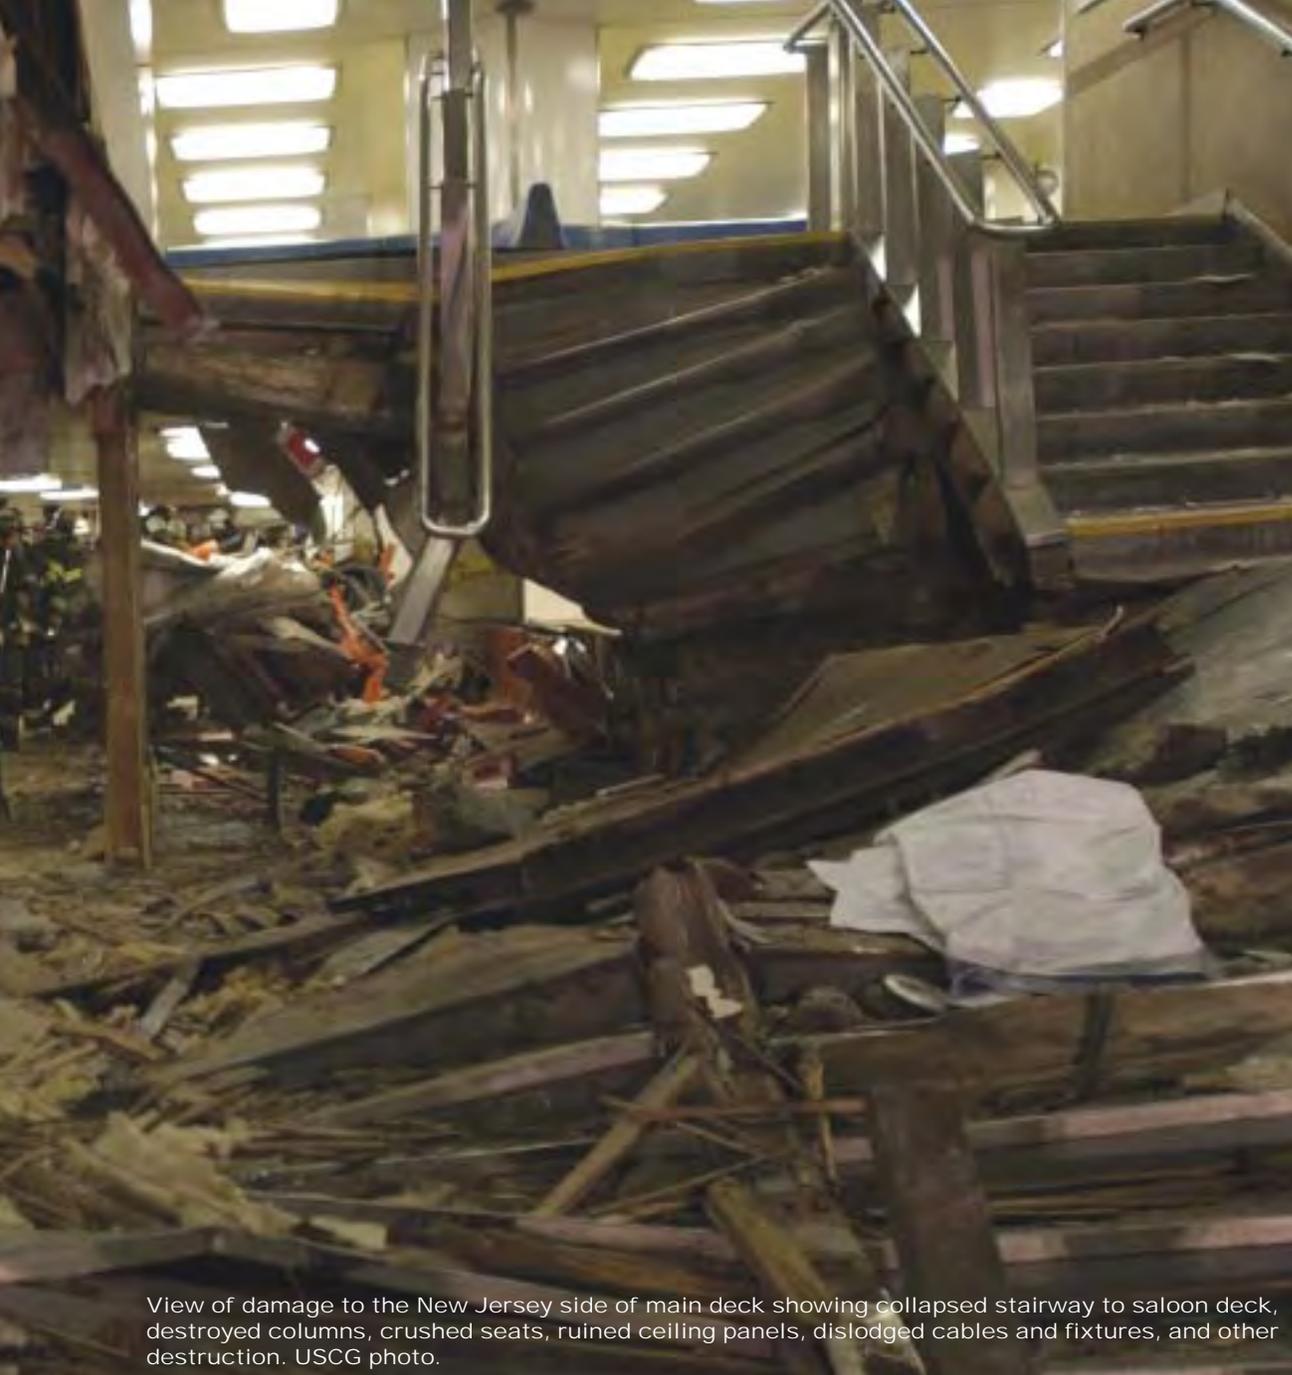
View of damage to the New Jersey side of main deck showing collapsed stairway to saloon deck, destroyed columns, crushed seats, ruined ceiling panels, dislodged cables and fixtures, and other destruction. USCG photo.
