# Proceedings

January-February 1993

Special issue on the hazardous cargo  
of the *Santa Clara I*

## Special issue on the hazardous cargo of the Santa Clara I

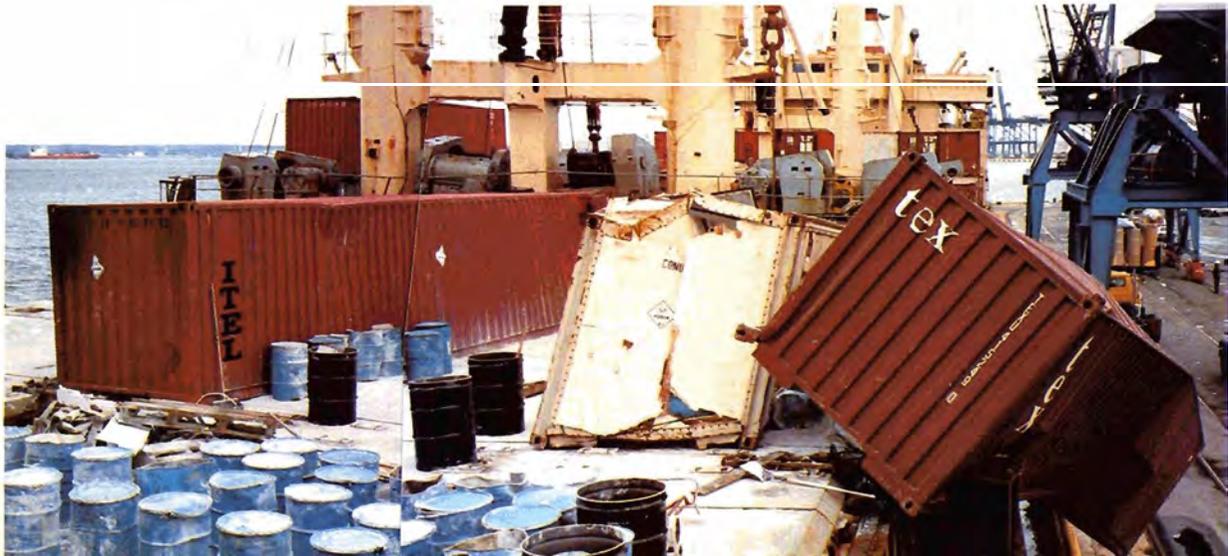
During the worst turbulence, the ship lost 21 containers up to 40 feet long and one piece of machinery overboard from stowage on the #2 hatch. Four of the lost containers were loaded with arsenic trioxide. Ten palletized drums of magnesium phosphide in the #1 upper tween deck broke loose and were breached.

*The Santa Clara I arrives in the port of Baltimore with a 40-foot container dangling off the side.*

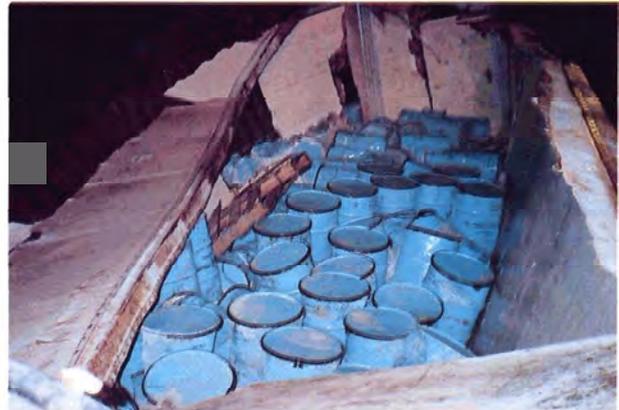
*Damaged fiberglass container with arsenic trioxide drums.*

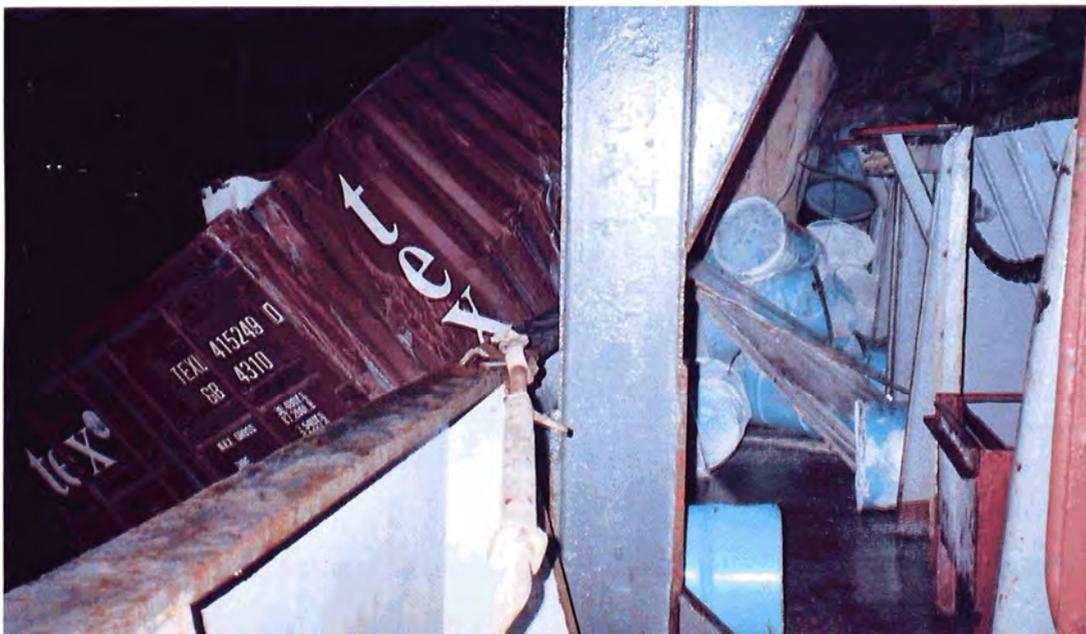
*View of container, debris and drums on deck looking forward.*

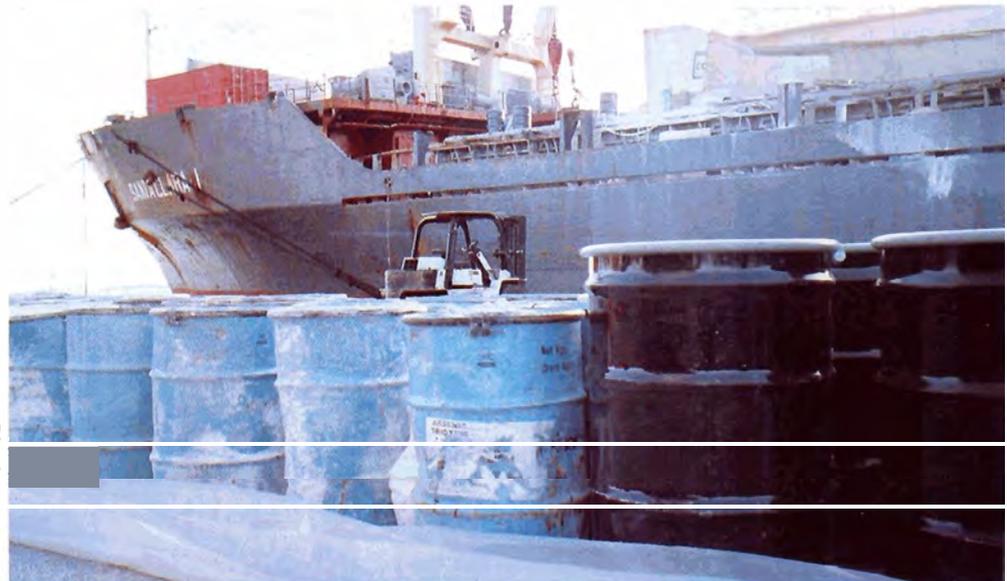
*Port side of the vessel after damaged general cargo container was removed. Arsenic trioxide drums and overpacks are in foreground.*

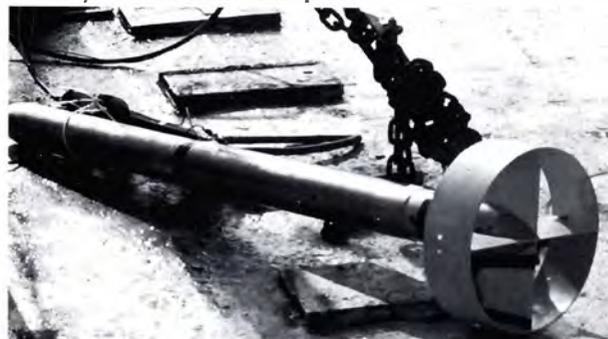
The EPA offered its research vessel *Peter W. Anderson* equipped with a remotely-operated vehicle (ROV) and an underwater sonar probe device known as a "fish" to positively identify the targets found by the air search. To ensure operational safety in the survey area, a moving buffer zone was imposed around the helicopters and surface vessels. Also, work by ship-borne sonar and ROV was limited to night time operations.

*The "fish" underwater sonar probe.*

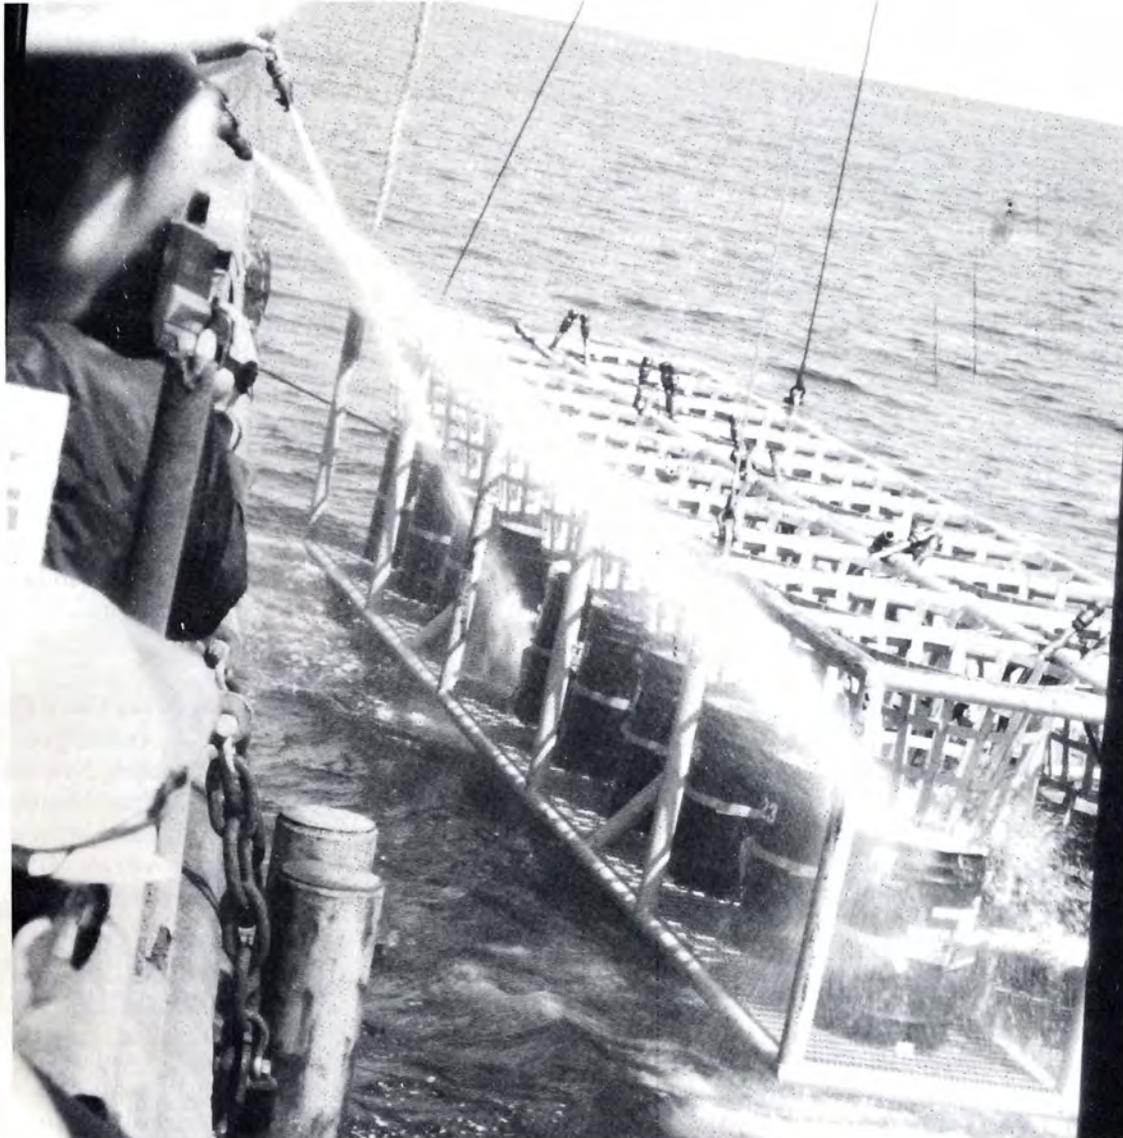
On April 14, the first rack of 20 filled overpack drums was raised to the surface by a barge crane and placed on deck. All racks were thoroughly decontaminated and tested to eliminate any possibility of exposure.

*Rack of arsenic trioxide drums in overpacks were washed thoroughly when brought to the surface.*

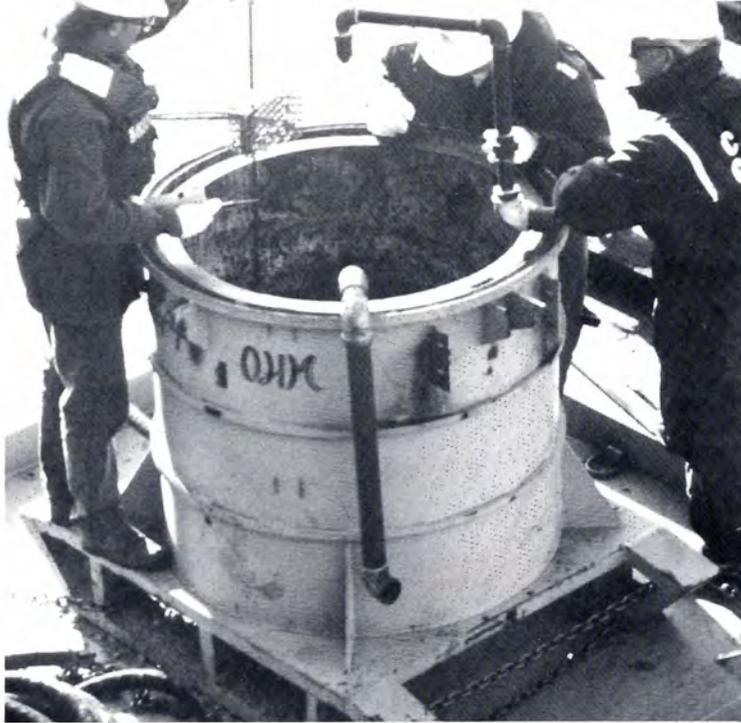
*Strike force members check the wet deactivator used to neutralize the magnesium phosphide.*

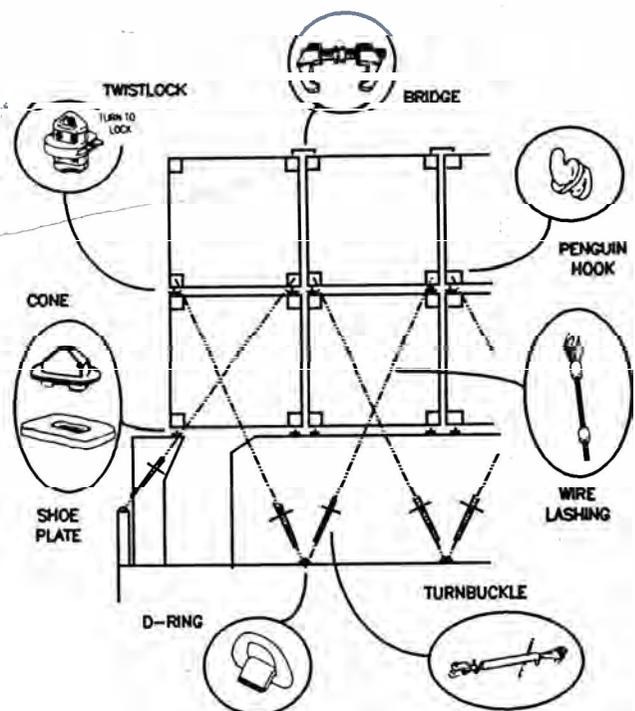
#### Stack-lash restraint system

The apparently well-designed system breaks down in the on board application by the crew. There was no Cargo Securing Manual on board, so stowage and securing was done based on experience. None of the crew members had had specific formal training in the subject. Upon inspection, there was an increasing mismatch between parts and improvised installations.

**Mechanical weaknesses which may have contributed directly to loss of deck cargo --**

- A) *Inadequate number of wire lashings to overcome static and dynamic loads on the container stow;*
- B) *mismatched and improvised lashing gear; (The most obvious irregularities were the use of an incorrect type of turnbuckle for wire lashings and the unconventional use of penguin hooks with wire rope lashings.)*

- G) *deficient lashing of the machinery on deck, minimizing restraints against transverse sliding;*
- H) *insufficient number of clips on machinery lashing; and*

- I) *unsecured hatch covers, permitting small lateral movements of entire stow and slackening of the securing system.*

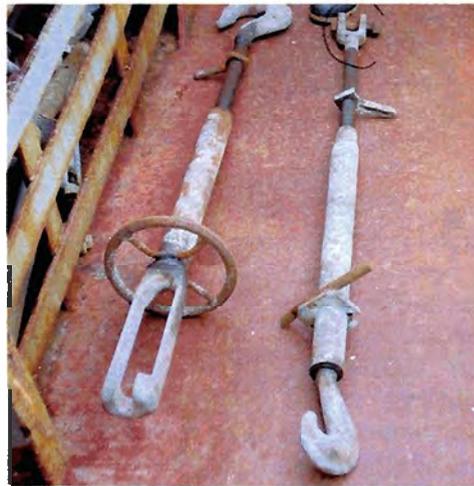
Two types of turnbuckles -- cylindrical claw on left and rigid hook on right.

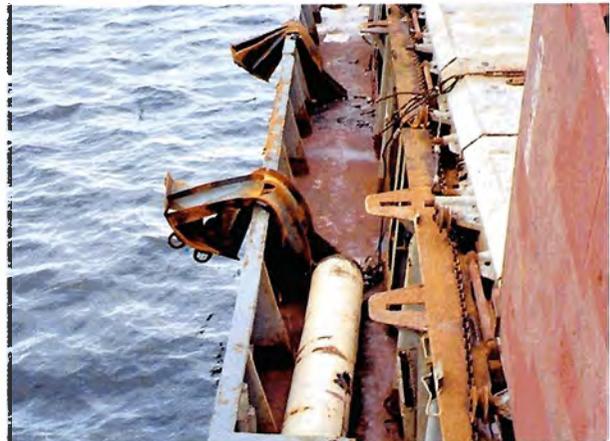
Failed deck pedestals on Santa Clara I.
