Report No. CG-D-02-07

An Evaluation of the Potential Failure Modes for Gaseous Agent Fire Extinguishing Systems Installed within the Protected Space

FINAL REPORT

February 2007

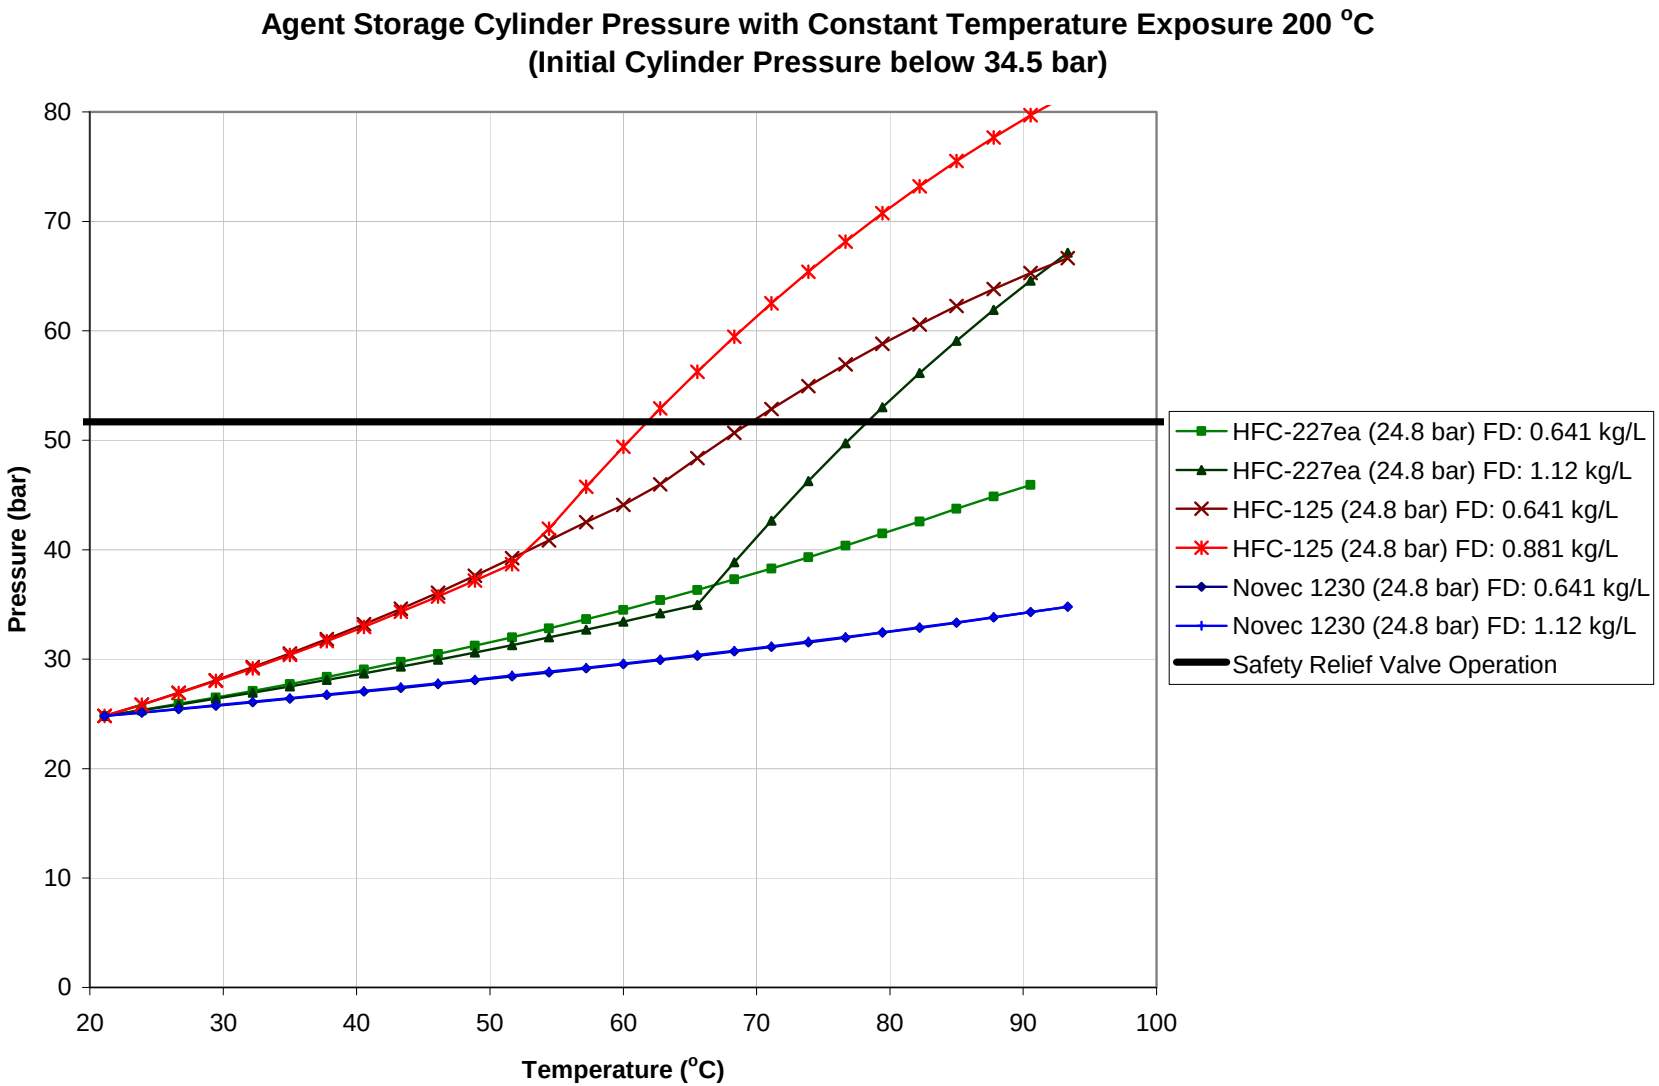
Figure 6. Agent Cylinder Pressure versus Temperature (Low Pressure Cylinders).

The temperatures of the agent cylinders corresponding to the operation of the safety relief valve are a function of the agent, cylinder fill density, and the degree of nitrogen pressurization (where applicable). Figures 6 and 7 give the pressure curves calculated utilizing the Peng Robinson Equation of State with Geometric Mixing Rules [Reid 1987, Henley 1981] for agents HFC-227each (FM-200 and FE-227), HFC-125 (FE-25), FK-5-1-12 (Novec-1230), carbon dioxide (IG-001) and IG-541 (Inergen) superimposed over the approximate safety relief valve operating

pressures. As can be seen from these figures, the temperature at which the safety relief valve would be expected to operate ranges from a low of 63 ^{o}C to a point where the 93 ^{o}C maximum temperature included in these figures is not close to causing the relief valve to operate.

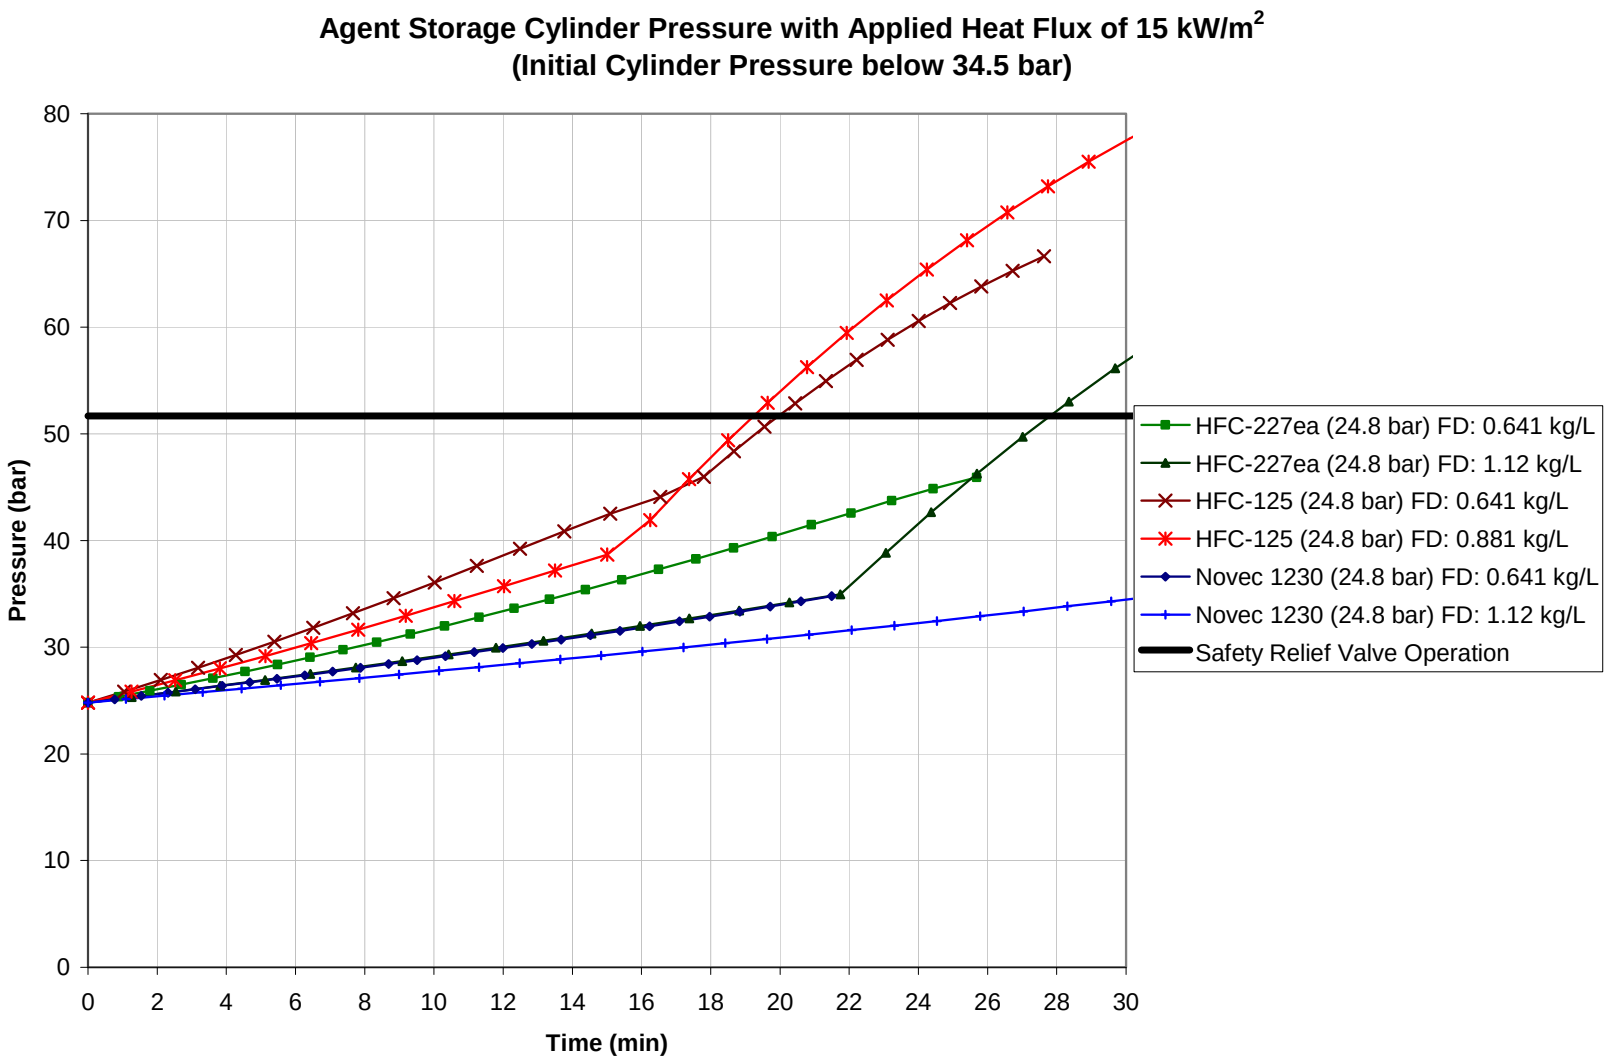
Figure 8. Agent Cylinder Pressure versus Time (Low Pressure Cylinders).

In a majority of the cases, the breakdown of the system was caused by the failure of a plastic or rubber component or subcomponent. For example, the O-rings in the halocarbon cylinder valves, the gasket in the Victaulic coupling and the outer shell of the flex hoses were vulnerable to these types of exposures. Smaller parts with less mass to distribute the heat and parts with exposed rubber tended to fail the quickest. Rubber flex hoses were particularly susceptible to failure due to the large area of rubber exposed to the heat source and the ignition of the outer jacket during the test.

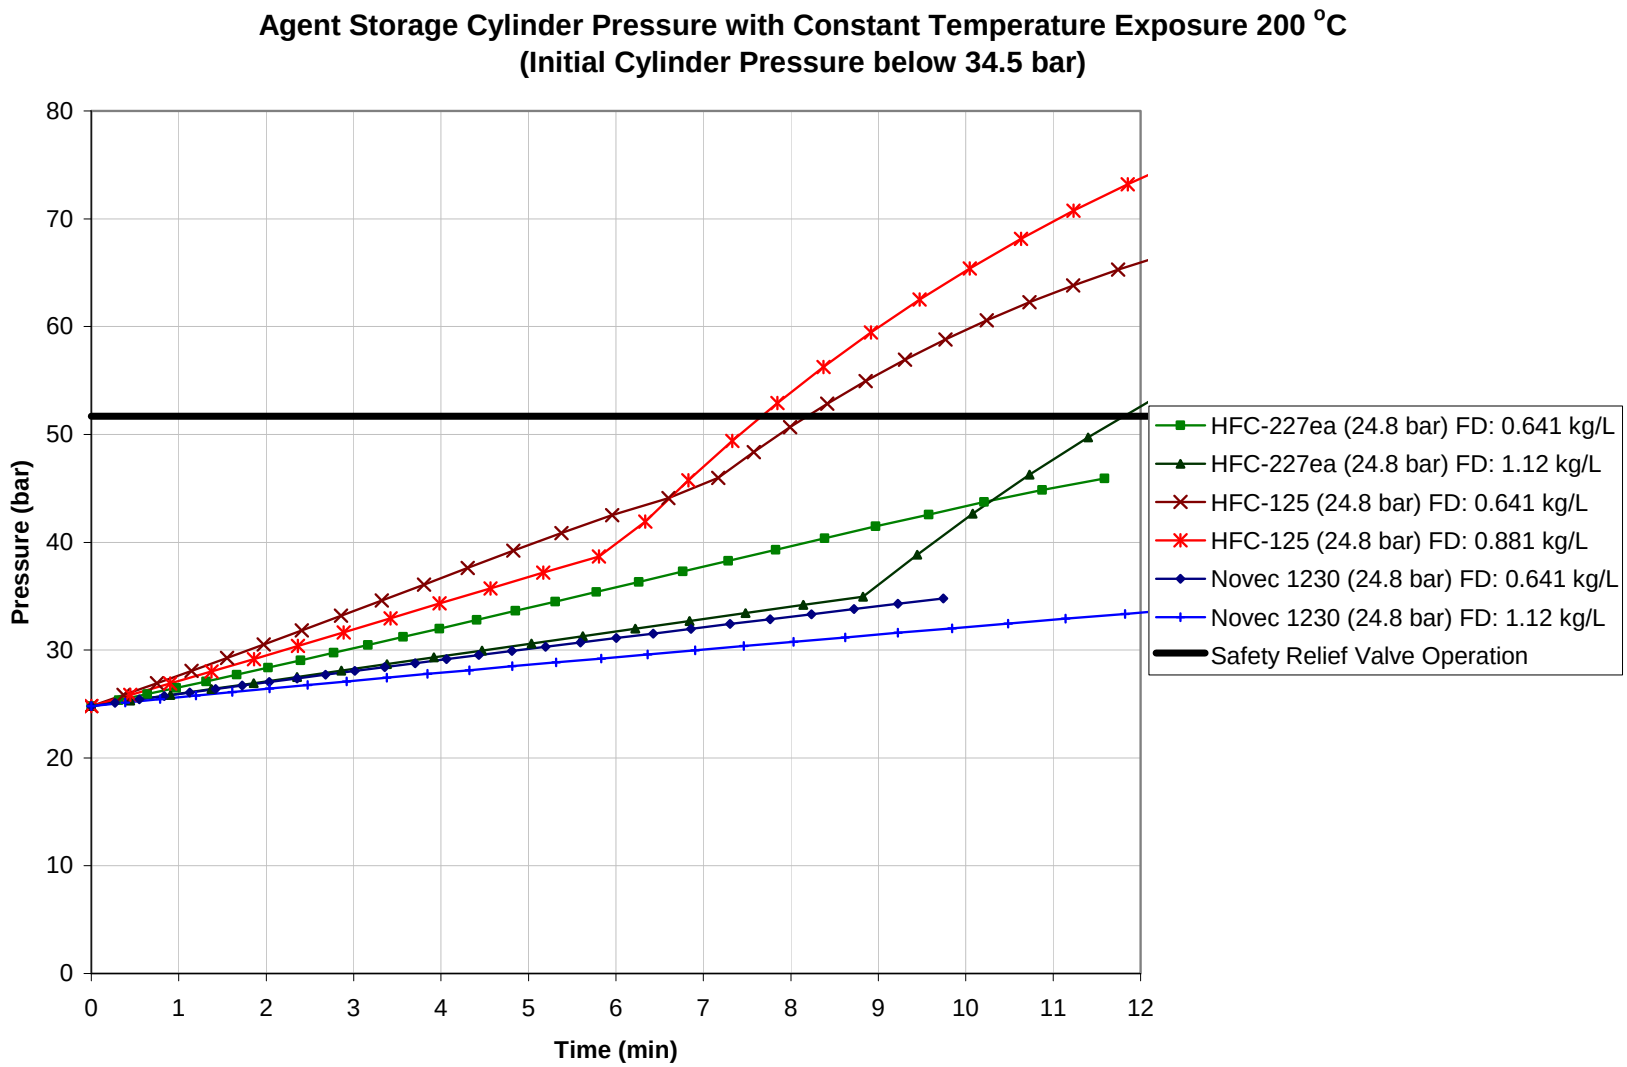
Figure 10. Cylinder Pressure with Constant Temperature Exposure of 200 °C (Low Pressure Cylinders).

The second heat transfer model utilizes a constant temperature exposure and estimates the cylinder response if immersed in the hot smoke layer formed within the space. This simplistic model utilizes a constant temperature exposure of 200 ^oC and a convective heat transfer coefficient of 59.6 $W/m^2\ ^oC$. The estimated times for safety relief valve operation under this scenario are given Figures 10 and 11. As can be seen from these figures, the time to failure is much lower in this analysis with the first cylinder burst disk rupturing at approximately 7.5 minutes.

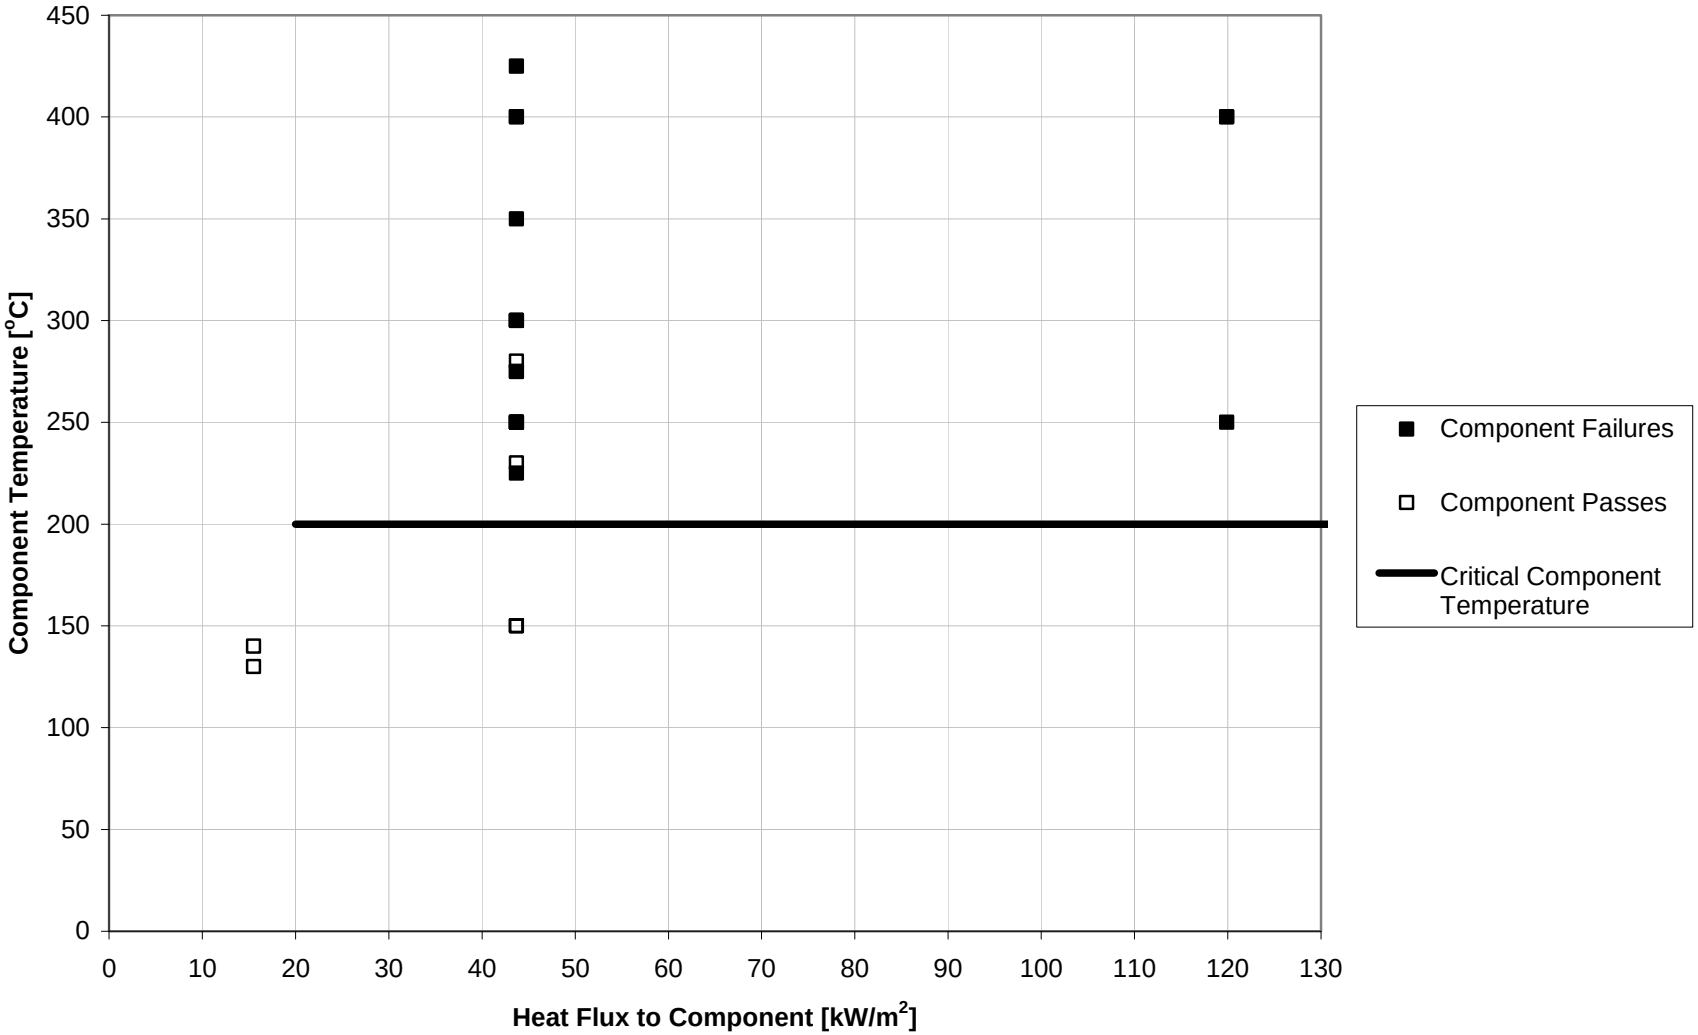
Figure 12. Critical Component Temperature.

Since the rubber components and/or subcomponents were observed to be the weakest link in the suppression system, the heat fluxes capable of damaging rubber materials were researched. Since the type of rubber used in the various components is unknown and probably varies from component to component and/or from manufacturer to manufacturer, the critical flux for several types of rubber (ethylene propylene, styrene-butadiene and chloroprene) were averaged to develop a "generic" critical value of 15 kW/m^2 [Tewarson, 2002].

In order to extrapolate these test results to a range of fire scenarios, a critical energy dosage was first determined. This critical energy dosage represents the point at which the combination of the exposure and duration was adequate to cause the component to fail. A first order approximation of the energy dosage is the product of the exposure and the duration (for exposures above the critical 15 kW/m^2 value). The exposures and energy dosages that resulted in component failure for these tests are shown in Figures 12 and 13. As shown in this figure, the critical energy dosage appears to fall in the range from 9-15 MJ/m^2 independent of exposure. More specifically, many components failed at this dosage for both the 43.4 and 119.9 kW/m^2 exposures. It should be noted that there is little if any data on Figures 12 and 13 at or near the critical exposure of 15 kW/m^2

The cylinder venting analysis suggests that the critical energy dosage for a radiant exposure is on the order of 16.2 MJ/m^2 but only about 6.8 MJ/m^2 for the convective (hot gas) exposure. As a result, the rubber components would fail prior to the venting of the cylinder when the exposure is caused by a radiant flux. However, for the hot gas exposure (immersion of the agent cylinder in the hot gas layer), the critical energy dosage required to cause the cylinder to vent its contents would be less than the critical value for the rubber components.

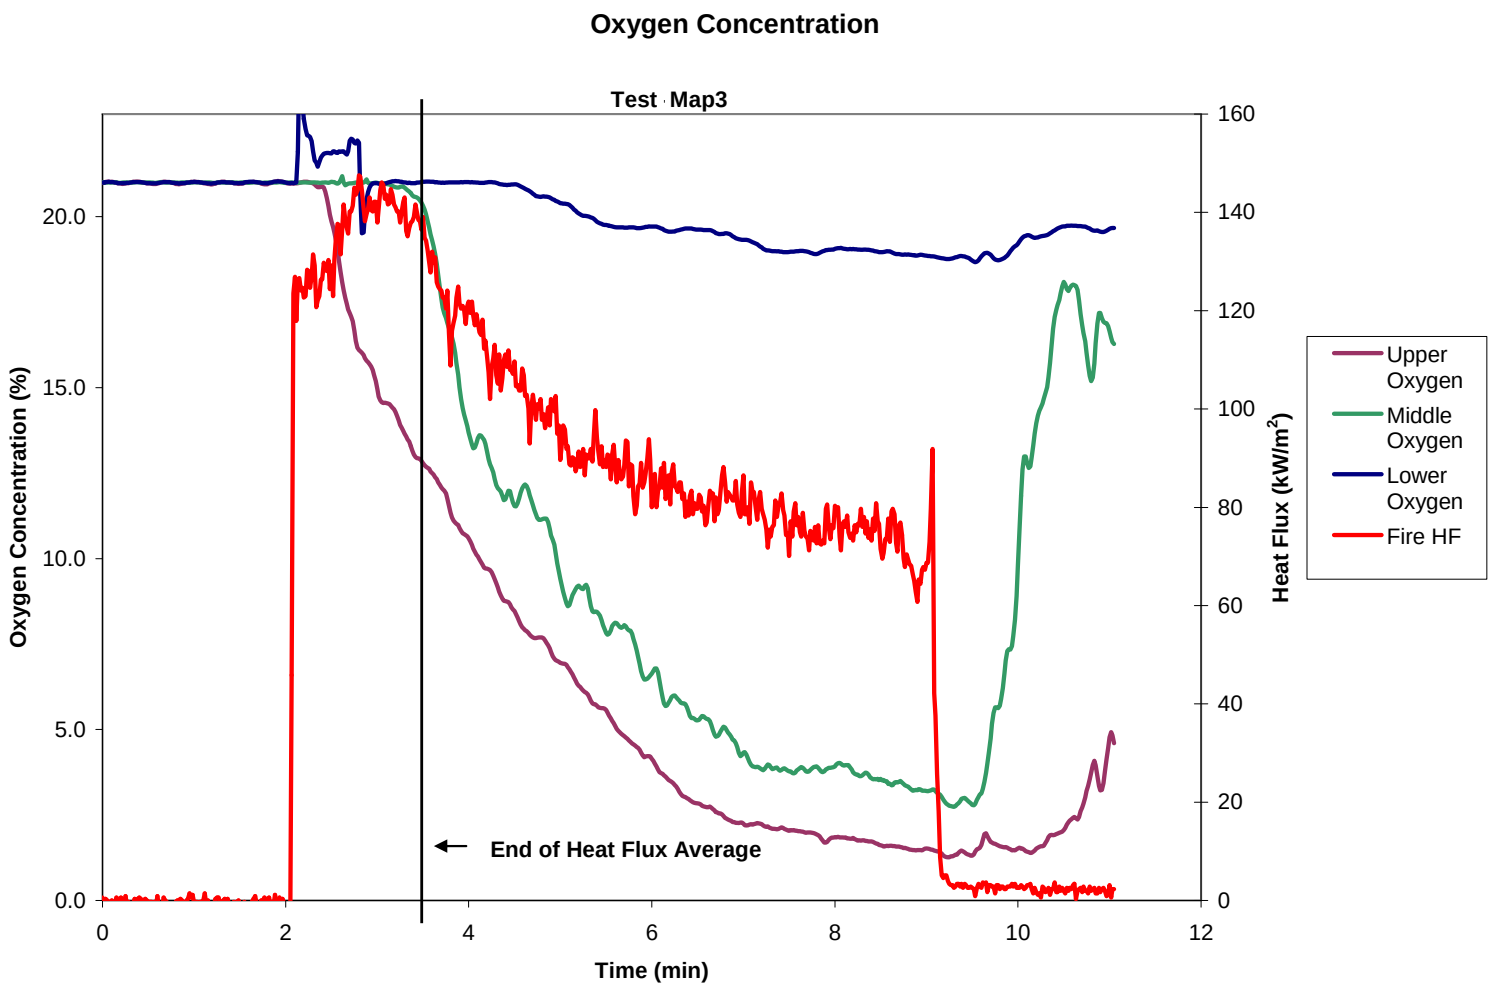
Figure 14. Oxygen Concentration and Heat Flux Plot for the 3.0 MW Fire.

The test conducted with the 3.0 MW spray fire was terminated seven minutes after ignition. Despite limiting the test to seven minutes, the heat fluxes measurements indicate that the diminished oxygen concentration in the space had a significant affect on the fire prior to securing the spray. To ensure that the average heat fluxes were calculated during the time period when the fire was at maximum capacity, the oxygen concentration measured at the same approximate elevation as the spray was analyzed. The time when the middle oxygen analyzer showed a significant drop in concentration was used as the final point in the heat flux average calculation. For the 3.0 MW spray fire, the middle oxygen concentration dropped off 1.5 minutes into the spray fire. The drop in concentration and the associated heat flux are shown in Figure 14.

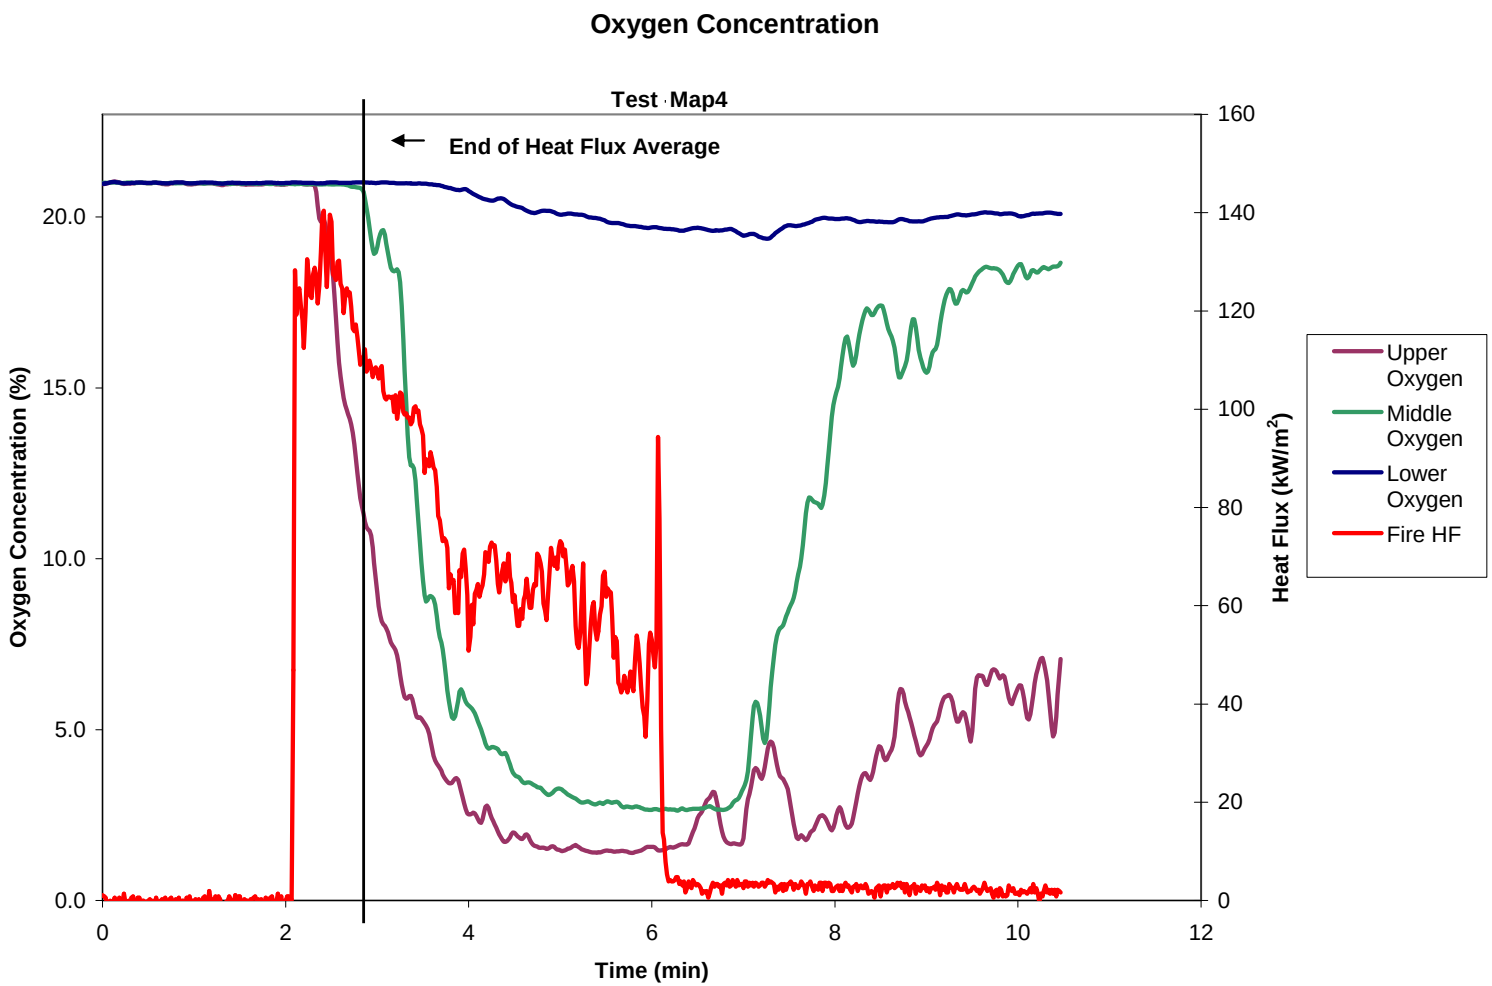
Figure 15. Oxygen Concentration and Heat Flux Plot for the 6.0 MW Fire.

The test conducted with the 6.0 MW spray fire had similar issues with the diminishing oxygen concentration as the 3.0 MW fire. The 6.0 MW spray fire was secured four minutes into the test. Once again, the middle oxygen concentration was used to determine the time period for calculating the average heat fluxes. For the 6.0 MW fire, the data was averaged starting 15 seconds after ignition for a period of 35 seconds (ending 50 seconds after the start of the spray fire). A graph of the oxygen concentration and heat flux is shown in Figure 15.

The heat fluxes measured in the hot layer only exceeded the critical value of 15 kW/m^2 (the flux required to melt most plastic materials) for very large fires (greater than 6 kW/m^3). However, the temperatures in the hot layer exceeded 200°C for most of the fires which would be adequate to cause an agent cylinder to vent its contents.

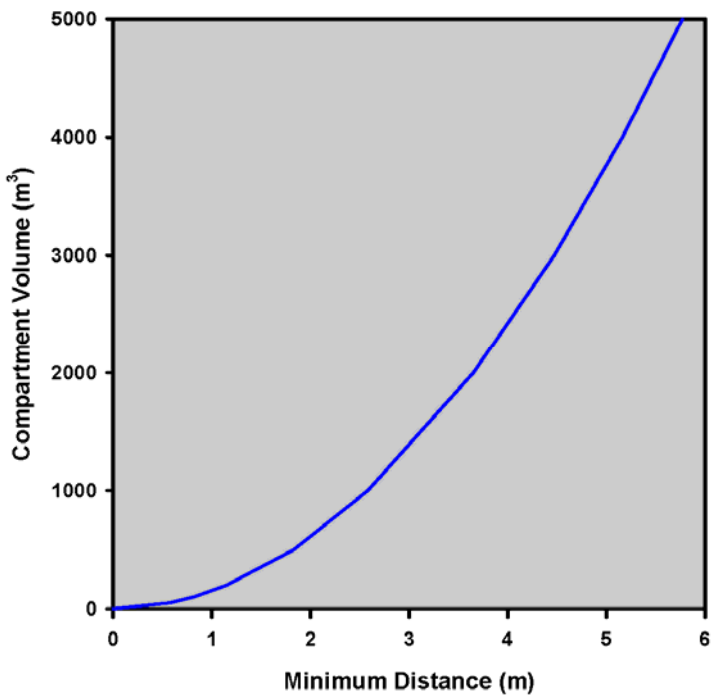
Figure 16. Minimum Safe Distance Between a Gaseous Agent Cylinder and a Fire as a Function of Compartment Volume.

Equation 2 was used to define the minimum safe distance between the fire and the cylinder (not the minimum separation distance), by setting $\dot{q}''$ equal to 15 kW/m^2 (the critical exposure for most components containing plastic materials) and solving for distance, R, as a function of compartment volume. The results of these calculations are shown graphically in Figure 16.

As shown in Figure 16, the minimum safe distance between the fire and the cylinder increases with compartmental volume (as one would expect). This increase is related to the increased amount of oxygen available for combustion in the larger machinery spaces (i.e., the size of the fire required to consume the oxygen in ten minutes is larger for the larger spaces).

The minimum separation distance between cylinders is determined by multiplying the minimum safe distance by two. More specifically, the cylinders need to be spaced such that a fire located between two cylinders can only damage one of the cylinders.

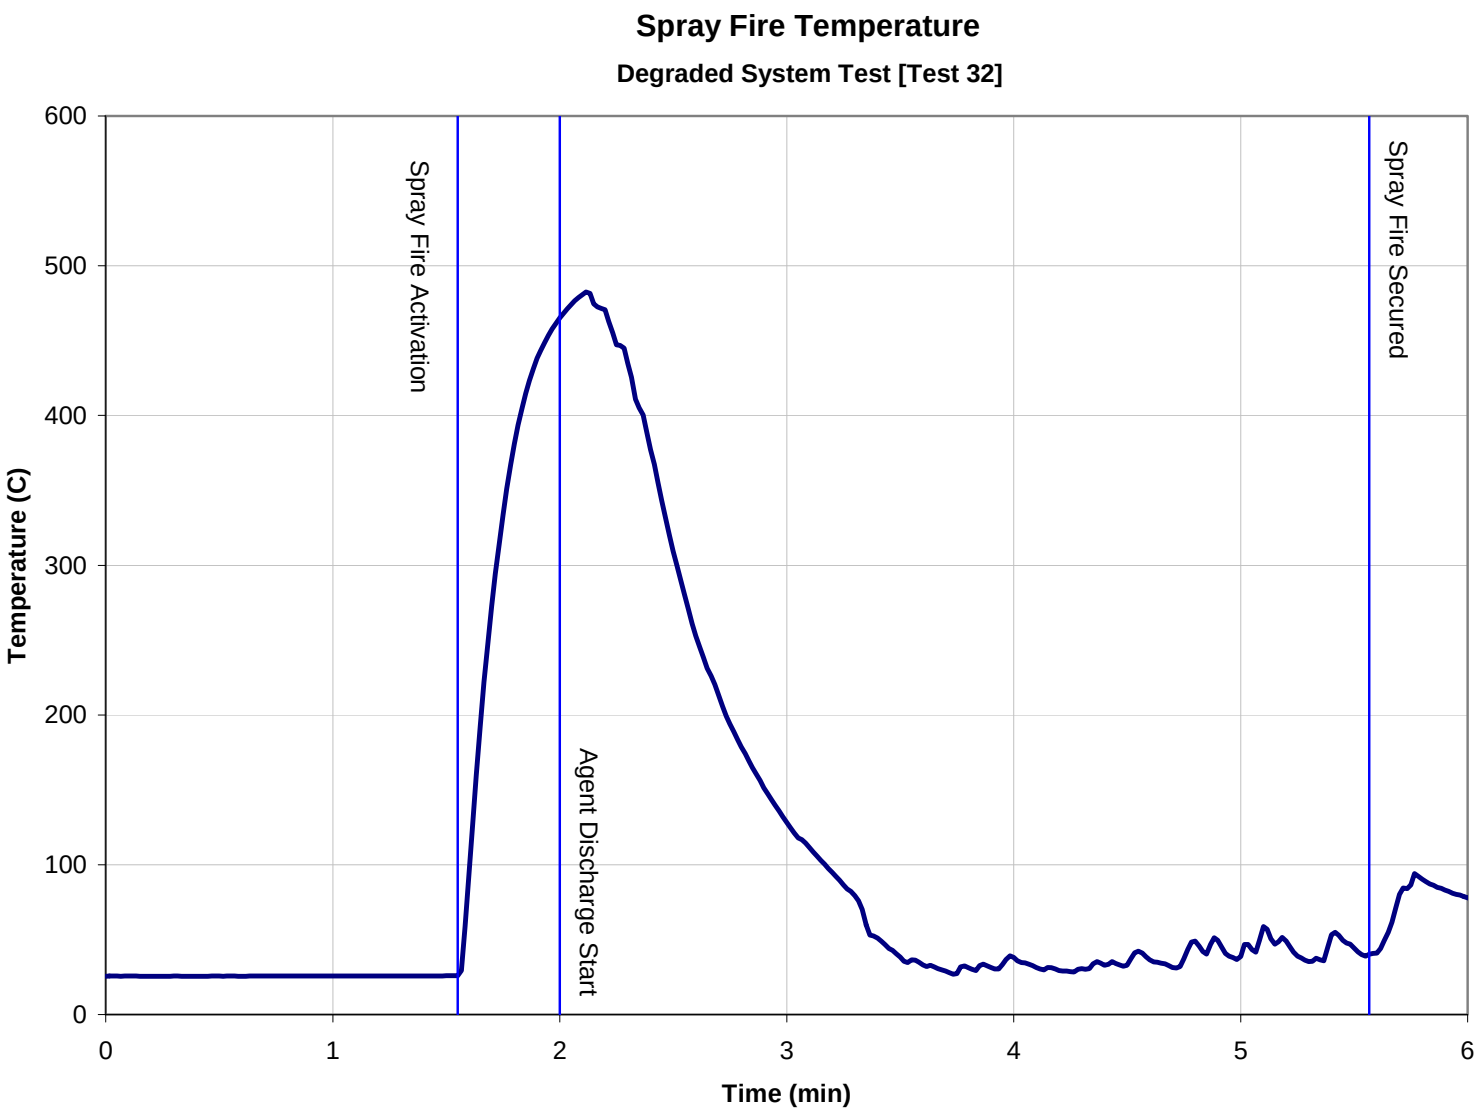
Figure 17. Degraded System Test Fire Temperature Measurements.

A degraded system test was conducted to evaluate the extinguishing capabilities of a damaged system (one that is only capable of discharging the minimum extinguishing concentration of agent (cup burner concentration) into the space). The degraded system was tested against a 1.1 MW heptane spray fire located on the side of the diesel engine mockup under the obstruction plate (MSC/Circ. 848 Test Fire 3F). The system was unable to extinguish the fire during this test.

The spray fire temperature, the system operating pressures and the HFC-227ea concentration are shown in Figures 17 through 19. As shown in Figure 17, the system was able to quickly knockdown the fire but was unable to completely extinguish it. The system discharge time of 10.8 seconds and average nozzle pressure of 6.2 bars shown in Figure 18 are within the approved system design limits. The measured agent concentration, given in Figure 19, shows an initial peak near the cup burner value followed by a steady decline in concentration as the agent was consumed by the fire.

These results of this test demonstrate that the loss of an agent cylinder could render the system ineffective (not able to extinguish the fire). As a result, the system needs to be designed and installed in a manner to ensure that the design concentration of agent (1.3 times the minimum extinguishing concentration) is available at the time the system is activated.
