UNITED STATES COAST GUARD

INVESTIGATION INTO THE CIRCUMSTANCES SURROUNDING THE SINKING OF THE UNINSPECTED FISH PROCESSING VESSEL

ALASKA RANGER

OFFICIAL NUMBER 550138, IN THE BERING SEA ON 23 MARCH 2008 WITH THE LOSS OF FOUR LIVES AND ONE PERSON MISSING AND PRESUMED DEAD

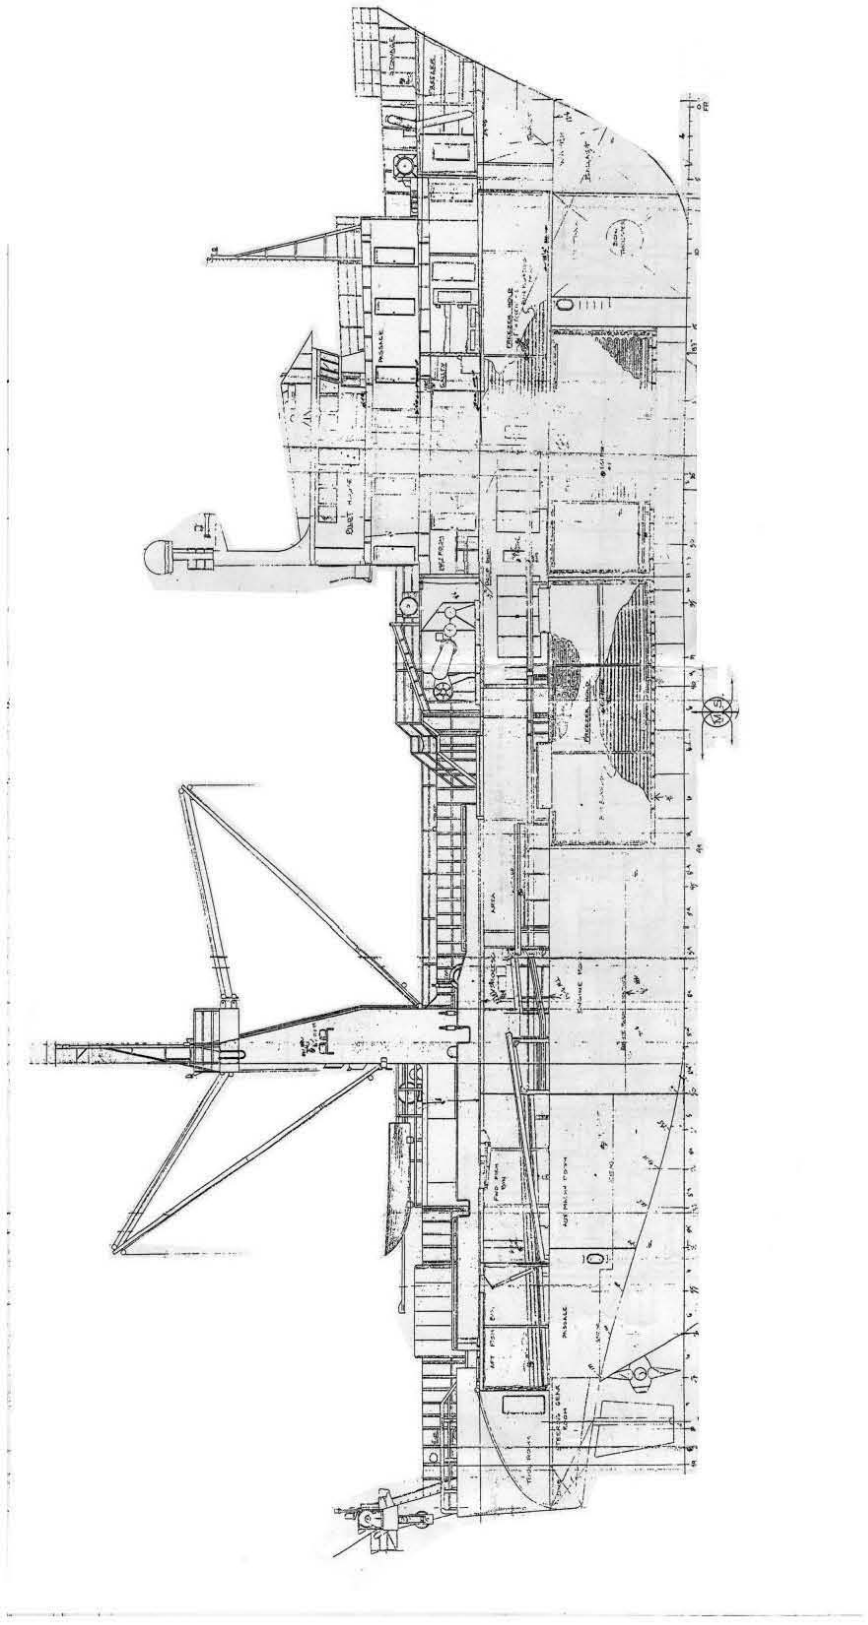
Figure 3: Inboard Profile of the ALASKA RANGER

The design and arrangement of the ALASKA RANGER was typical of an offshore supply vessel converted to a fish trawler/processor. An all steel vessel with three complete decks, pilot house and raised foc'sle, the ALASKA RANGER had a raked stem, straight sides and a transom stern. The decks had pronounced sheer forward and the deck house was located forward of amidships with hatches from the open trawl deck to the fish bin and aft holds.

During the 1989 conversion, the vessel was razed to the main deck and reconstructed from that point upwards. The full length of the main deck was enclosed providing space for the factory, or processing space. Below the main deck the double bottoms were reportedly raised to 4 feet above the baseline, and the former mud tanks were replaced with fish holds. In addition, the exhaust stacks, originally located forward, were moved aft directly over the engine room. The vessel was outfitted with two gantries for fishing operations; one was amidships, and the other was over the stern ramp.

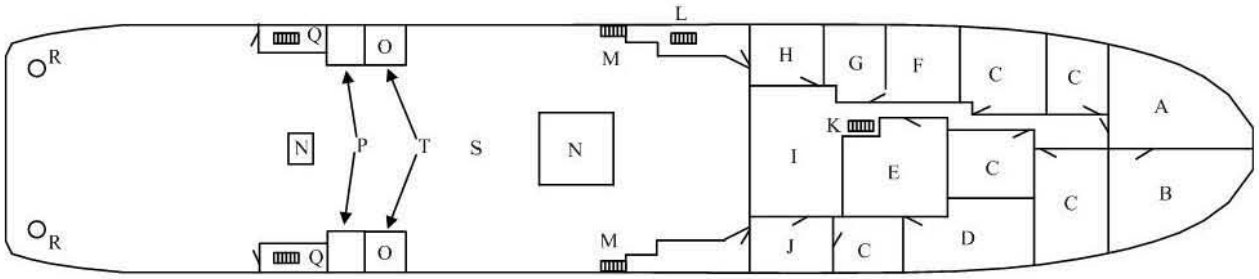
Figure 7: Shelter Deck

Above the main deck was the shelter deck. The shelter deck was comprised of the house and the trawl deck. The trawl deck was bounded by bulwarks six feet high from the house to the stacks and eight feet high from the stacks to the stern ramp. Large freeing ports were spaced along the length of the bulwarks. Inboard of the bulwarks were fish bulwarks that extended forward from the stern ramp towards the house. These fish bulwarks were 39 inches high with cutouts for personnel access. The trawl deck had two watertight hatches. The aft hatch was used to drop catch into the fish bin, and the forward hatch, which led into the factory, was used to offload processed catch.

The house was accessed by port and starboard doors leading to interior passageways and contained the crew's mess area, the galley, berthing areas and storage compartments.

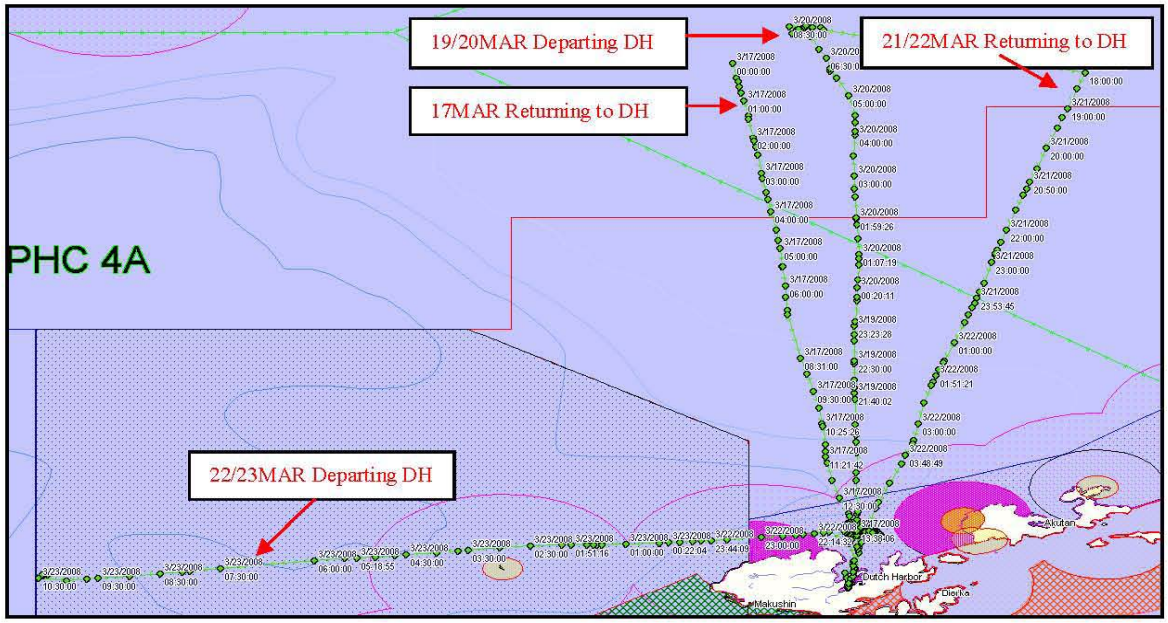
Figure 10: Vessel Trackline for 17 to 23 March (Provided by NMFS and based on VMS data)

The ALASKA RANGER got underway at 1210 Alaska Daylight Savings Time (all times ADT) on 22 March and began heading nearly due west with the Captain and the Day Engineer on watch. The vessel drafts were approximately 16.2 feet forward and 19.5 feet aft. At the stern, the main deck and overhead of the rudder room were approximately 1 foot below the waterline. Figure 10 shows the transit north from Dutch Harbor on 19 March and the return trip south on 22 March, as well as the trackline going nearly due west from Dutch harbor on its last voyage.

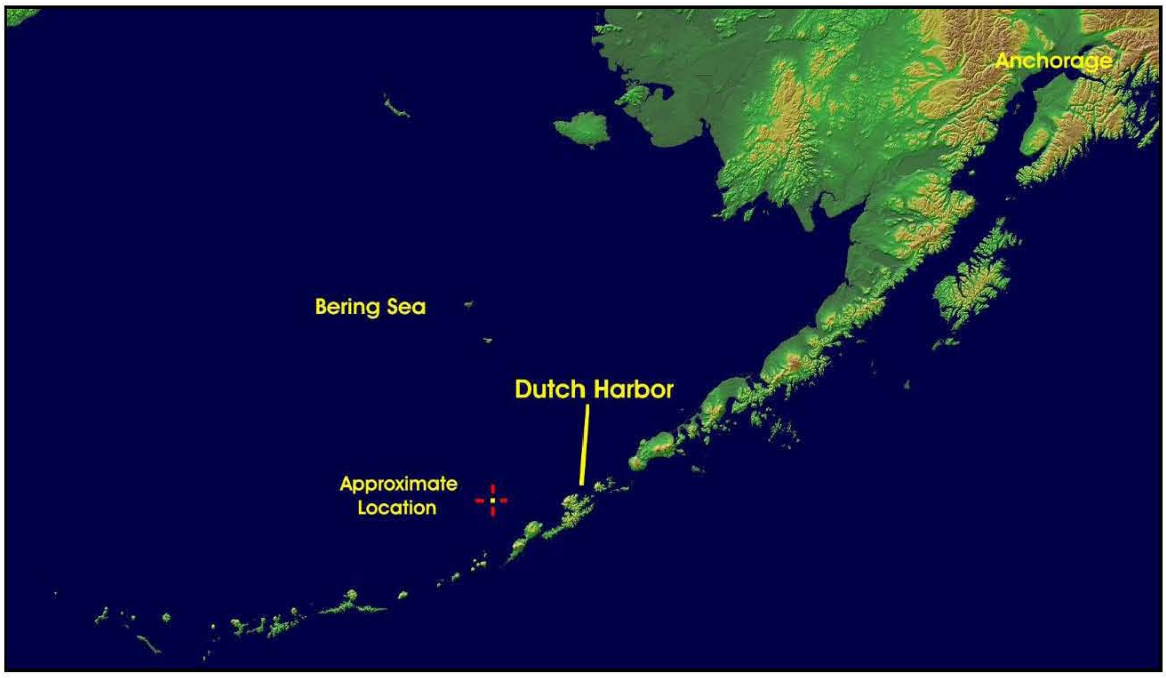
Figure 11: Reported position of the ALASKA RANGER at the time of the casualty.

The Night Engineer testified that he was in the engine room making a logbook entry when the rudder room high water bilge alarm sounded. He went to the alarm panel in the forward end of the engine room, silenced the alarm, and then proceeded aft through the engine room and hydraulics room to the rudder room to investigate. The Night Engineer testified that as soon as he looked into the space, he saw a significant amount of water rapidly coming toward him, and closed and dogged the door. Using a phone in the hydraulics room, the Night Engineer called the Mate on watch in the pilot house, reported major flooding in the rudder room, and told the Mate to sound the general alarm. The Night Engineer then called the Chief Engineer and informed him of the flooding.

In the hours preceding the alarm, and during the time that elapsed before the crew abandoned ship, no one heard any unusual noises or sounds. Similarly, no one felt any strange vibrations. With the exception of sudden significant flooding, there were no obvious indications of a collision, explosion, or other catastrophic failure.

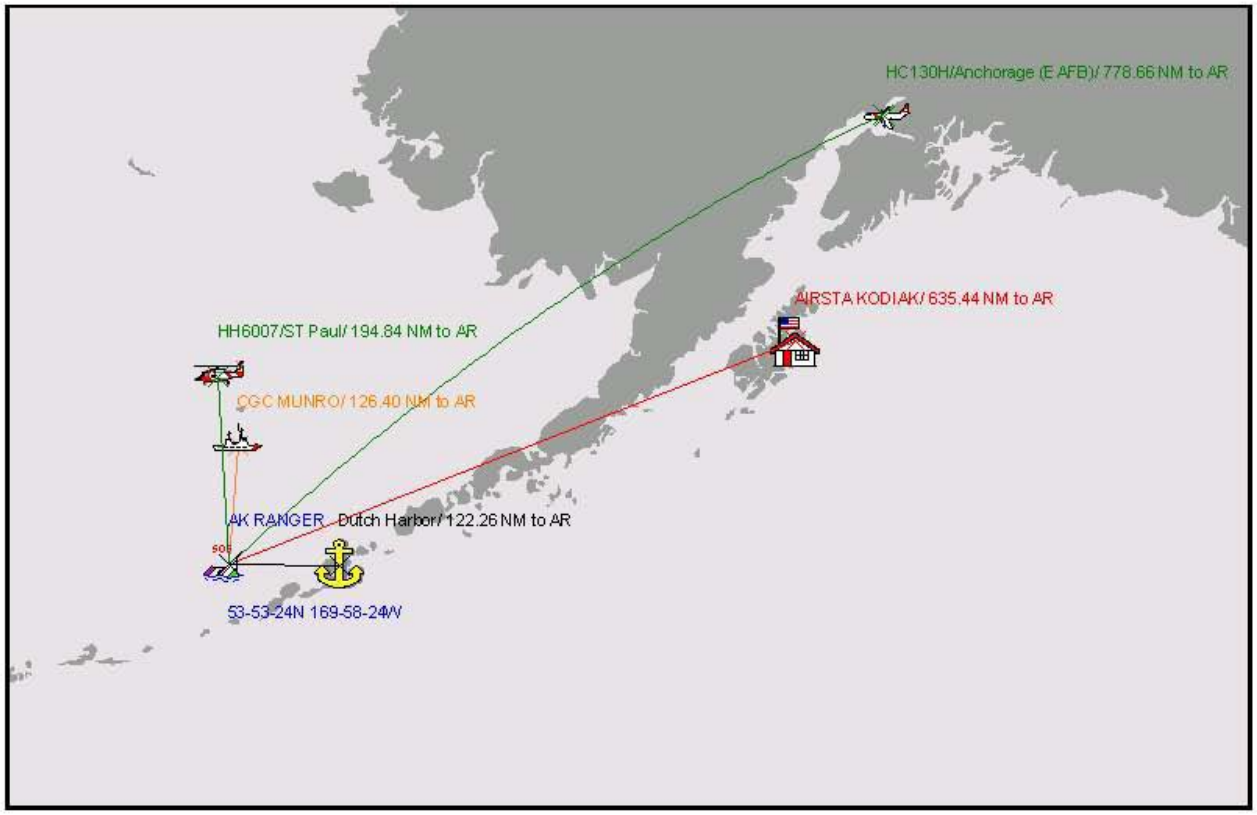
Figure 12: Relative distance of USCG response assets

At 0252, the CGC MUNRO heard a mayday call from the ALASKA RANGER over the 2182 kHz distress frequency. The CGC MUNRO was running on diesel engines, with gas turbines on five minute standby. They immediately shifted to the gas turbines and began transiting at best speed to intercept the ALASKA RANGER, which was approximately 127 NM to the south.

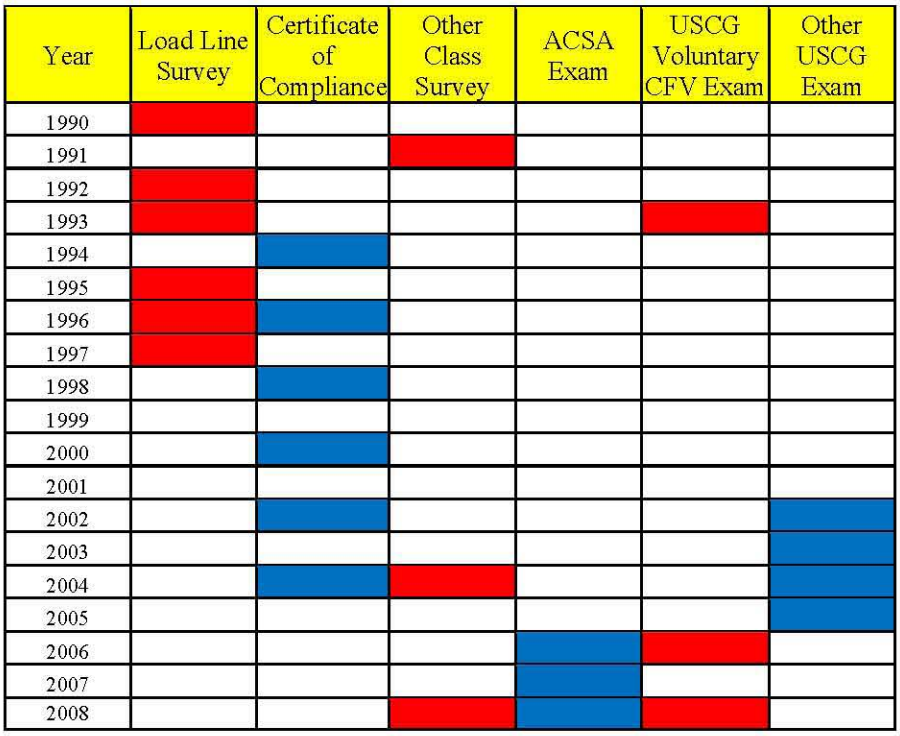
Figure 13: Summary of Third Party Examinations

However, the ALASKA RANGER was never classed by ABS or any other recognized classification society after it was converted to a fish processing vessel. This is likely due to confusion over the applicability of the major conversion definition. Though the MBI did not find any signed correspondence reversing the decision and informing FCA that the ALASKA RANGER did not need to meet survey and classification requirements, an unsigned copy of the 20 November 1990 letter was found in USCG files with a handwritten note from the MSO Seattle Chief of Inspections stating "Change on policy – from F/V [fishing vessel] to processor is not a major conversion."

Figure 13 provides graphic display of the third party exams and inspections conducted onboard the ALASKA RANGER from 1990 until 2008. The most recent Load Line Certificate was issued in June 1996 and, subject to successfully completing required annual inspections, would have been valid until 31 October 2000. However, because the last annual load line inspection was conducted in December 1997, the Load Line Certificate expired in 1998. The reason this occurred is unclear. According to FCA's Operation Manager, "I was not in the office or taking part in any of those decisions at that time, but I assume that the load-line lapsed then because it was not required to do business."

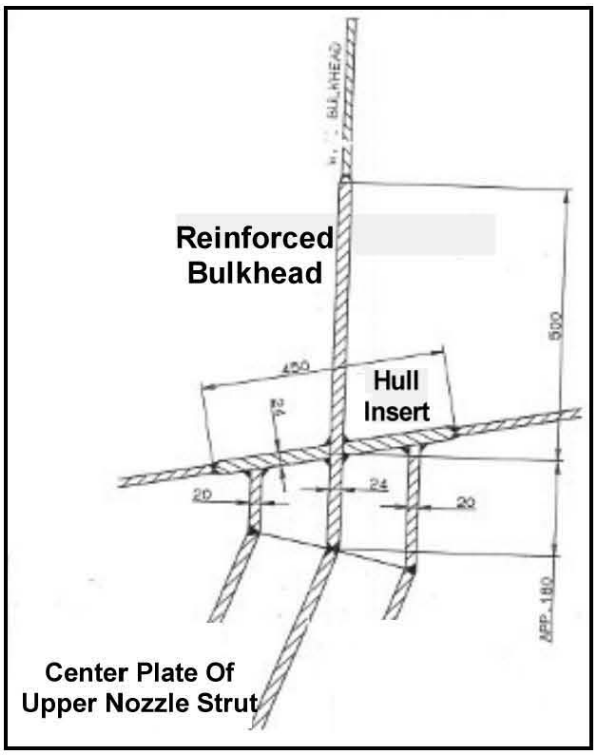
Figure 23: Portion of nozzle manufacturer's installation drawing

As shown in Figure 23, an excerpt from the MAN B&W installation plans, the center plates of the upper nozzle struts were to extend through the hull and join directly to a reinforced longitudinal bulkhead, which was to be 24mm thick and extend from frame 56 to frame 58. The existing 12 mm hull plating in way of the nozzle strut attachment was to be removed and replaced with hull plating twice as thick. The two plates inboard and outboard of the center plate of the upper nozzle supports were to be welded to the 24 mm hull plating insert.

This design transferred the weight of the Kort nozzles to the internal framing of the vessel, which is the recommended practice. According to Ship Design and Construction ([redacted], Editor, 1980, published by Society of Naval Architects and Marine Engineers), "the inboard ends of shaft struts are usually carried through the shell and attached to special framing arranged to distribute the load from the arms to a sufficiently broad and rigid structure to eliminate any likelihood of local vibration. The hole in the shell plating is closed by heavy plate around the strut arm."

The Kort nozzles were supposed to be installed in November 1991 while the ALASKA RANGER was at Yamanishi Ship Building & Iron Works, Ishinomaki City, Japan. While in the shipyard, TMPS discovered the actual structural arrangements of the vessel were different from that assumed during development of the installation plans. Correspondence between a TMPS employee with the vessel in the shipyard and the owner of TMPS states the potable water tanks had "no swash bulkheads or framing" and details of the cofferdams and #4 fuel oil tanks differed from what was shown in the MAN B&W installation plans.

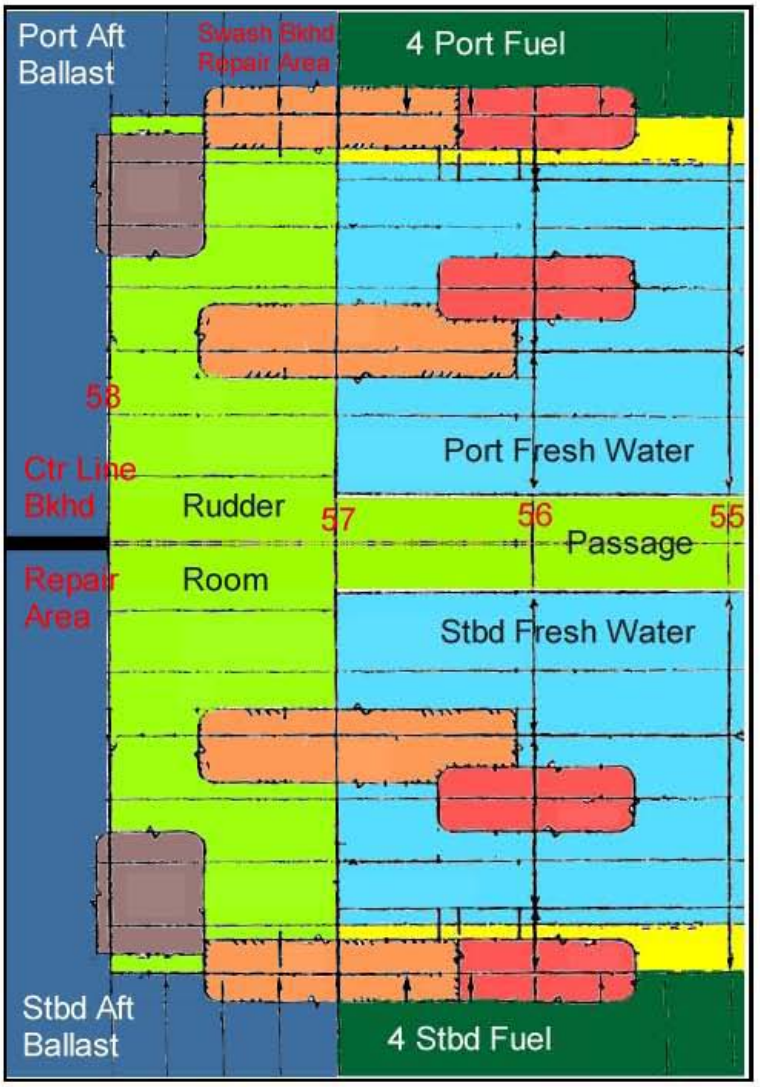
Figure 24: Portion of drawing developed by shipyard for Kort nozzle installation

The detailed shipyard drawings specified a 24 mm hull plating insert (orange at top and bottom of Figure 24) installed directly aft of the existing insert (shown in red) to which the outboard shaft bearing housing strut were attached. This insert was directly under the longitudinal bulkhead that separated the #4 fuel oil tank (shown in dark green) and the adjacent cofferdam (yellow) as well as the rudder room (light green) and the aft ballast tank (blue). The shipyard drawing indicated that the bottom 1.8 feet of this longitudinal bulkhead was to be replaced with 24 mm thick plate and additional brackets were to be installed to support the bulkhead.

The shipyard design also called for similar modifications to the hull plating (second orange area from top) and longitudinal frames in way of the inboard Kort nozzle strut attachments. The inboard hull plating insert was not directly aft of the inboard shaft bearing housing strut (second red area from top). The longitudinal frame and hull plating were located in the potable water tanks (light blue) and rudder room (light green).

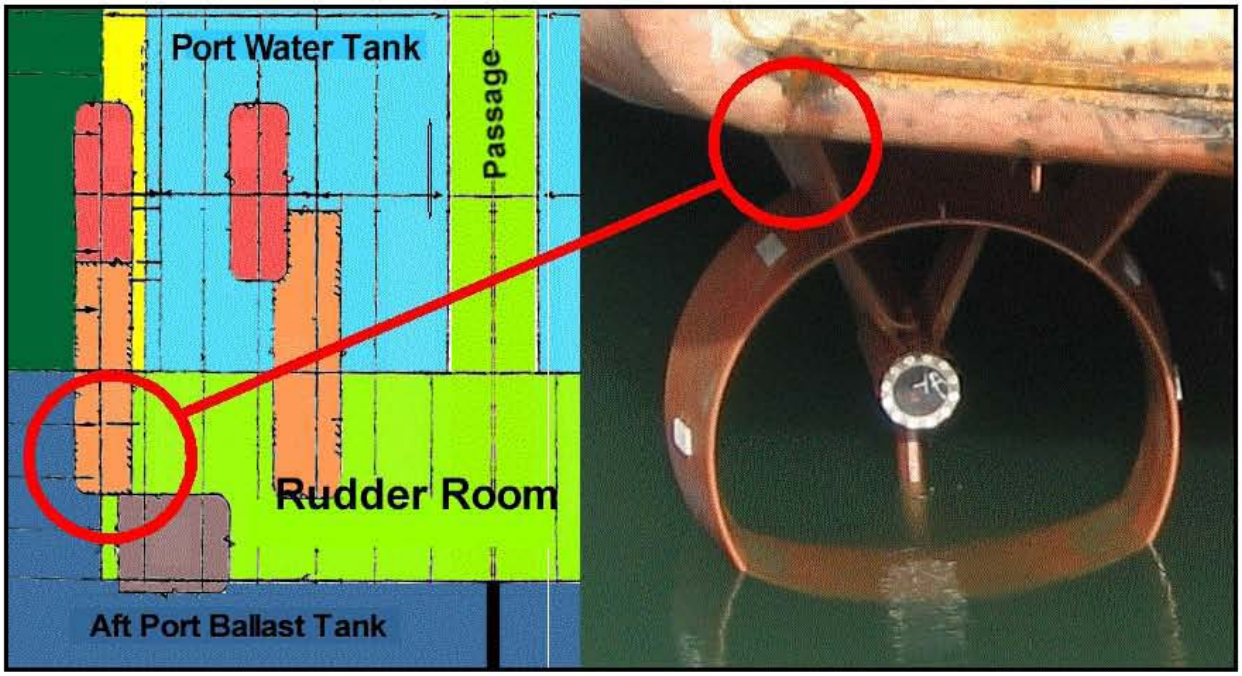
Figure 25: Upper right red circle: Location of Kort nozzle strut fractures

Lower left red circle: Location of corroded frames in port aft ballast tank.

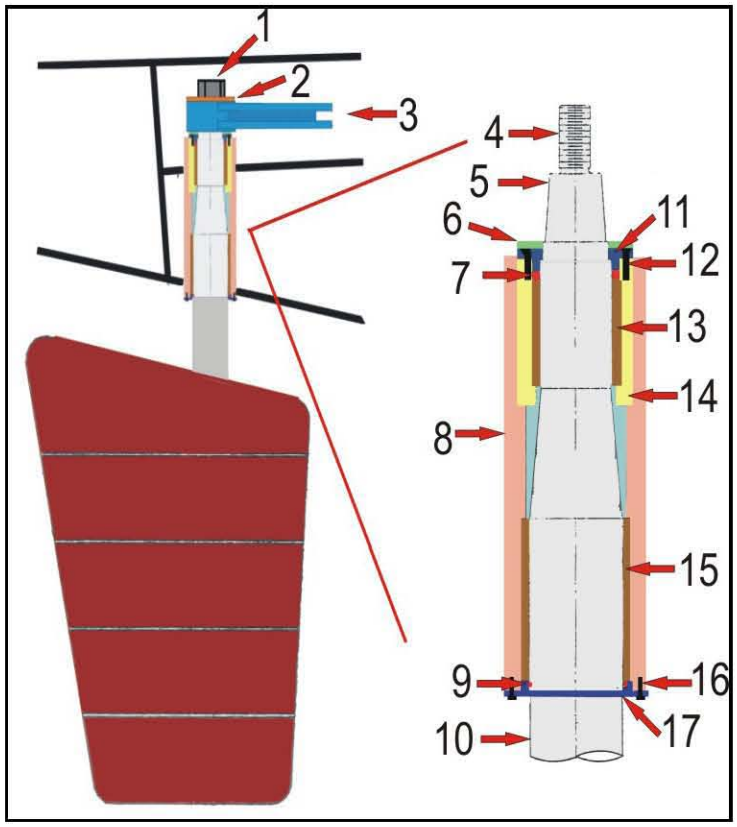
Figure 29: Rudder configuration

The ALASKA RANGER was equipped with two semi-balanced spade rudders. Each rudder blade was approximately nine feet high and is estimated to have weighed about 7,250 lbs.

The threaded section of the rudder stock accepted a 4 inch diameter, 4 threads per inch, national coarse rudder nut (1). A washer (2) was placed between the rudder arm and the nut. A steel keeper plate, not shown in Figure 29, was fitted on top of the steel nut and served as a locking device. It was welded to the top of the rudder stock and to both sides of the nut, and locked the entire assembly in place to prevent the nut from coming loose.

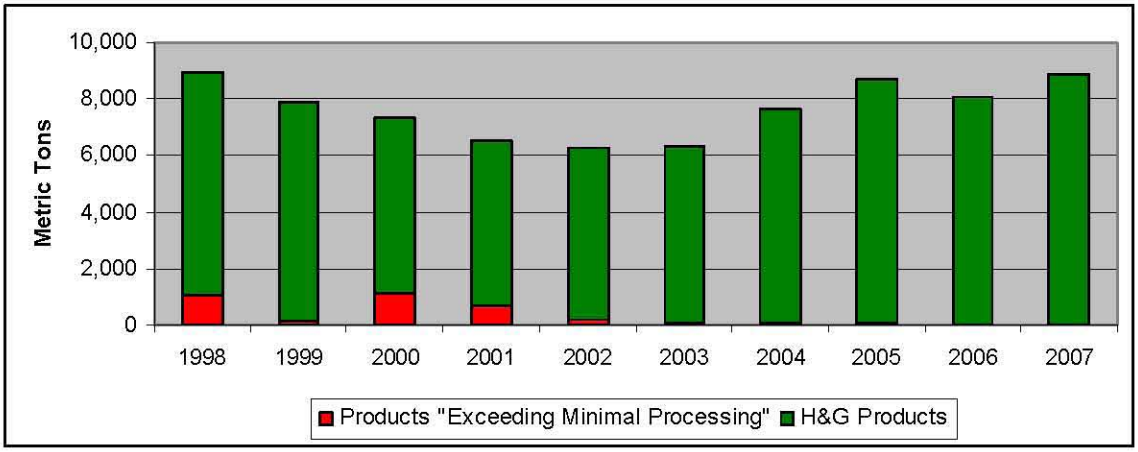
Figure 35: ALASKA RANGER Catch Sorted by ACSA Product Code

The ALASKA RANGER consistently produced NMFS product codes 10 and 14, "Headed & gutted, Tail Removed" and "Roe" respectively, which are both defined as "Exceeding Minimal Processing." As shown in Figure 35, products defined by ACSA as "Exceeding Minimal Processing" have accounted for less than 1% of the total annual product produced on the ALASKA RANGER since 2002. However, in order to continue producing these products, the ALASKA RANGER had to enroll into ACSA or meet classification and load line requirements.

The application requirements in the ACSA Agreement were not followed for the ALASKA RANGER. On 5 April 2006, more than 10 weeks before the issuance of the ACSA Agreement and D13 Instruction, FCA submitted an application to enroll the ALASKA RANGER and six other vessels into ACSA. In a letter sent 22 months later, D13 told FCA the application for exemption from the requirements to be classed by the ABS or a similarly qualified organization and the load line requirements "constituted acknowledgement that the subject vessel operates as a fish processing vessel as defined in 46 CFR Part 28."

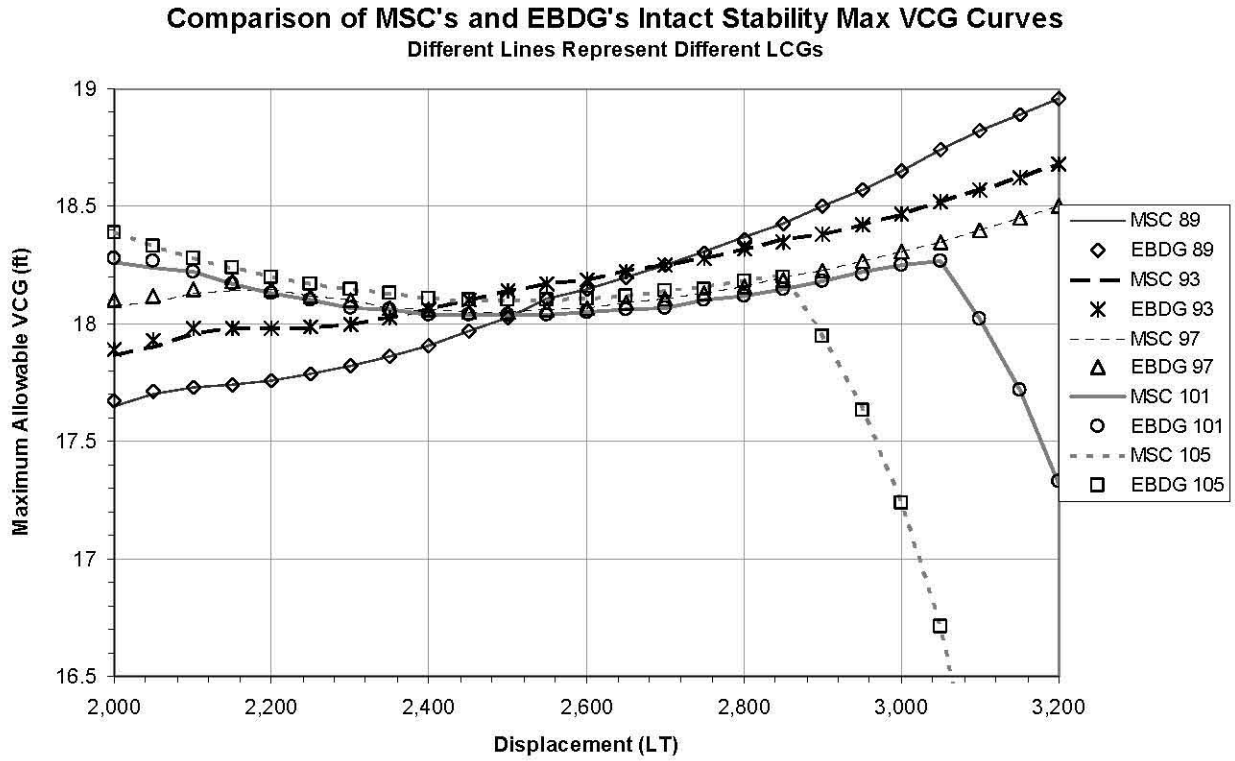
Figure 1: Comparison of Max VCG Curves

In order to verify the loading guidance provided in the T&S book, an independent generation of the ALASKA RANGER's max VCG curves was undertaken. In our review, the maximum VCG was computed using the four criteria considered by EBDG as well as the water on deck criteria in 46 CFR 28.565. As seen in Figure 1, there was good correlation between EBDG's and MSC's intact stability analyses. Our review revealed that the water on deck criteria was not limiting in any case so EBDG's omission of this criteria from their maximum VCG curves did not impact the results.

In general, the limiting criteria were the Intact Righting Energy requirements contained in 46 CFR 28.570. Specifically, the GM requirement and righting energy between 30° and downflooding were the most restrictive. Since the lowest downflooding points were aft on the ALASKA RANGER, aft trim conditions at deeper drafts quickly reduced the allowable VCG as seen in Figure 1 on the LCG = 105 curve at displacements greater than 2900 LT.

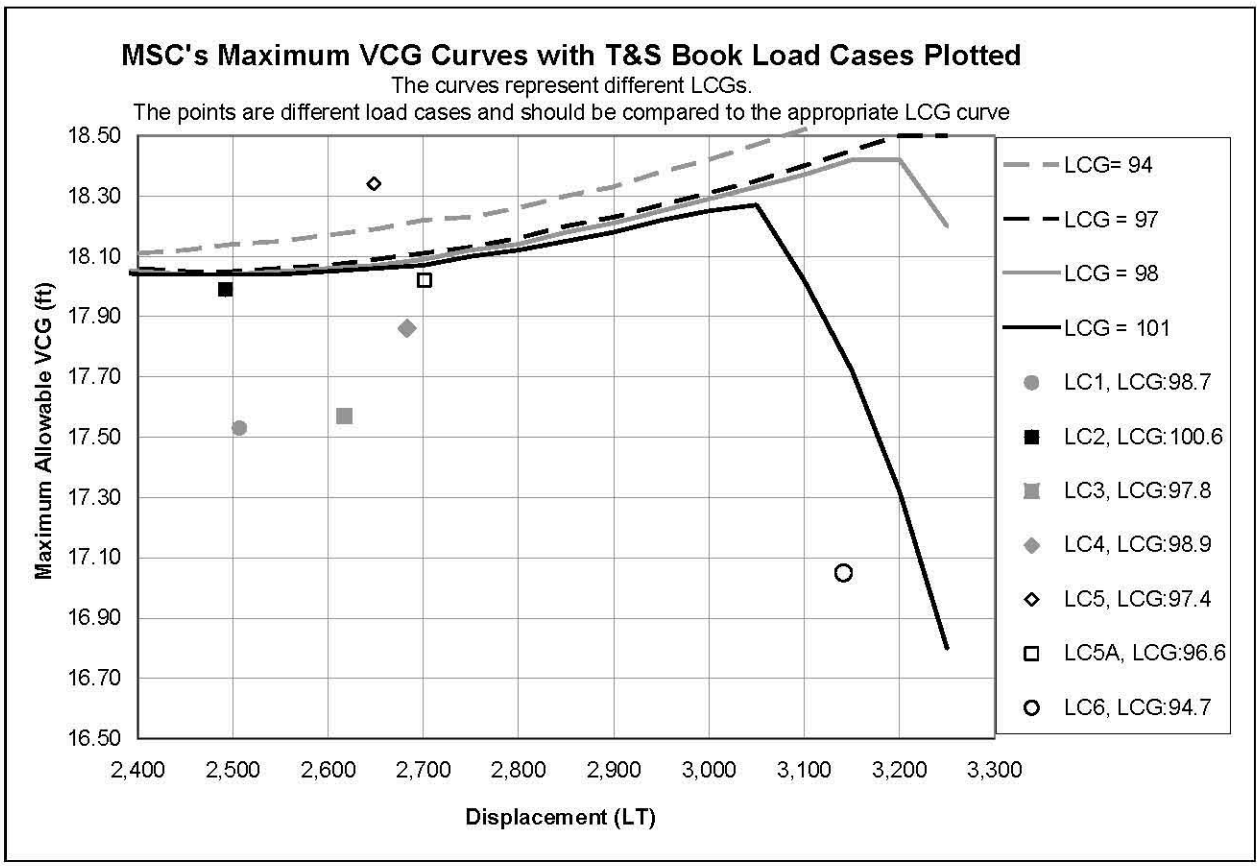
Figure 2: Load Case Evaluation

The load cases provided in the T&S booklet, including topside ice as required by 46 CFR 28.550, are plotted in Figure 2. It should be noted that the stability calculations in the ALASKA

RANGER's T&S booklet included an illustrative load case #5 which failed to meet the criteria, as well as a modified version, load case #5A which passed.

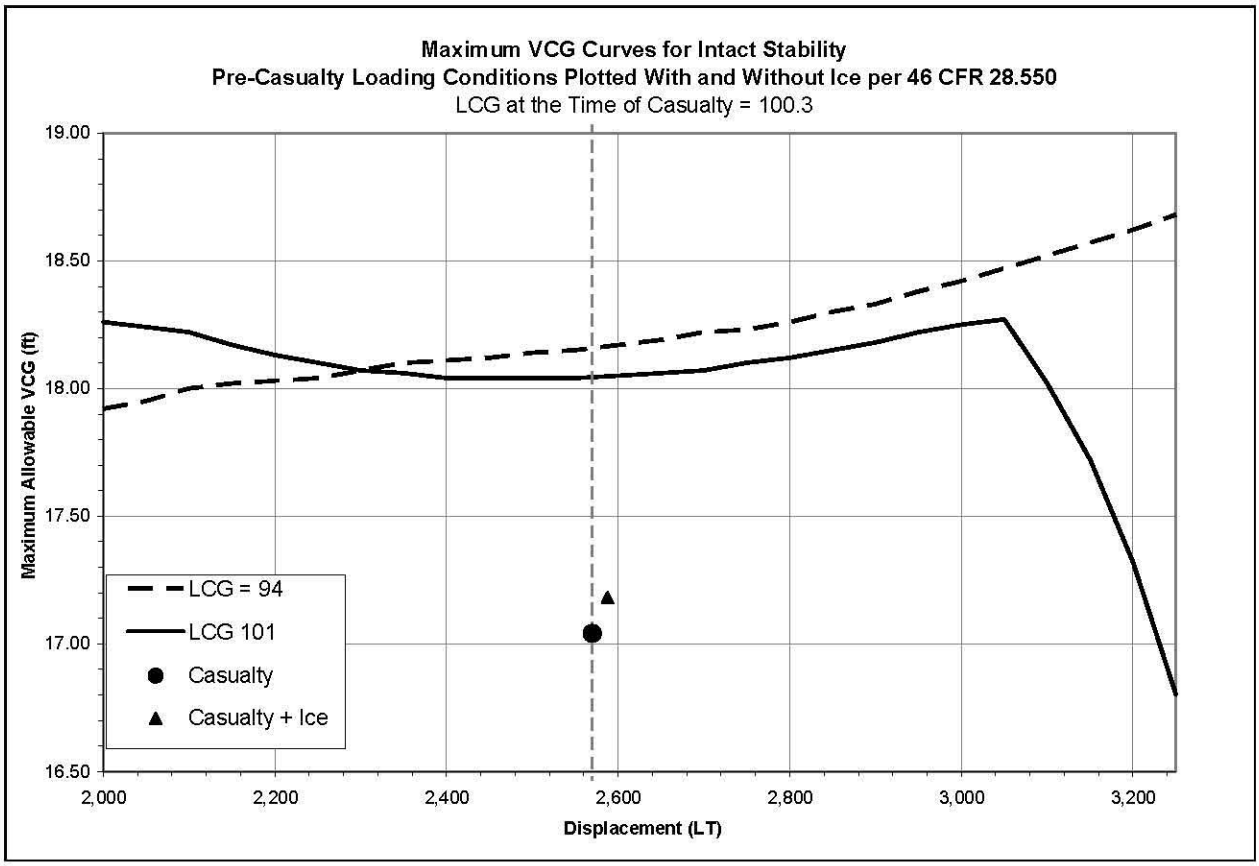
Figure 3: Range of Stability

Paragraph 2-e of reference (a) requested a determination of the maximum trim angles and displacements for which the ALASKA RANGER could pass the applicable intact and damaged stability requirements. Since the vessel did not meet the damage stability requirements of 46 CFR 28.580 in any of her conditions of loading, damage stability was excluded from this portion of the analysis. Based on the information provided, at the time of the casualty the ALASKA RANGER had a large intact stability margin for VCG, trim, and displacement. This large margin created many combinations of displacement and trim at which the vessel would meet intact stability requirements. Figure 3 displays the limiting KG curves over the range of displacements considered in the T&S booklet load cases. The dotted curve shows the forward most LCG considered among the load cases and corresponds to 2.9 feet of forward trim. The solid curve represents the aft most LCG corresponding to 3.5 feet of trim by the stern.

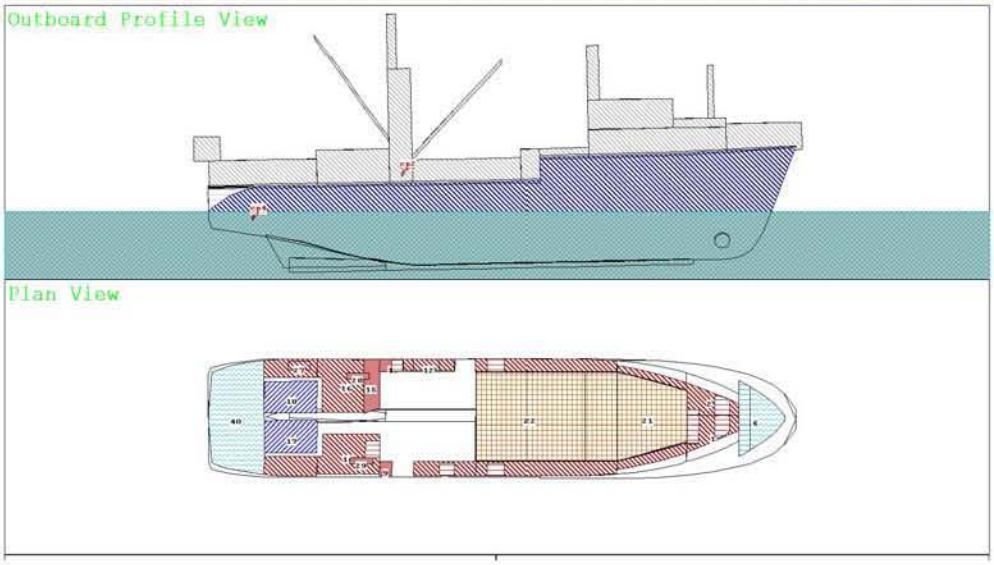
Figure 4: Summary of Pre-Casualty Load Condition

Based upon the information in the T&S booklet for full load departure as well as the additional modifications called out in paragraph 5-c of reference (a), an estimate of the pre-casualty loading condition was developed. This estimate is summarized in Figure 4. The 122,000 gallons of fuel

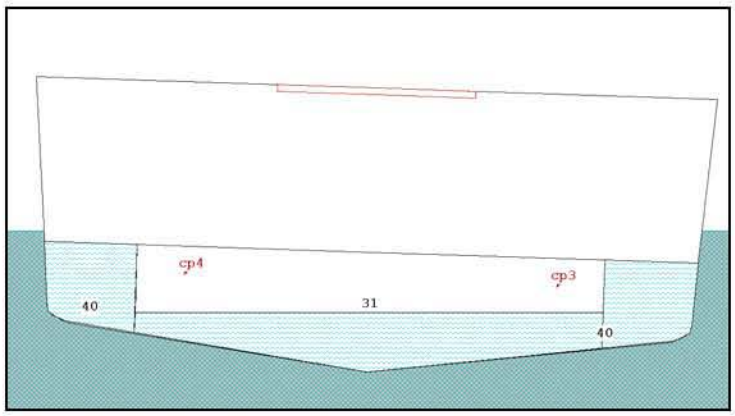
Figure 6: Example of Rudder Room Flooding at 50%

The initial rate of flooding into the Rudder Room was estimated by assuming that the flooding began through the rudder bearing, after the complete loss of one rudder and shaft. McDermott Shipyard Dwg. No. 54271-2101-1, Rev 2, dated October 25, 1973 shows that the upper rudder tube bearing is 9 inches in diameter. It also indicates that the longitudinal, transverse and vertical locations of the top of the rudder tube as being 178.59ft aft of frame 0, 10.75 ft outboard from centerline and 16.85 ft above baseline. Figure 6, shows the ALASKA RANGER's body plan at the location of the rudder posts. The points labeled "cp3" and "cp4" are the locations of the top of the rudder bearing and the assumed location of flooding.

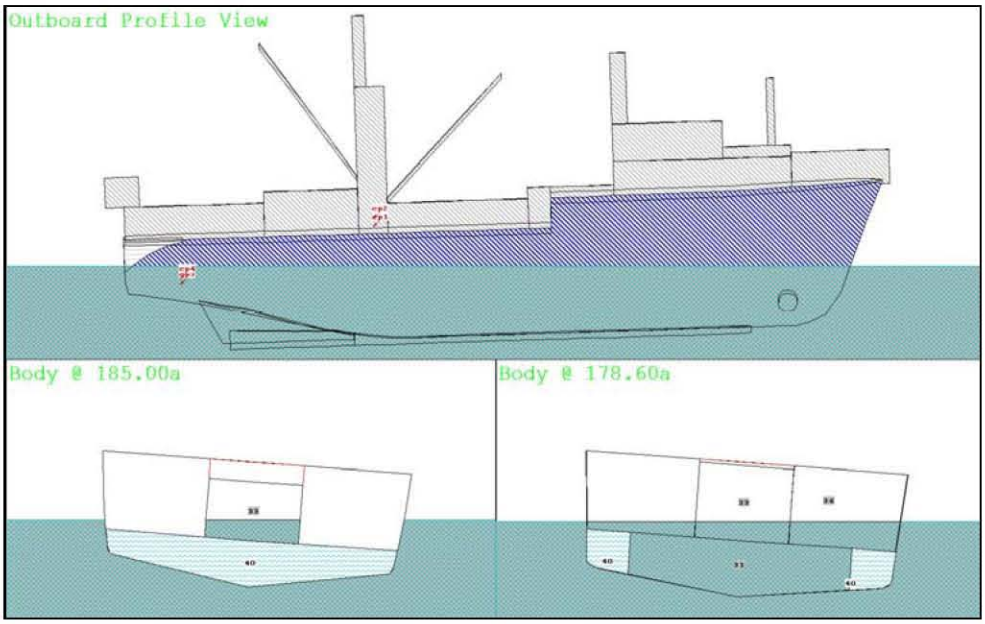
Figure 8: Step C in 1st Flooding Scenario

Reference (a) indicated that after the Rudder Room flooded, the next compartments to have reported flooding were the Ramp Room as well as the Harbor Generator Room, Workshop, and Aft Machinery Alley. The flooding of these compartments was modeled as step C in Table 3, and is depicted in Figure 8. In our model, these flooded compartments were allowed to flood to the waterline throughout the scenario so that as the flooding progressed, more water would flow in. It is not clear whether this floodwater came from a hull breach or upward from the rudder room below. However, our model suggested that with the rudder room flooded, the deck in the ramp room would have been 2 feet below the static water line, making a hull breach a reasonable source of flooding.

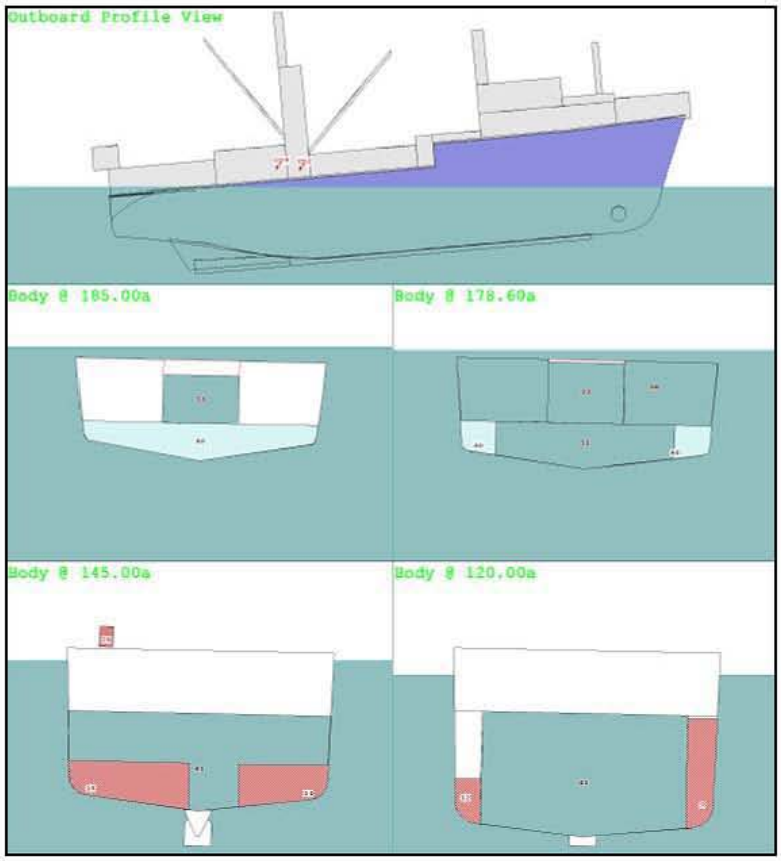
Figure 9: Step D in 1st Flooding Scenario

Reference (a) indicated that the Hydraulics Room was the next compartment to flood. The bulkhead at frame 50 was not watertight and so in step D, the entire engine room was allowed to flood. As seen in Figure 9, once the engine rooms were completely flooded, the aft portion of the trawl deck is awash increasing the likelihood that the #4 Hold and the Fish Bin would begin to downflood.

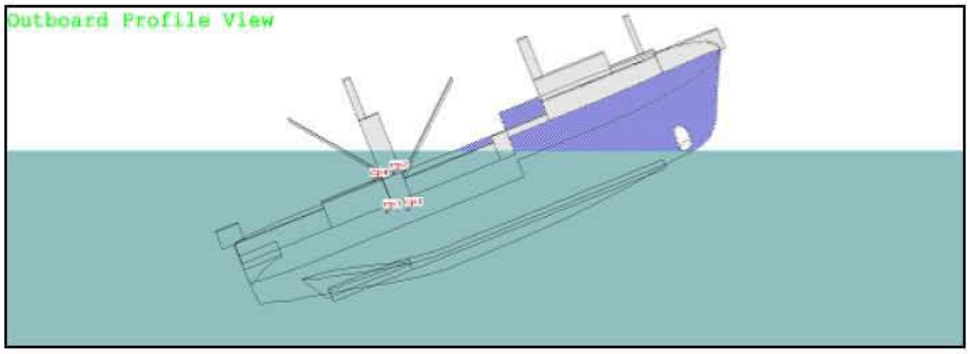
Figure 10: Step E in the 1st Flooding Scenario

Figure 10 shows the model's attitude with the Fish Bin and #4 Hold flooded. Although this analysis describes one potential sinking scenario, it doesn't predict any significant listing until the model had extreme trim by the stern. Please note that this sinking scenario neglects the effects of wind and sea conditions.

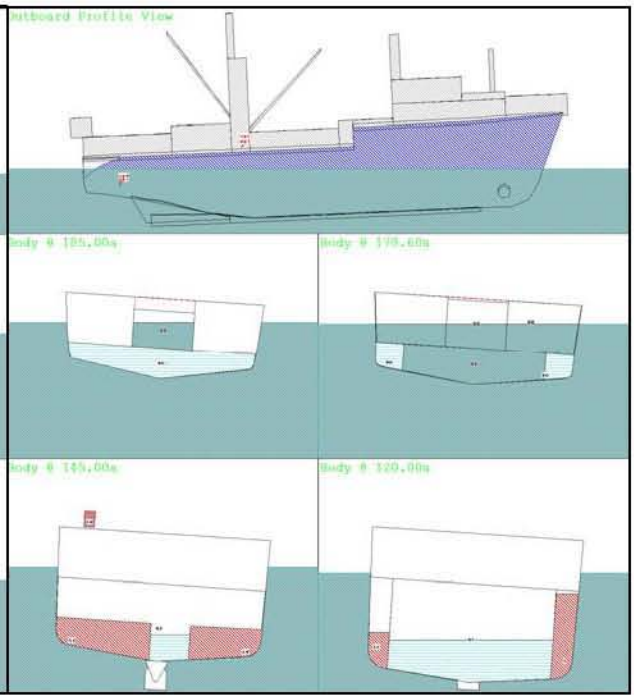
Figure 12: Step G in the 2nd Flooding Scenario

The engine room aboard the ALASKA RANGER was assumed to be made up of two separate compartments until flood water reached the main engine shafts. Cutouts in the bulkhead at frame 50 were considered to be the point where flood water would begin spilling from the hydraulics space forward into the machinery space. This spilling would have begun when there was approximately 6.8 ft of water at the forward end of the hydraulics room. This corresponds to approximately 29.5 LT of seawater as shown in Figure 11. After the spilling occurred, the forward machinery portion of the engine room was filled until the level at the spill point matched that in the hydraulics space. This occurred on the model with approximately 182 LT of water in the forward machinery space as shown in Figure 12.

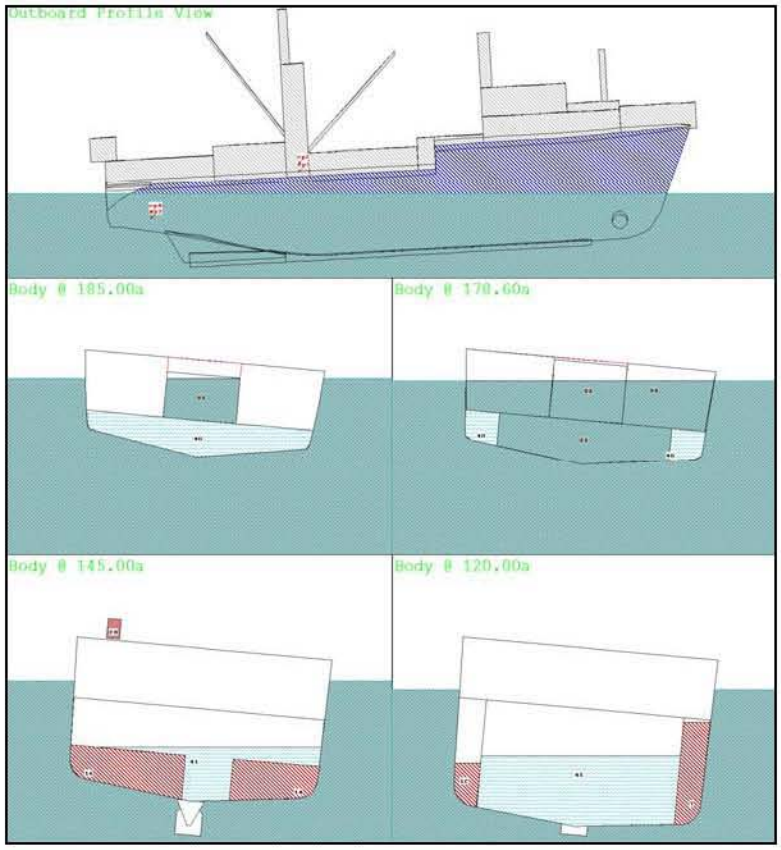
Figure 13: Step I in 2nd Progressive Flooding Scenario

Reference (a) also indicated that by 03:45, or 1 hour and 45 minutes after the initial report of flooding in the rudder room, the ALASKA RANGER had lost her generators and main diesel engines. It was assumed that the loss of the main engines corresponded to step I in the scenario where the engine rooms were flooded with 10 ft of water. Using the slowest flood rate in Table 2, the total 511 LT of flood water in all flooded compartments, would have taken approximately 50 minutes to ship through the rudder bearing. Presumably, the progressive flooding between compartments would occur more slowly than the initial flooding into the rudder room. However, this rough check verified that the flooding rates discussed in section 4.2 were not out of the question when compared with the timeline in reference (a).

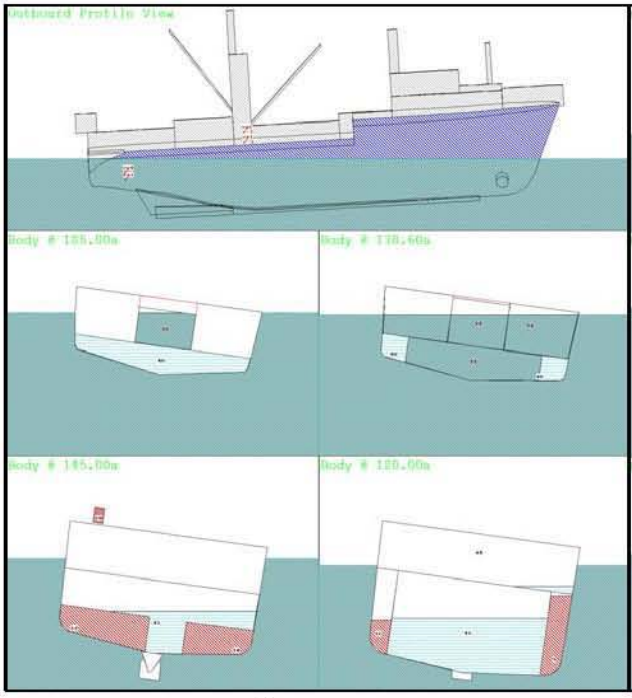
Figure 14: Step J in 2nd Flooding Scenario

As noted previously, the ALASKA RANGER reportedly listed hard to starboard after losing power (presumably due to flooding in the engine rooms). However, Table 4 shows only between 4° and 5° static starboard heel angle once the engine rooms are flooded. One plausible condition that would increase the free surface effect and create a greater heel angle is a small quantity of flood water on the processing deck. Limited flooding on the processing deck is a reasonable assumption considering the aft end of the trawl deck was nearly submerged in step I of the scenario. When only 15 LT of flood water was added to the processing deck, the model heeled sufficiently to put the starboard corner of the transom in the water as shown in Figure 14. With 50 LT of flood water on the processing deck, the heel angle doubled to 16°. At this point, our model indicated that the starboard side of the trawl deck was underwater from frame 47 to the transom.

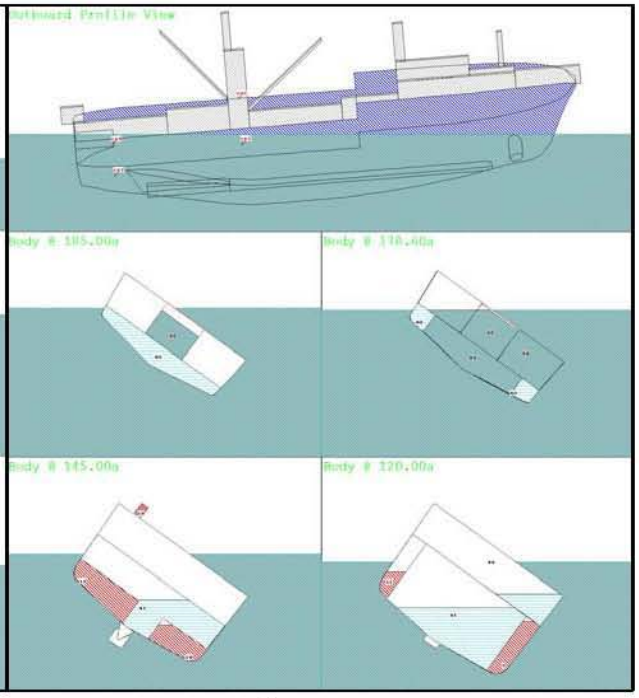
Figure 15: Step L in 2nd Flooding Scenario

Figure 15 depects step L in the flooding scenario. Here, the processing deck was flooded with 100 LT of sea water. At this point, the model was heeling 36° to starboard with the trawl deck awash and the engine room downflooding points submerged. Further speculation on the next compartments to flood and their effect on stability provided little value and was fraught with inaccuracy. Additionally, only the lowest downflooding points were considered, whereas there were presumably other air vents on the superstructure that would have allowed the ingress of water. Ultimately, the order of further flooding does not change the outcome; once the engine room was flooded, water was flooding the processing deck, and the trawl deck was awash, our model indicated that the ALASKA RANGER could not have survived. Again, please note that this sinking scenario neglects the effects of wind and sea conditions.
