U.S. Coast Guard Marine Safety Office Portland, Maine

STATE OF REGULATORY COMPLIANCE WITH 406 MHZ EPIRB CARRIAGE REQUIREMENTS ON COMMERCIAL FISHING VESSELS IN NORTHERN NEW ENGLAND

Jeff Ciampa
Fishing Vessel Safety Examiner, U.S. Coast Guard

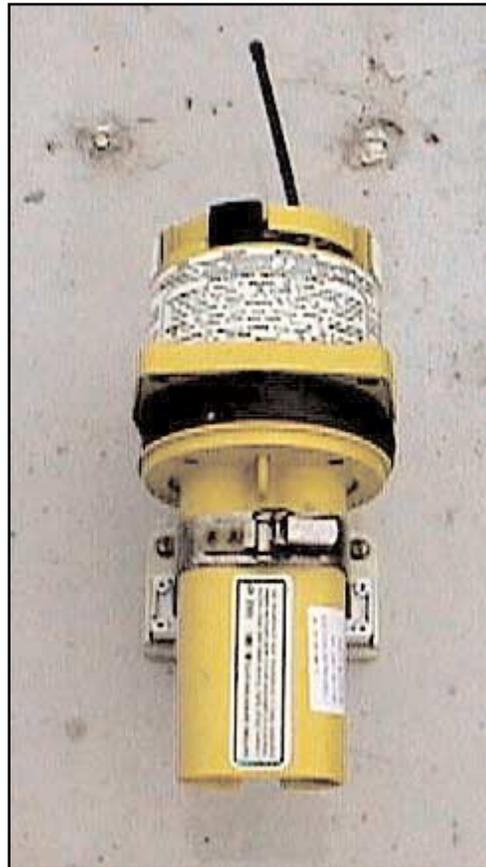
406 MHz EPIRBs are compact radio beacons intended to provide automated distress signaling in the event of sinking. The system is designed to alert search and rescue authorities of the name and description of the vessel in distress, and provide highly accurate position information to facilitate search and rescue efforts.
