MAR 06 2014

MEMORANDUM

From: D. M. Fears, CAPT
Board President

Subj: MAJOR INCIDENT INVESTIGATION (MII) BOARD REPORT REGARDING THE
CIRCUMSTANCES OF THE CASUALTY TO CGC WAESCHE'S SRP 24104 &
INJURIES TO A SMALLBOAT CREWMEMBER ON 11 NOV 13

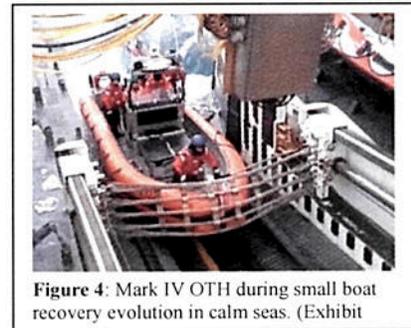
According to Chapter 21 of TP-7525, the stern ramp system is designed to allow for launch and retrieval of the cutter small boats in up to mid sea state 5 on the Beaufort Scale by use of a centerline stern ramp. (Exhibit 30.) The ramp includes a capture mechanism that automates the capture process and removes manual steps that would impose safety hazards to personnel. (Exhibit 30.)

No damage to the boat recovery system occurred during the mishap. However, the capture system was not Fully Mission Capable (FMC) at the time of mishap.
