Final Report
for
**UNITED STATES DEPARTMENT
OF THE INTERIOR**

**FORENSIC EXAMINATION OF DEEPWATER
HORIZON BLOWOUT PREVENTER**

VOLUME II APPENDICES

Report No. EP030842
20 March 2011

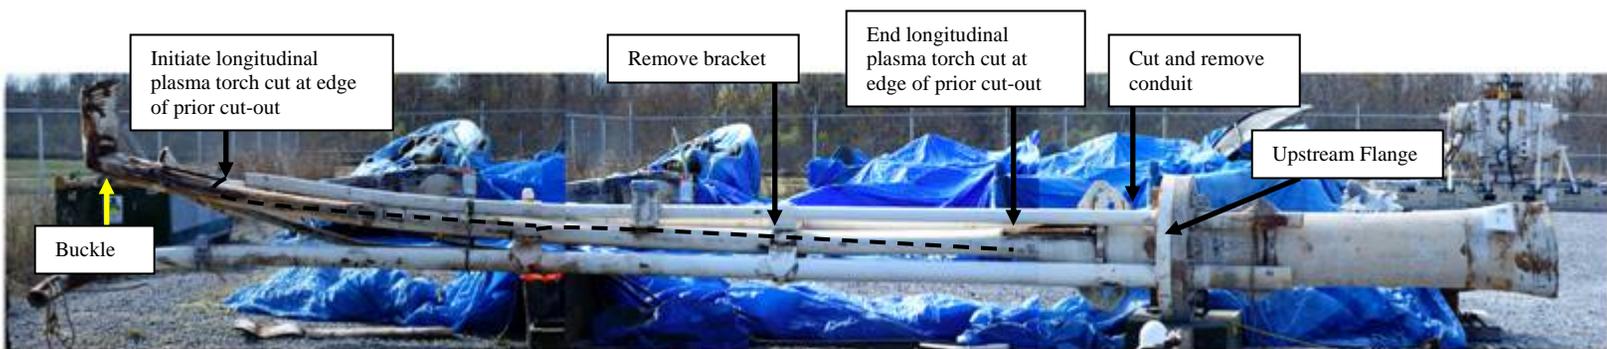
Figure 2 – Longitudinal cut on the edge of the riser.

6. Eyelets will be welded to the top piece of the riser to permit attachment for lifting.
7. The second longitudinal cut will be down the edge of the riser the length of the drill pipe from the cut-out nearest the buckle end of the riser down to the flange (see Figure 2). This cut must be performed carefully to produce a vertical angle directing any metal splatter from the cutting operation to the far side of the internal riser surface and away from the drill pipe.

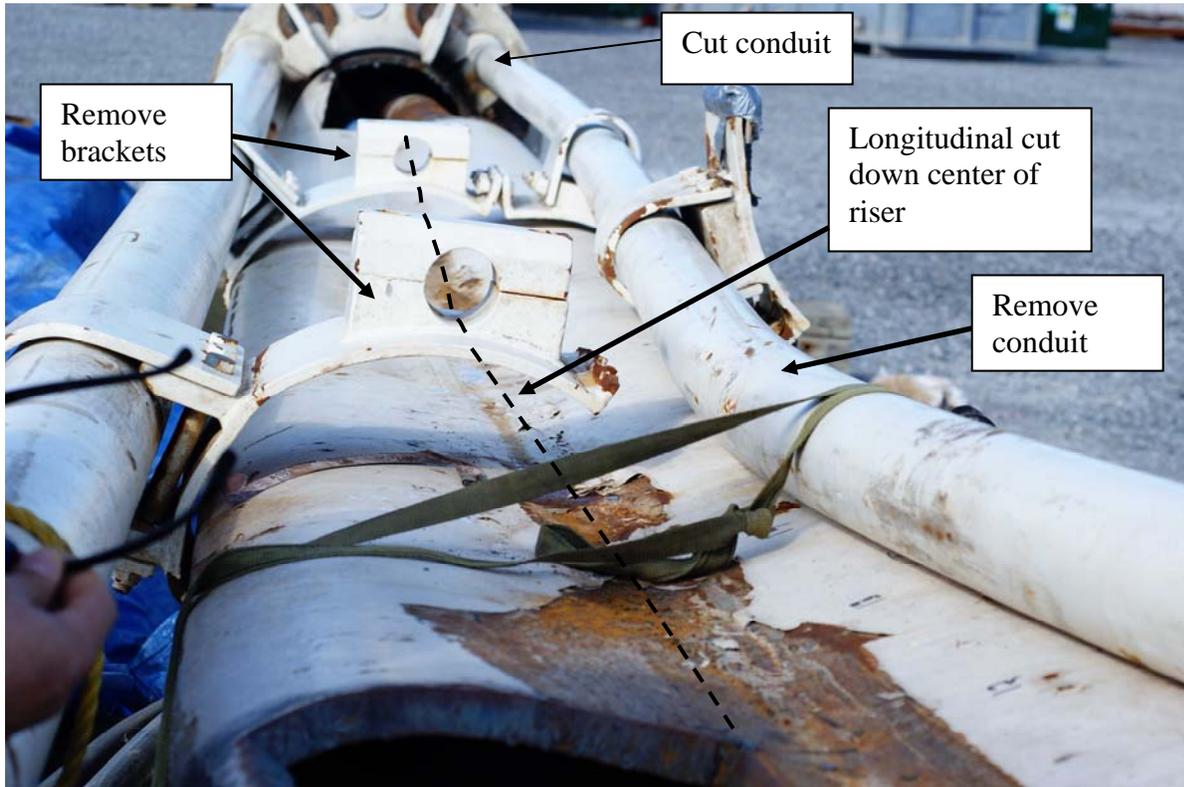
Figure 3 – Longitudinal cut down center of riser.

3. Clearly mark the riser as to the cuts to be made (see Figure 2, Figure 3, and Figure 4)
4. All cuts will be made with a plasma torch.
5. The first longitudinal cut will be down the middle on the riser top surface from the cut-out nearest the buckle end of the riser down to the flange (see Figure 3).

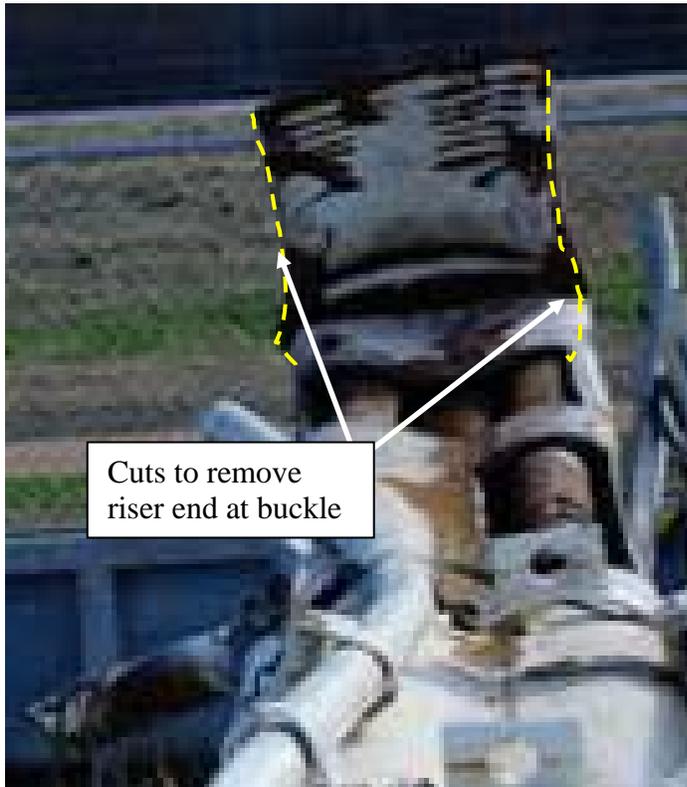
Figure 4 – Cuts to remove riser from ends of drill pipe at 90° bend.

8. Cut the riser at the 90° buckle and downstream to remove the top (as positioned in the evidence yard) of the riser (see Figure 4).
9. Remove the short piece of drill pipe from the buckle portion of the riser.

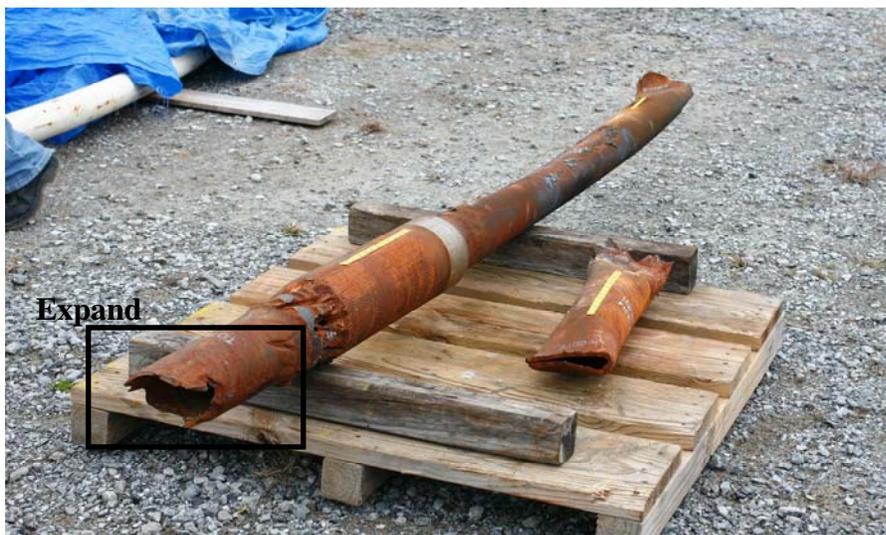
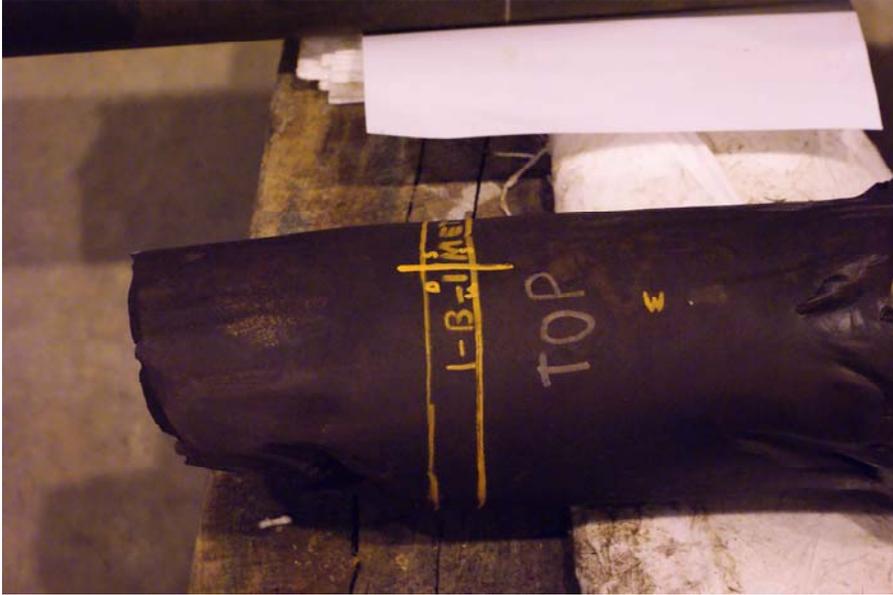
Figure 5 – Area to cut Item No. 1-B-1.

Because of the constraints posed by the fracture / sheared surface and the corresponding friction weld at the pipe joint, a one-inch metallurgical ring sample (as opposed to typical 3-inch sample) will be selected for the downstream end of Item No. 1-B-1 (Table 3). Figure 5 shows the location on Item No. 1-B-1 from which the one-inch metallurgical sample will be removed.

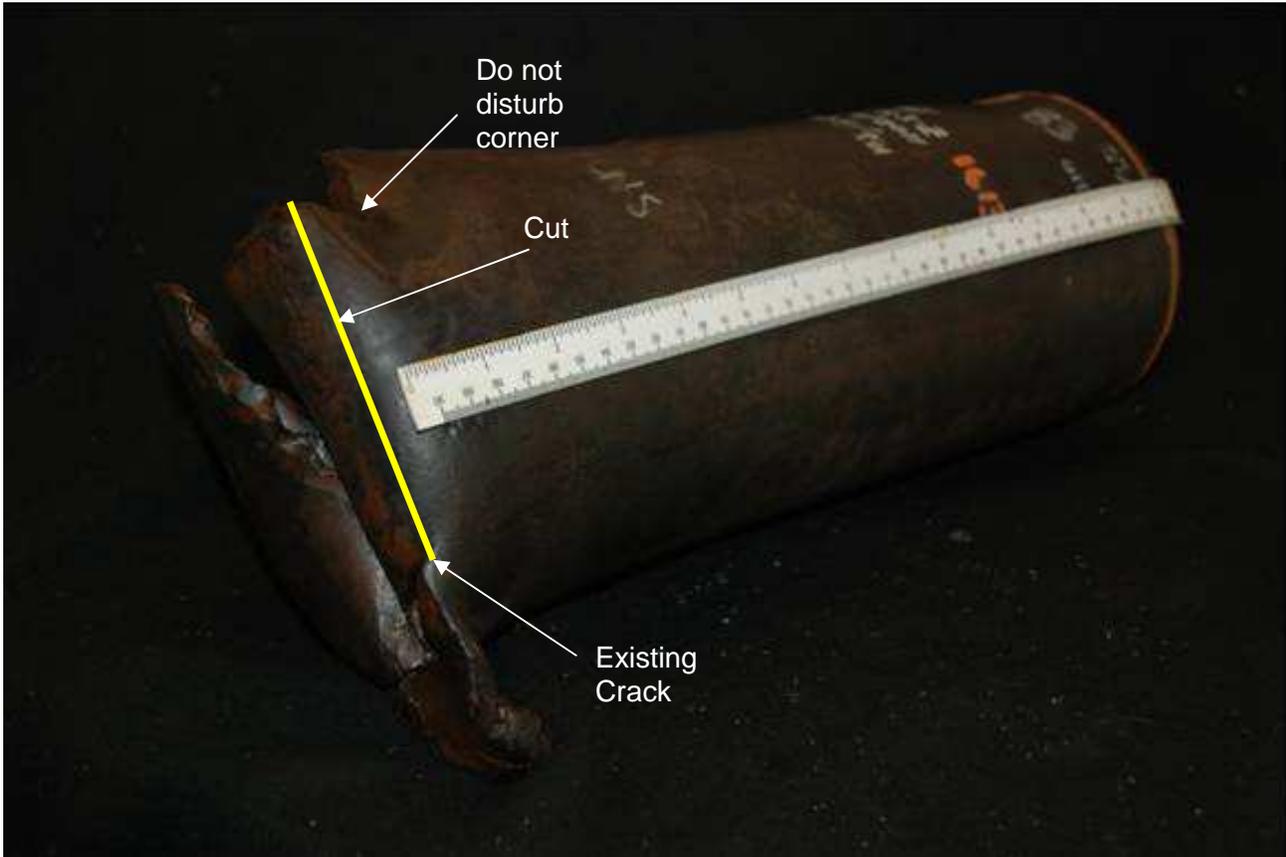
Figure 1 – Documentation of the proposed cut on Item 83 on the side without the “flat”

2. Examine surfaces using a stereo microscope where appropriate.
3. Cut Item 83-Z to reveal the surfaces that are curled into the ID of the pipe (see Figure 1 and **Error! Not a valid bookmark self-reference.**).

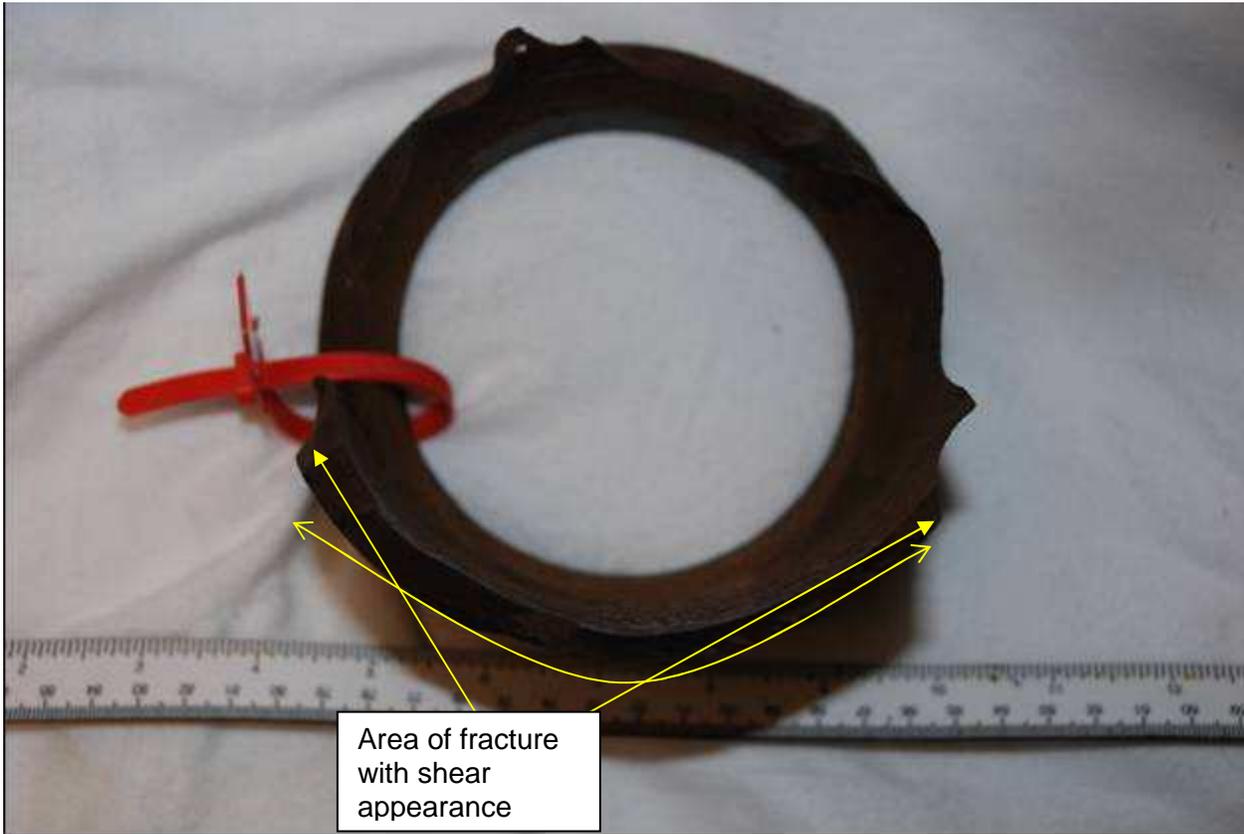
Figure 3 – Top view of Item 1-B-1-Z

4. Examine and photograph the cut surfaces from both sides of the pipe section Item 83-Z.
5. Cut fracture surface area from Item 1-B-1-Z (see Figure 3 and Figure 4).
