PROCEEDINGS OF THE MERCHANT MARINE COUNCIL

Continental Oil Rig 43A Gulf of Mexico . . .

Shipboard Fire and Safety Test Facility Dedicated	184
Issue Numbers on Merchant Marine Officers' Licenses	186
Continental Oil Rig 43A Gulf of Mexico, 24 October 1967 Explosion and Fire With No Loss of Life	188

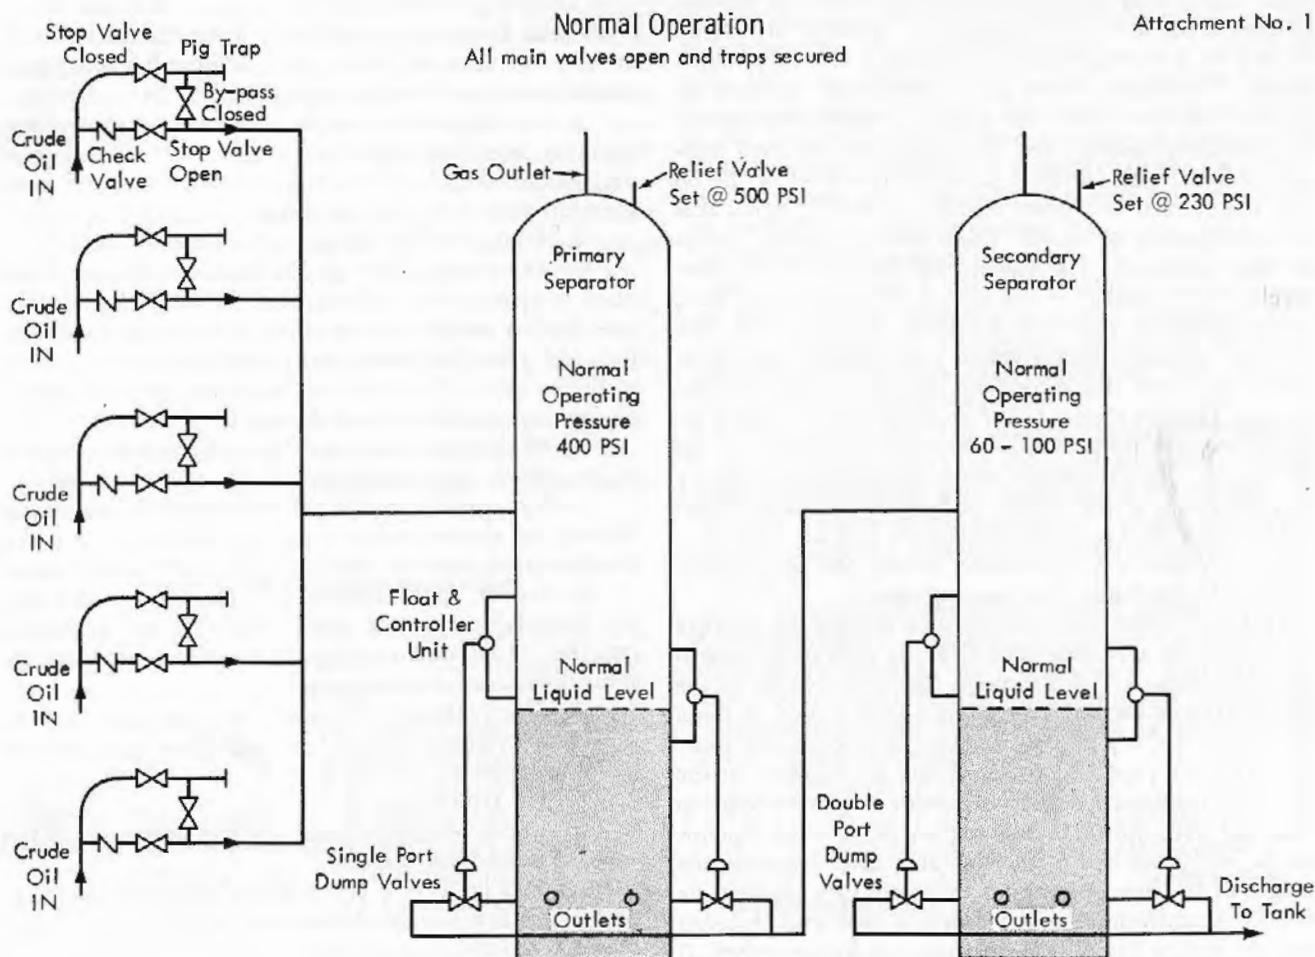
AFTER: The rig is transformed into a mass of blackened wreckage. An explosion followed the rupture of a storage tank, touching off a blaze that enveloped the platform for 48 hours. No lives were lost, but damages ran to \$3½ million.

1. It is concluded that the cause of the casualty was the rupture of the 3,835 barrel storage tank by an excessive pressure, exerted internally. The exact source of this pressure cannot be definitely determined; however, it may be reasonably concluded that the gas pressure arrived at the platform with the pig from 69-K. After passing through the primary separator, and causing the secondary separator relief valve to lift, the gas reached the storage tank at a pressure in excess of 230 p.s.i. due to probable failure of the level-actuated dump valves, possibly due to fouling by sand.

3. A second factor contributing to the tank failure was the U-shaped section of pipe which connected the two compartments of the tank. This pipe may have acted to throttle the flow of oil from the smaller compartment and contributed to the development of over-pressure.
