Adrift in Fog

Poor visibility, errors in judgment, and diminished situational awareness lead to tragedy on the Ohio River.

Lessons Learned

from **Casualty Investigations**

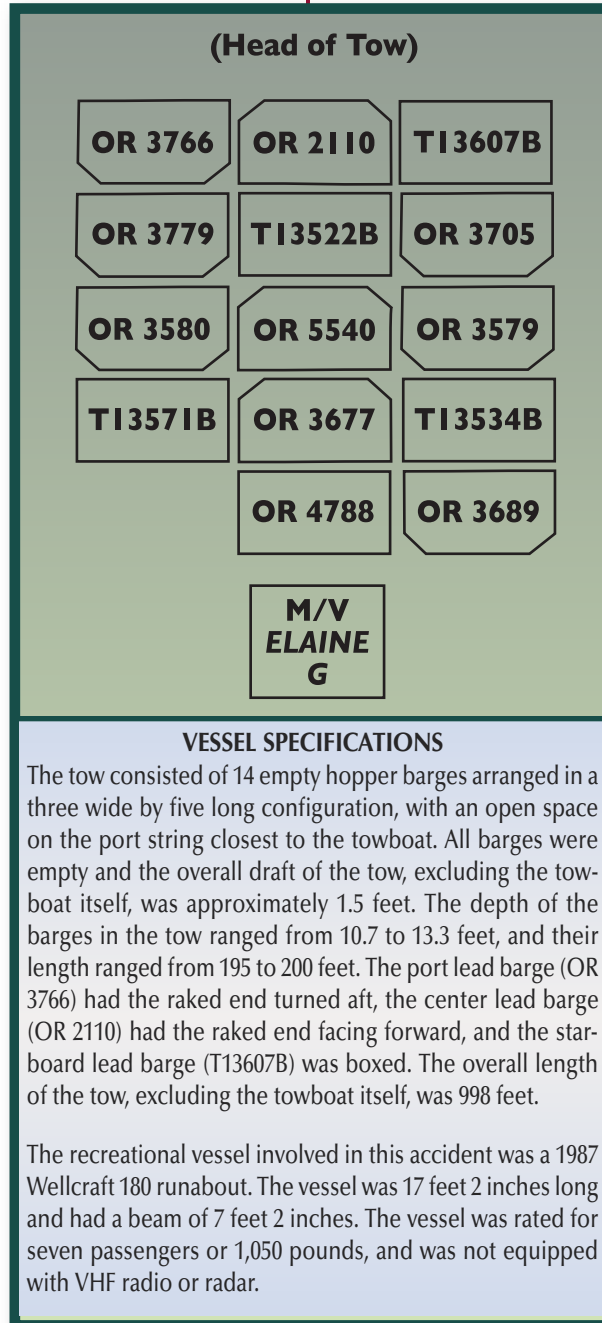
Equipment: The pilot stated that he turned on the automatic fog signal just before the watch relief, as the

captain entered the pilothouse. The towboat was equipped with standard navigational equipment, including two radars and two VHF radios. Both radars had been recently serviced and were functioning properly. The tow was lit with a green running light on the forward starboard corner, a red running light on the forward port corner, a special flashing amber light on the forward centerline, and a seven-watt white “steering light” on a seven- to eight-foot pole located all the way forward in the center of the tow. In addition, the tow had 2’ by 2’ low-intensity lights at each barge coupling on the port and starboard sides.
