PROCEEDINGS

OF THE MARINE SAFETY COUNCIL

Vol. 33, No. 7

ATC 3060 Casualty	122
Another Big Bang Out of Crude Oil	128
Marine Safety Council Membership	134

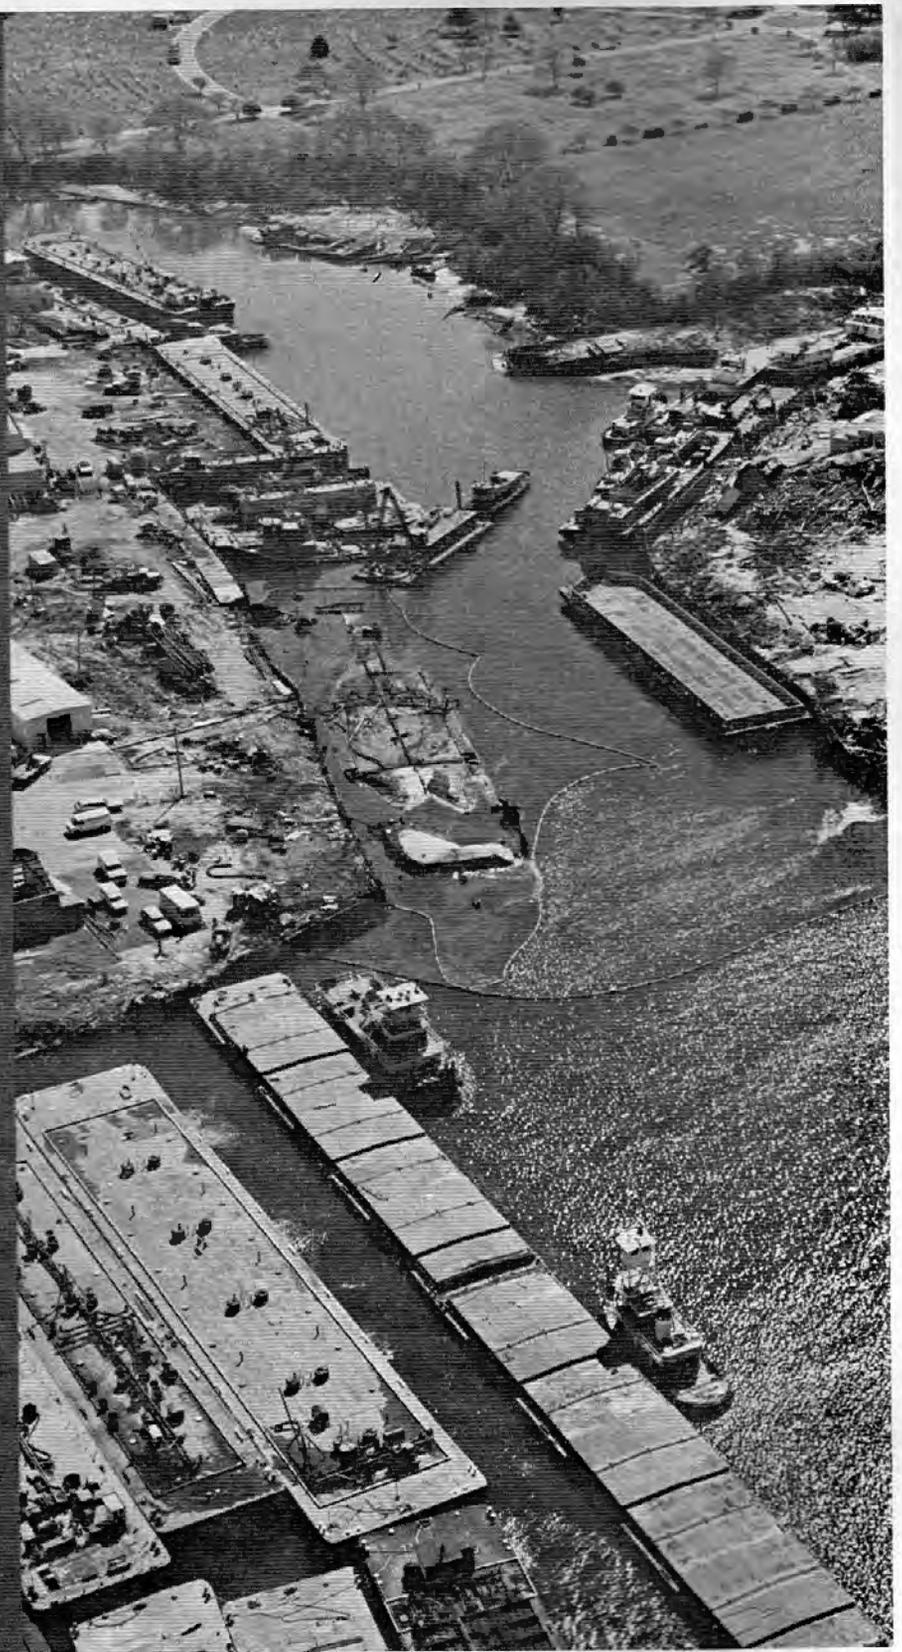
At 1527, 17 March 1975, while welding repairs were in progress on the tank barge ATC 3060 at the Allied Towing Corp., Norfolk, Va., the vessel exploded, burned, and sank. The welder and his helper, standing on a float between the barge and the dock, were killed. A fire watchman who was in No. 3 starboard tank at the time of the explosion and a laborer tending the welding machine on the dock were seriously burned. Two persons standing on a tug astern of the ATC 3060 suffered minor burns and injuries. Three employees within terminal buildings were injured by falling objects during the blast. The master of another tug in the vicinity suffered a heart attack during the incident. Three towing vessels moored at the Allied Towing Corp. facility were damaged extensively by fire and missiles. Damage to vessels and shore facilities was estimated at \$1.2 million.
