Proceedings

of the Marine Safety Council

Vol. 43, No. 3

March 1986

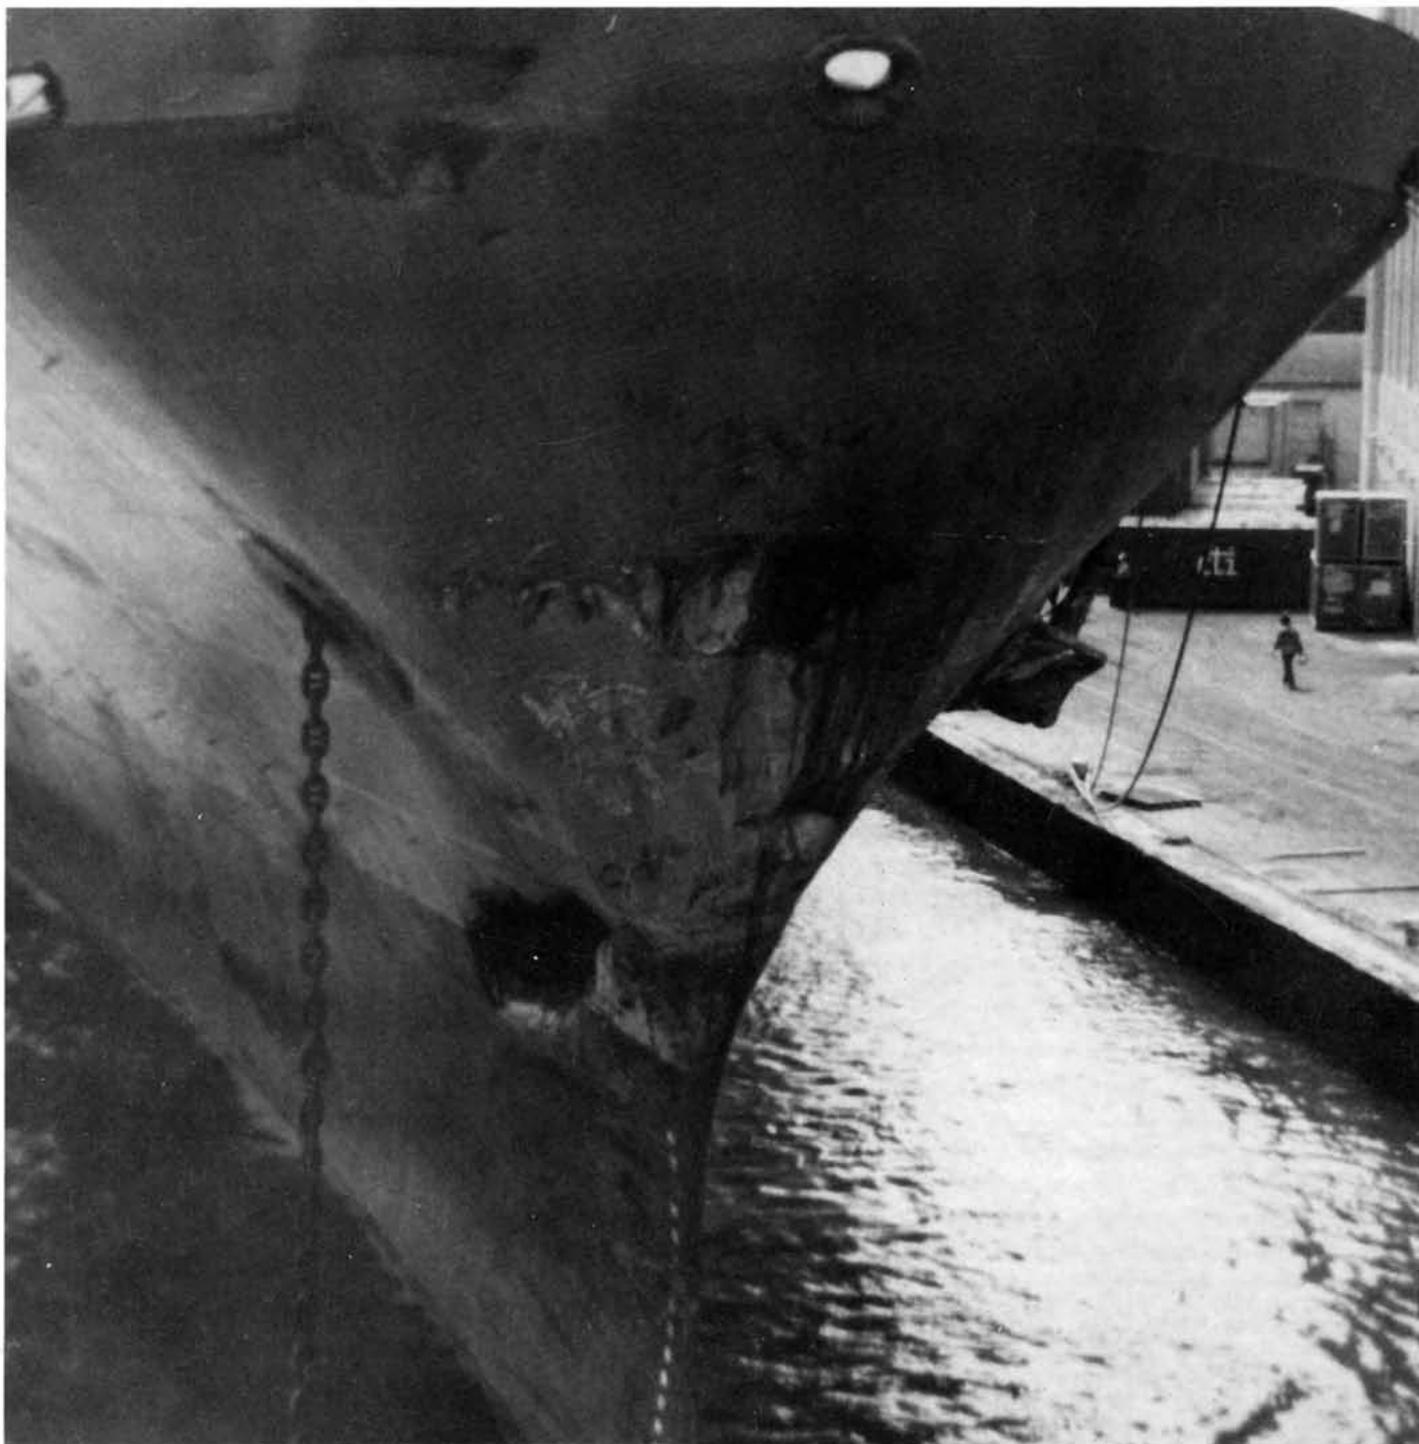
Automated propulsion throttle runaways have resulted in damage similar to that sustained by this vessel. The article on page 43 presents some of the Coast Guard's findings on this safety problem. (Official U.S. Coast Guard photo)

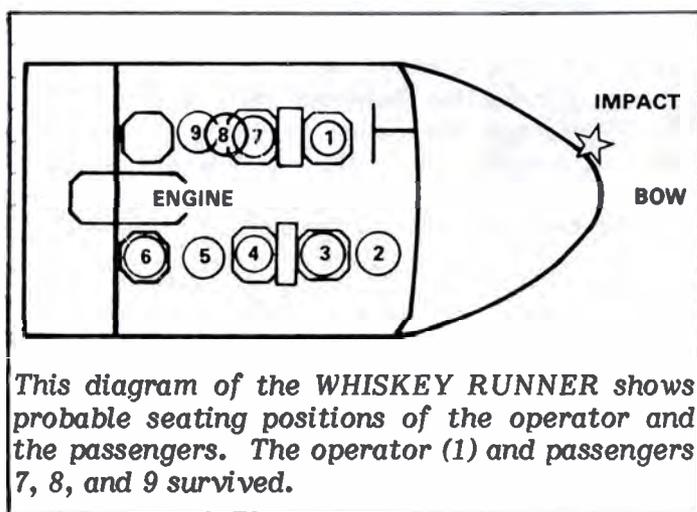
- Passenger 2: pinned between right-front seat and dashboard.
- Passenger 3: below deck in forward section, feet toward bow.
- Passenger 4: below deck in forward section, feet toward stern.
- Passenger 5: below deck in forward section, feet toward stern.
- Passenger 6: outside boat with legs through hole in port bow.

According to the medical examiner's report, three of the fatalities were due to drowning; these three persons had head and facial injuries as well as other minor injuries to the body. The other two fatalities received more traumatic injuries as a result of the collision and died from loss of blood. Blood, urine, stomach content, and tissue samples from the deceased passengers were analyzed for alcohol and drugs.
