Examples of Proper FRP Repairs

What to Expect During a Hull Inspection Fiberglass Vessels

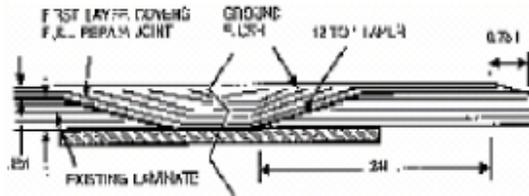
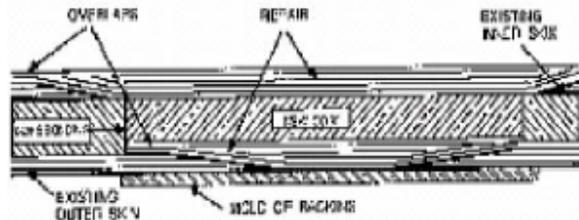
FIGURE 2-2

Note 12:1 Ratio Taper of Material

- The recommended method is to lay the first layer over the entire joint, including overlap, then build up the required thickness.
- The subsequent layers should be somewhat wider than necessary, then ground smooth after cured for the final layer used to seal the exposed edges.
- The laminating process should be done carefully to ensure that the proper glass content is maintained and the plies are fully pressed into the various breaks in the joint.
- The extent to which additional reinforcement is carried is dependent upon the location of the repair in the vessel, the size of the repaired area and the quality of the repair materials.
