MEMORANDUM

Subj: FINAL DECISION LETTER ON THE CGC POLAR SEA CB-L CAPSIZING, CLASS "B" MISHAP, 09 MAR 2009.

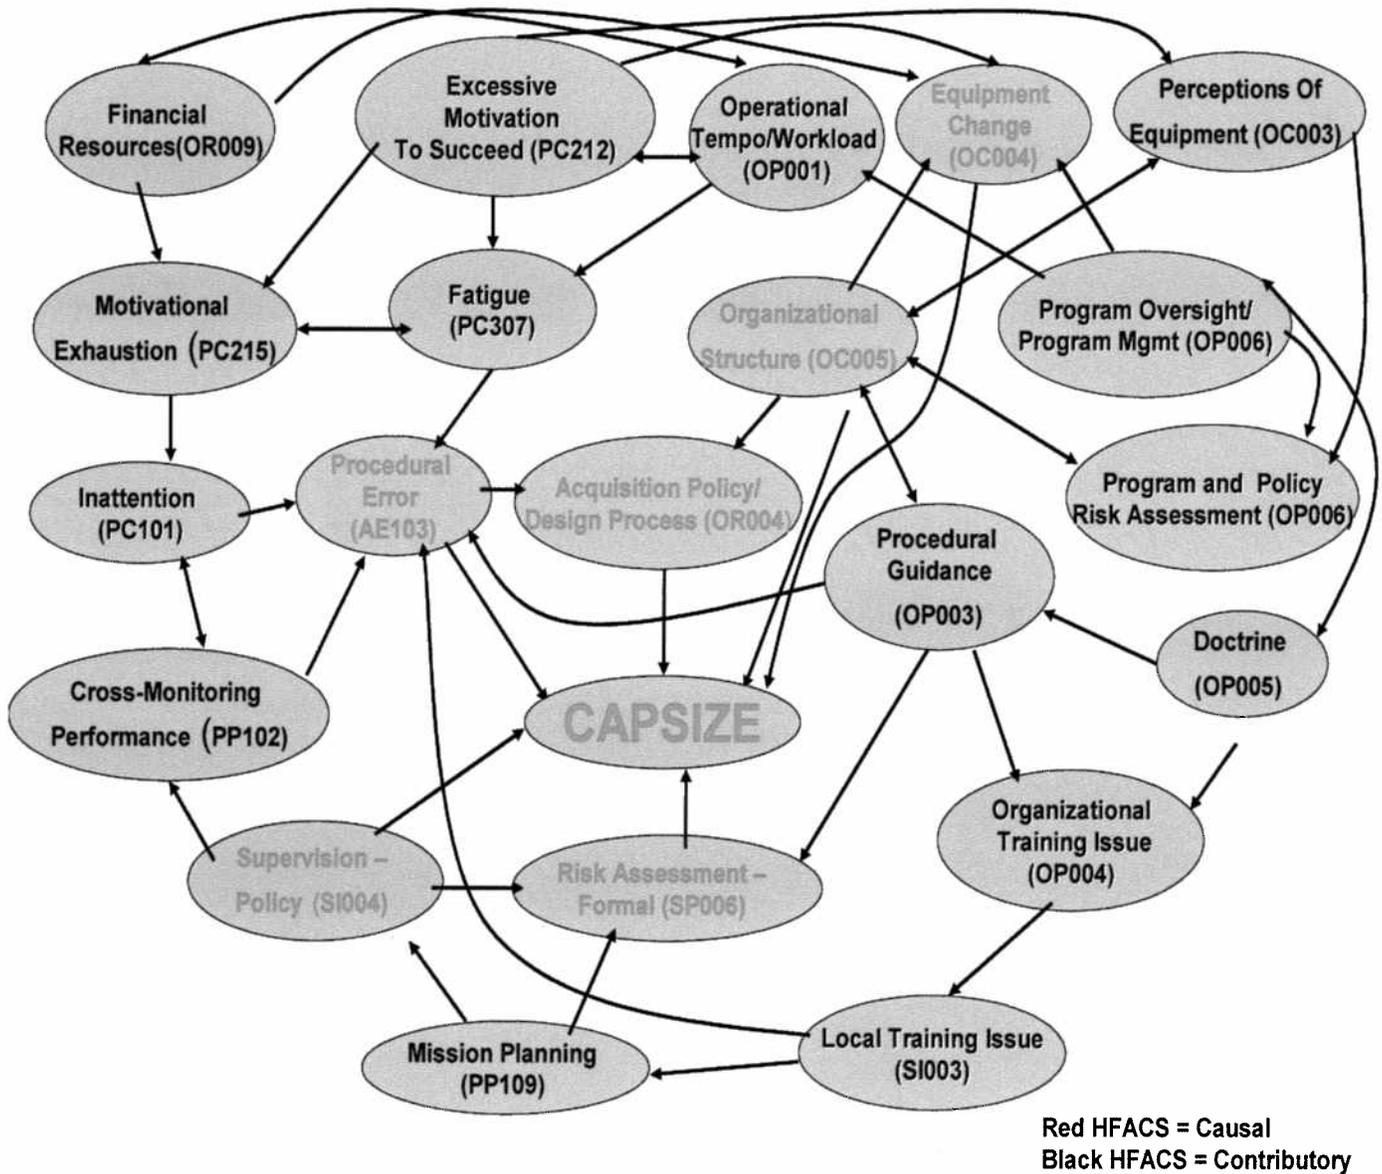
Relationship of HFACS Elements

A. HUMAN FACTORS: As outlined in reference (b), the Department of Defense Human Factors Analysis and Classification System (DoD HFACS) provides a systematic, multidimensional approach to error analysis, standardizing the human factors analysis approach for the investigation of mishaps. DoD HFACS examines four main tiers of failures/conditions: Acts, Preconditions, Supervision, and Organization. Enclosure (1) illustrates the relationship of HFACS elements in an Influence Diagram for this mishap.
