PROCEEDINGS OF THE
MERCHANT MARINE COUNCIL
UNITED STATES COAST GUARD

Vol. 9

December 1952

No. 12

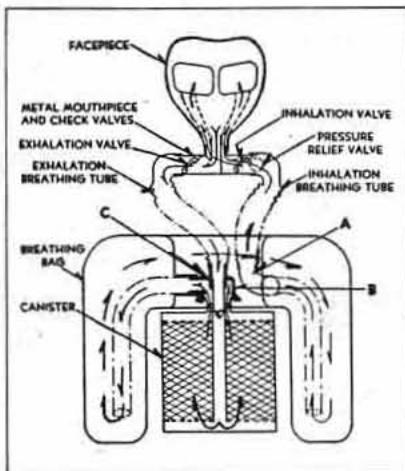
THE FACEPIECE ASSEMBLY

The facepiece assembly consists of a facepiece and attached breathing tubes. The facepiece is the "All-Vision" type, having large contoured lenses. Lens fogging is prevented by the flow of dry oxygen directed across the lens by ducts located in the facepiece.

Attached to the lower portion of the facepiece is a metal facepiece valve assembly, containing inhalation and exhalation check valves and a manually operated pressure relief valve. (This valve permits one-direction flow only. Therefore, it is not possible to inhale through it and contaminate the breathing system.)

Connected to the ends of the valve assembly are corrugated rubber breathing tubes. The inhalation breathing tube leads into the left side of the breathing bag via an elbow (A) mounted on the plunger assembly. The exhalation tube directs the exhaled breath into the canister via the plunger casting (B). The breathing tubes are fastened at both ends by

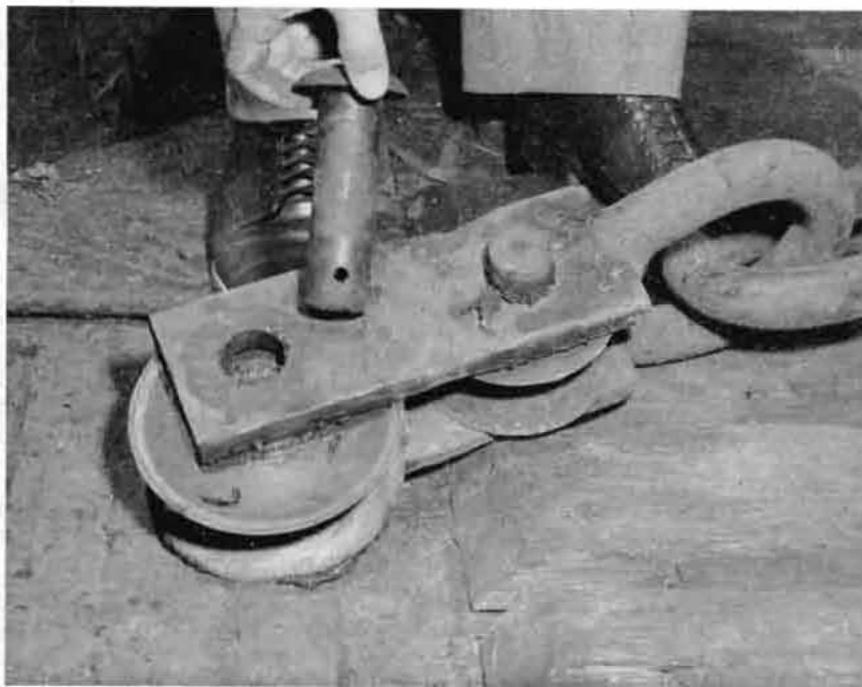
The apparent cause of this fatal accident was the breaking off of the cotter pin on the fair-lead block which allowed the towing wire to sweep across the deck and fatally injure the deceased. Obviously, the cotter pin in question was *inadequate* and *unsafe* due to its deteriorated condition. By referring to the illustrative picture, it can be readily seen just how inadequate the cotter pin assembly would be even under the best of conditions.

We suggest and urge that such fair-lead block arrangements be recognized as unsafe and, recommend that a bearing pin secured *with* a nut and retaining pin be used.
